NAFLIC

TECHNICAL BULLETIN — MAY 2007

324. Cracking found on Maurer Sohne Mouse

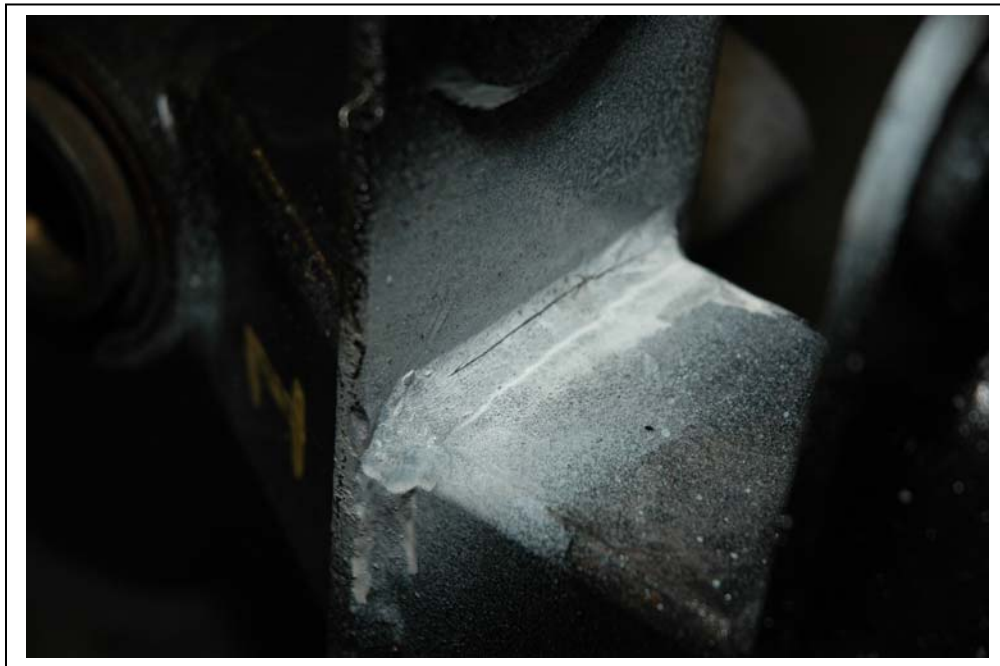
During a recent thorough examination of the wheel clusters from a Maurer Sohne Mouse Coaster manufactured in 1994, cracks were recorded in the horizontal welds on the sides of several Clusters. The defects were detected using fluorescent magnetic particle inspection. The manufacturer was contacted provided with all the relevant information.

Maurer Sohne has made a welding repair/procedure available. However it would be advisable that anybody with similar problems should seek guidance prior to implementing any repairs. Care must be taken when repairing the clusters as distortion may occur during the welding process.

Careful monitoring of the Cluster in this area should be scheduled into the daily inspection.
