# NAFLIC

TECHNICAL BULLETIN — DECEMBER 2007

## 328. KMG Afterburner

Bulletin No.: FRB-SB006  
Ride: Afterburner by KMG International BV  
Relative Rides: All Models

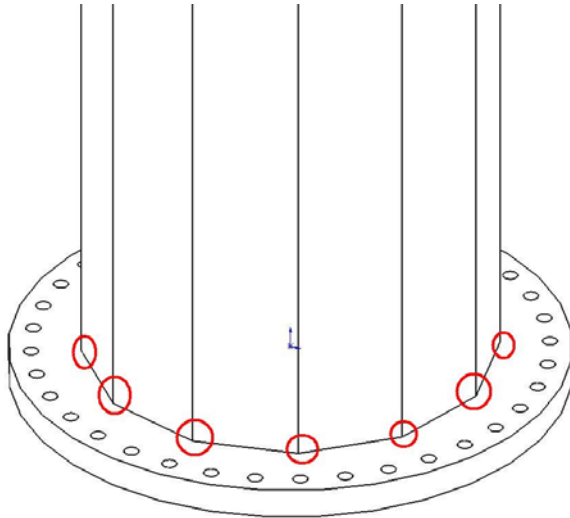
**Situation**

On recent investigation on one of the Afterburner rides, it was discovered that structural fatigue cracking of the swing arm was developing on Afterburner rides supplied by KMG. Applied area is the weld which connects the 12-sided tube to the bottom bearing flange.

Cracks were found in the area of the corners of the 12-sided tube, just above the weld to the bearing flange plate, perpendicular to the swing direction of the swing arm. Attached is a situation drawing of the affected area.

Affected areas next to the weld of the bearing flange are shown in the sketch below.

All Afterburner rides need to be tested for cracks by a certified NDT company by using visual and magnetic testing. For these tests, the paint must be removed from the steel tube and weld. The results need to be reported to KMG. In case cracks are discovered, the cracks need to be grinded out and to be repaired by a certified welding company.
