## 328. KMG Afterburner

Bulletin No.: FRB-SB006  
Ride: Afterburner by KMG International BV  
Relative Rides: All Models

Regarding: NDT testing of swing arm weld area

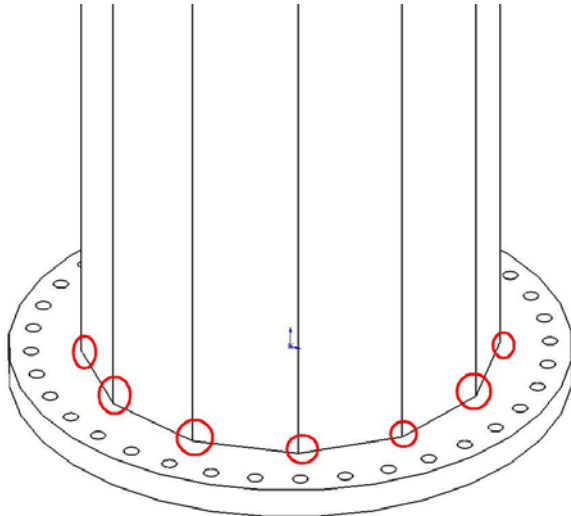
**Situation**

On recent investigation on one of the Afterburner rides, it was discovered that structural fatigue cracking of the swing arm was developing on Afterburner rides supplied by KMG. Applied area is the weld which connects the 12-sided tube to the bottom bearing flange.

Cracks were found in the area of the corners of the 12-sided tube, just above the weld to the bearing flange plate, perpendicular to the swing direction of the swing arm. Attached is a situation drawing of the affected area.

Affected areas next to the weld of the bearing flange are shown in the sketch below.

All Afterburner rides need to be tested for cracks by a certified NDT company by using visual and magnetic testing. For these tests, the paint must be removed from the steel tube and weld. The results need to be reported to KMG. In case cracks are discovered, the cracks need to be grinded out and to be repaired by a certified welding company.
