# NAFLIC

TECHNICAL BULLETIN — JUNE 2008

## 341. Satori Techno Jump

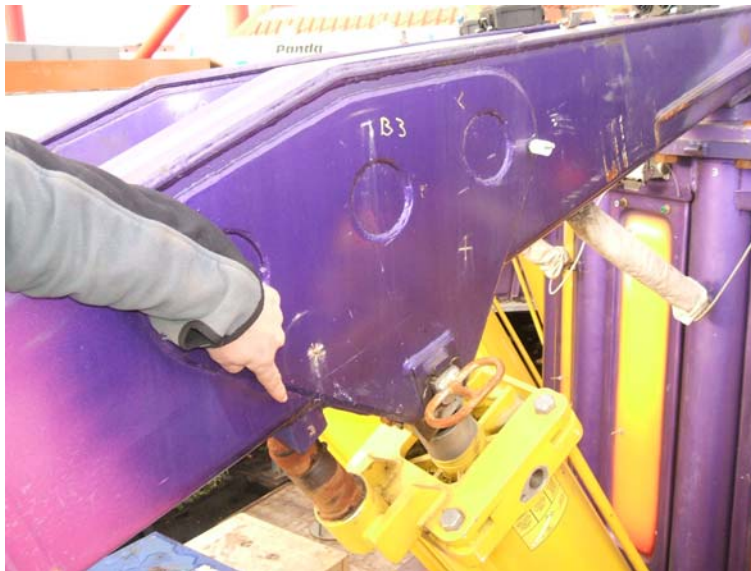
The defects are located on the underside of the radial arms adjacent to the lifting cylinder attached damper unit. A block is welded to the radial arm that makes contact with the damper; the defects are located on the block to arm weldments. A modified block design has been supplied by SARTORI that has been subjected to a design review by ACG Engineering Ltd. This area is subjected to numerous stress reversals during one ride cycle and therefore needs regular monitoring.

1.1 Location of defects in the radial arms.

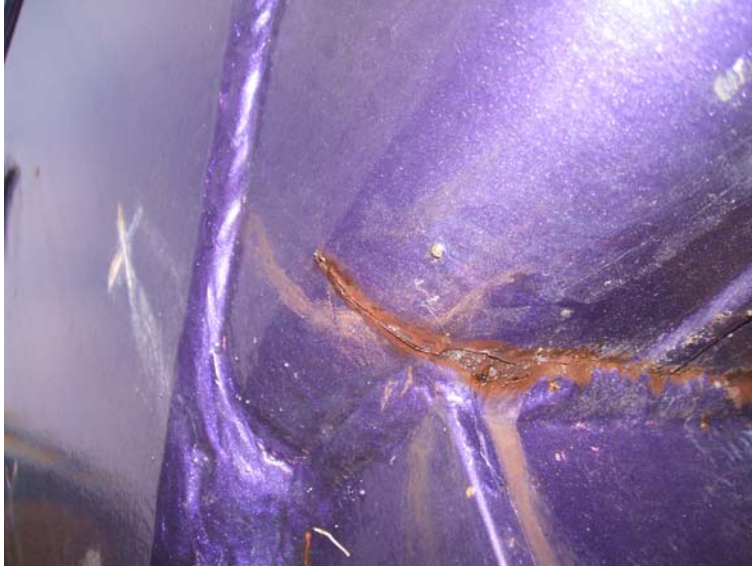
1.2 Typical example of a defect in the affected area.

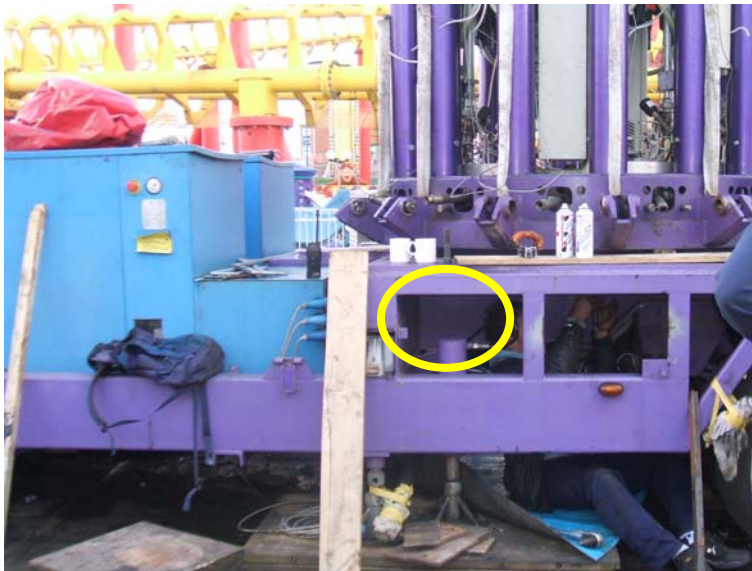
The cracking has occurred underneath the slew ring bearing as shown below. Sartori have been informed about the defect for which they provided a repair scheme. However, the cracking re-appeared within one season. It is considered necessary that an inspection of this area is included in the annual in-service inspection and the controller should also ensure that the trailer structure is included in the documented periodic checks.

2. 1Location of cracking under the slew ring.

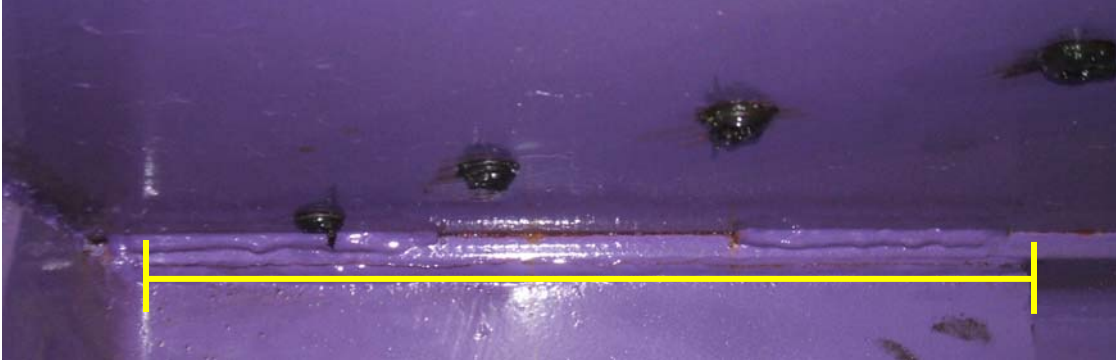
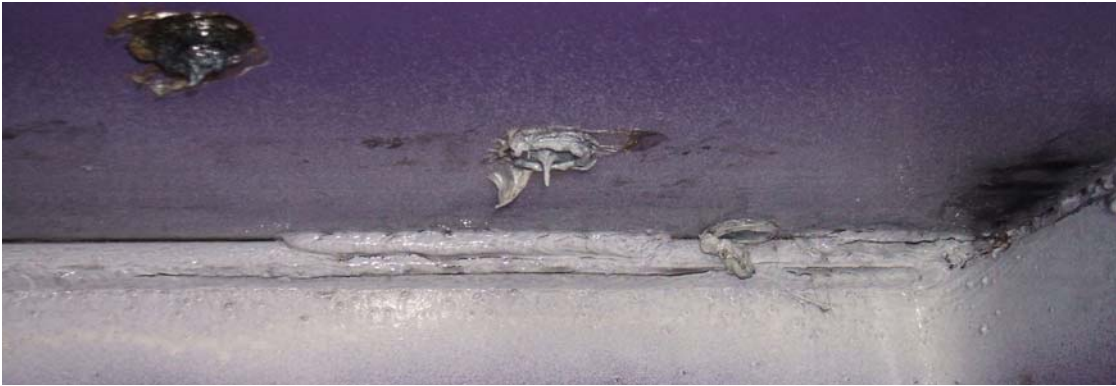
2.2 Detail of area of cracking under the slew ring.
