# NAFLIC

TECHNICAL BULLETIN — JUNE 2008

## 344. Mondial Top Scan

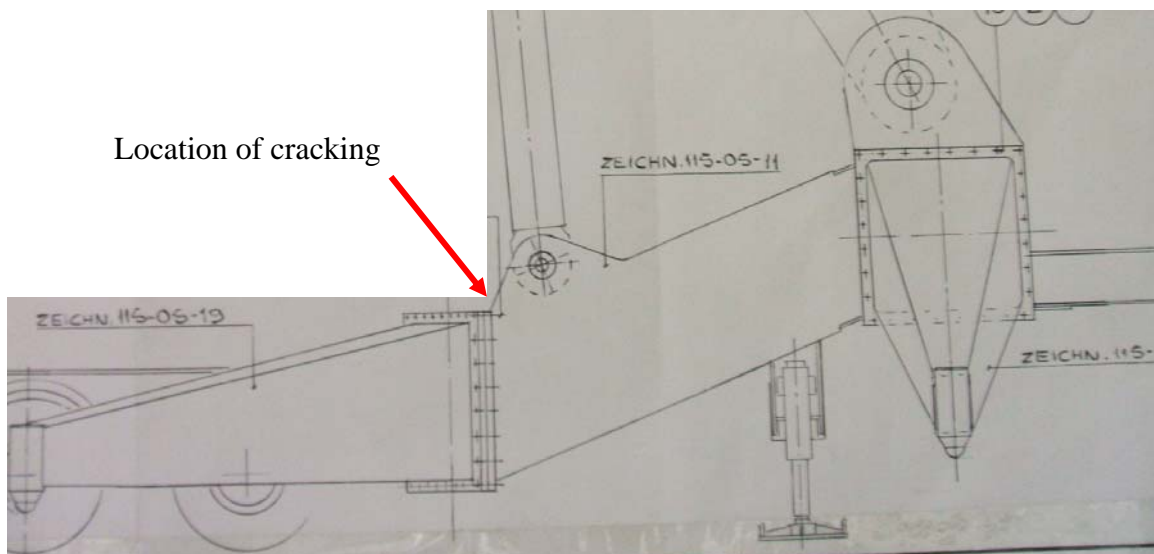
We have been informed by Leisure Technical Consultants Ltd. of defects on the Mondial Top Scan or Top Buzz device. The cracking is located in the outrigger – chassis weldments as shown below.

1. Side elevation drawing showing the location of cracking.  
(Taken from the manufacturers drawing).

A repair procedure must be obtained from Mondial prior to any repairs being carried out.
