National Association For Leisure Industry Certification

TECHNICAL BULLETIN — AUGUST 2008

352. Octopus Centre Stub Shaft Defect

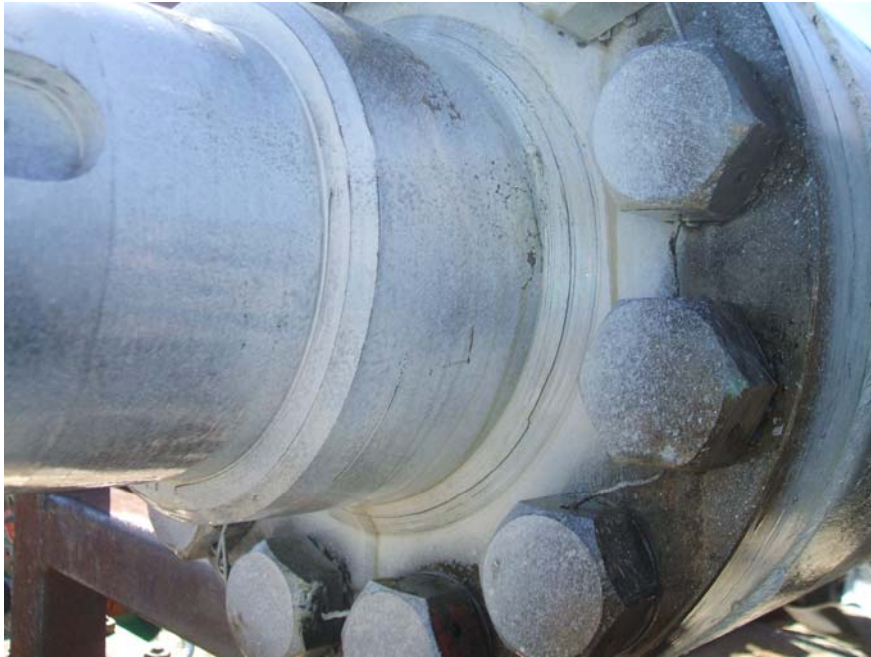
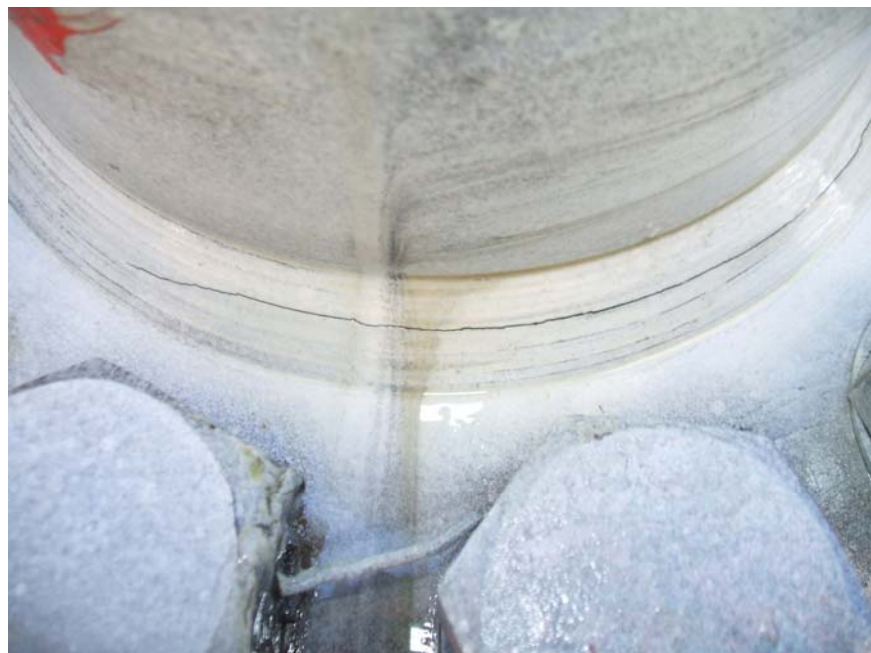
The committee has been informed of the following crack found on the centre stub shaft from a Hayes Fabrications Octopus ride. The shaft supports and aligns the inner and outer rotating poles of the ride centre.

This was the first time the shaft had been inspected since it was manufactured circa 1964. This demonstrates the importance of ensuring the shaft is disassembled from the ride in order to facilitate NDT. It was noted that the component was particularly difficult to remove from the device. Controllers and Registered Inspection bodies are reminded of the requirements of paragraph 137 in Fairgrounds and amusement parks Guidance on Safe Practice (HSG 175).
