# NAFLIC

TECHNICAL BULLETIN — AUGUST 2008

## 352. Octopus Centre Stub Shaft Defect

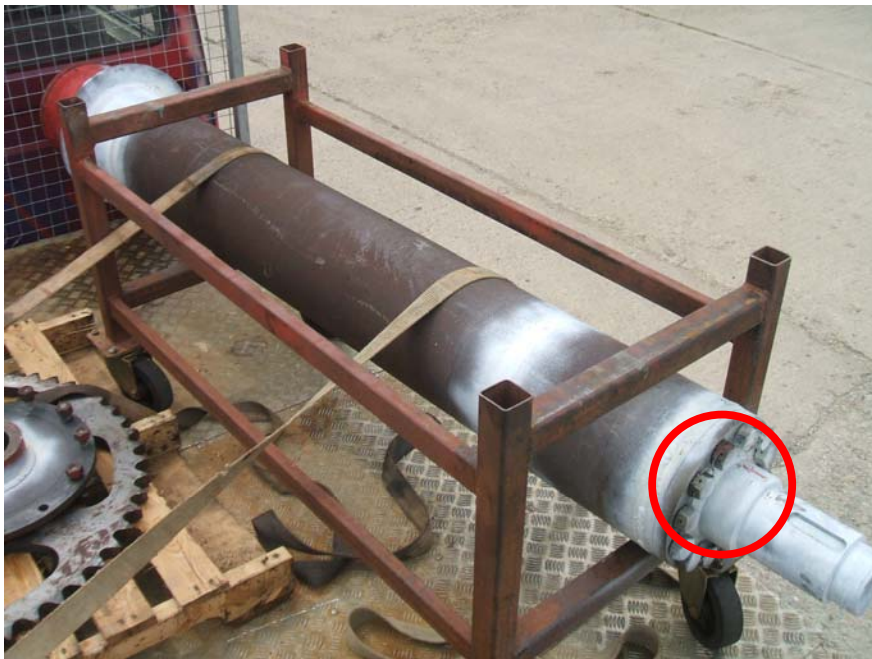
The committee has been informed of the following crack found on the centre stub shaft from a Hayes Fabrications Octopus ride. The shaft supports and aligns the inner and outer rotating poles of the ride centre.

This was the first time the shaft had been inspected since it was manufactured circa 1964. This demonstrates the importance of ensuring the shaft is disassembled from the ride in order to facilitate NDT. It was noted that the component was particularly difficult to remove from the device. Controllers and Registered Inspection bodies are reminded of the requirements of paragraph 137 in Fairgrounds and amusement parks Guidance on Safe Practice (HSG 175).
