Bulletin No:	B380CRM185-0
Release Date:	October 18, 2013
Effective Date:	October 18, 2013
Supersedes:	N / A
Completion Date:	Immediately
Page:	1 of 4

SERVICE BULLETIN

Ride Name: ZUMUR Affected Serial Nos.: All Units

Abstract of Issue:
Hydraulic Motor Shaft Maintenance and Inspection

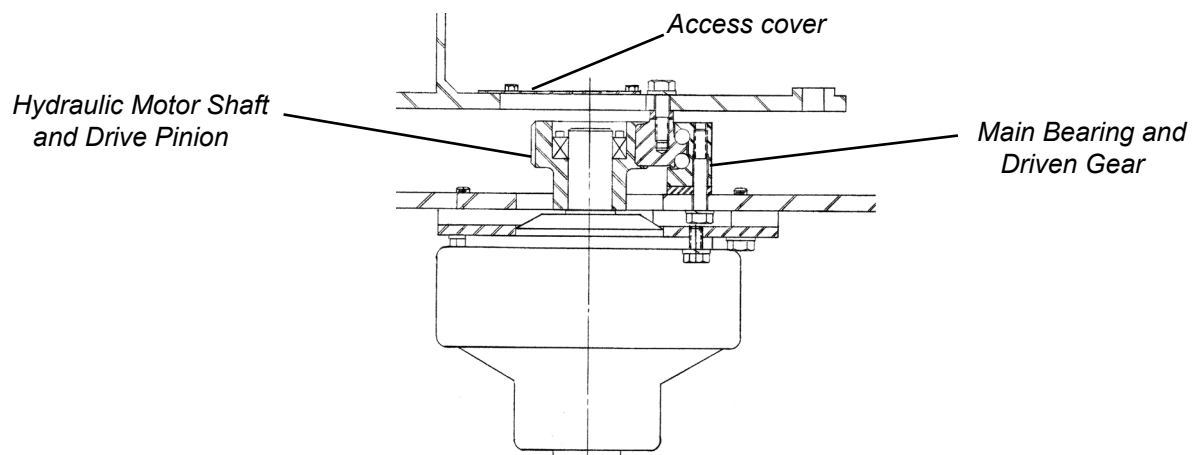
Maintenance and Inspection Schedule for Hydraulic Motor and Pinion

1. Pinion drive gear inspection - Look for wear or damage on the external teeth of the pinion.
2. Main bearing gear inspection - Look for wear or damage on the internal teeth of the main bearing.
3. Pinion drive gear and main bearing gear lubrication - Apply/redistribute grease to the gear teeth.

4. Pinion gear backlash adjustment - Check the backlash between the pinion gear and the main bearing gear teeth. Proper backlash is 0.010 to 0.015".
5. Non-destructive test (NDT) of the hydraulic motor shaft - This procedure is described in detail on page 4 of this service bulletin. (This inspection must be performed by certified Level II ultrasonic NDT inspection personnel).
