Bulletin No:	B380CRM185-0
Release Date:	October 18, 2013
Effective Date:	October 18, 2013
Supersedes:	N / A
Completion Date:	Immediately
Page:	1 of 4

SERVICE BULLETIN

Ride Name: ZUMUR Affected Serial Nos.: All Units

Abstract of Issue:
Hydraulic Motor Shaft Maintenance and Inspection

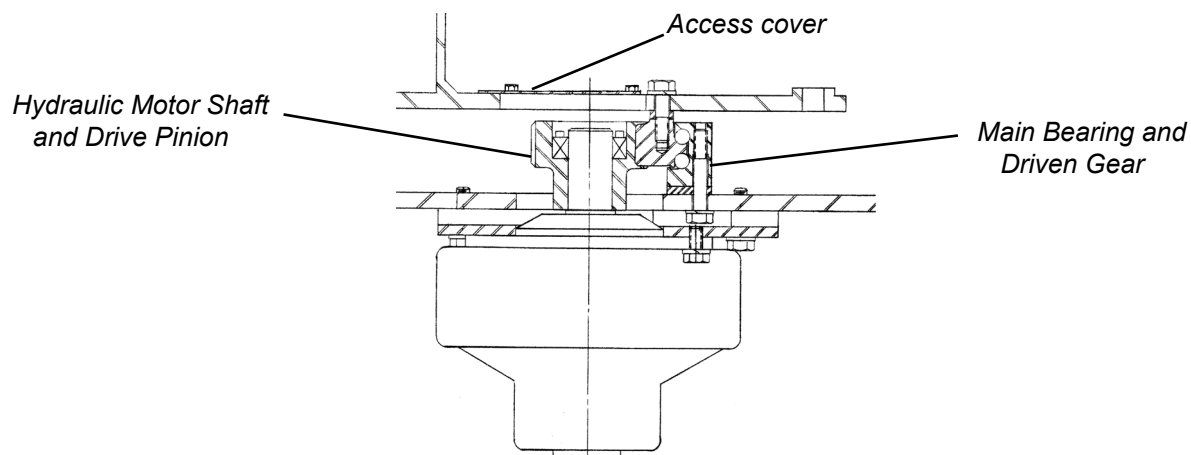
1. Pinion drive gear inspection - Look for wear or damage on the external teeth of the pinion.
2. Main bearing gear inspection - Look for wear or damage on the internal teeth of the main bearing.
3. Pinion drive gear and main bearing gear lubrication - Apply/redistribute grease to the gear teeth.

4. Pinion gear backlash adjustment - Check the backlash between the pinion gear and the main bearing gear teeth. Proper backlash is 0.010 to 0.015".
5. Non-destructive test (NDT) of the hydraulic motor shaft - This procedure is described in detail on page 4 of this service bulletin. (This inspection must be performed by certified Level II ultrasonic NDT inspection personnel).

NOTE: Remove the four bolts which secure the access cover over the drive pinion to gain access to the components described below.
