SAFETY ALERT/ACTION NOTE **CRAZY FROG TYPE RIDES**

This alert results from the now closed investigation into the Crazy Frog accident on Blackpool Central Pier on 29 July 2009. The investigation involved HSE Specialist Mechanical Inspectors and Specialists from the Health and Safety Laboratory (HSL).

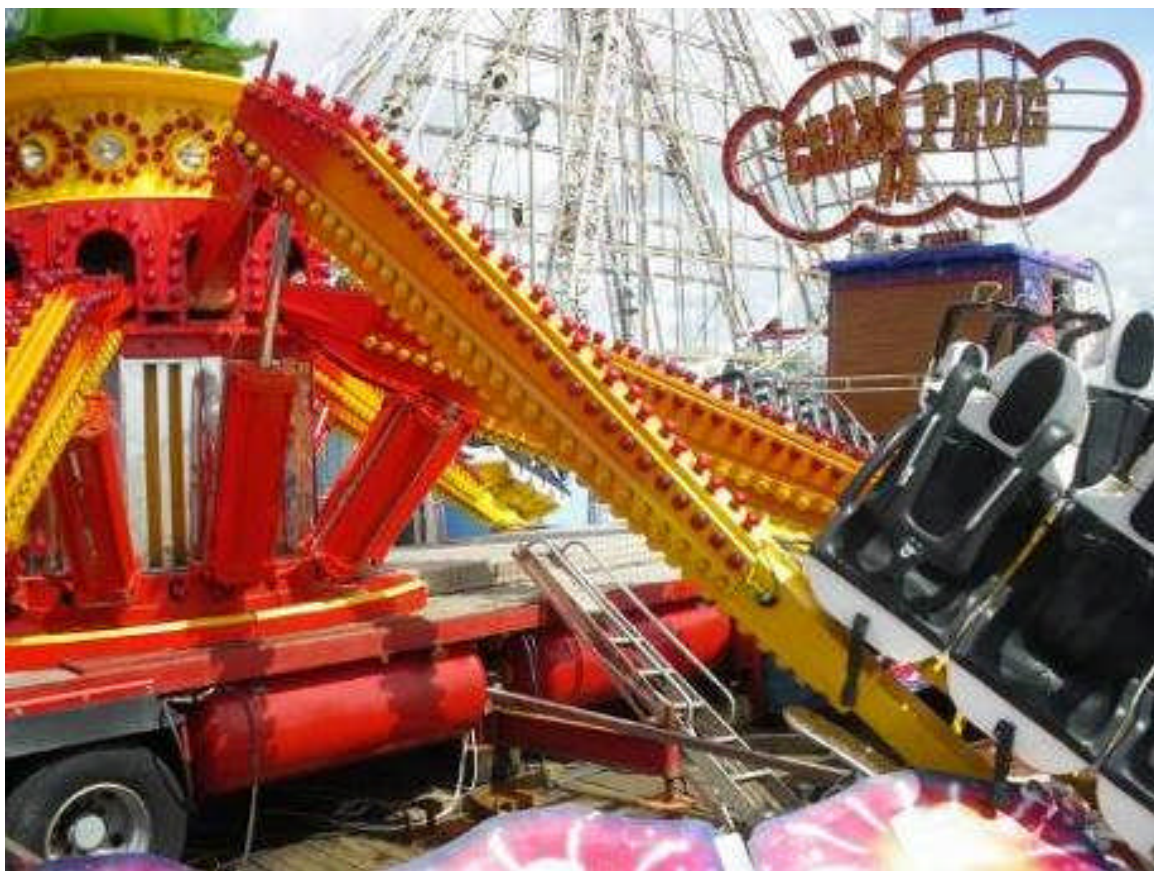
The accident occurred when a radial arm collapsed whilst the ride was running. Two riders were in the car at the time but there were no serious injuries. A photo of the ride with the broken arm in situ is at Fig 1.

The Report into the accident concluded that the failure of the arm was the result of fatigue cracking. The arm fractured through 3 sides of the fabricated box section. This cracking is highly likely to have started at the site of a series of welds that had probably been made to repair a previous instance of fatigue cracking. It is believed that this was done sometime after manufacture. Another of the arms had received similar welds. Some of these welds were of poor quality incorporating weld laps, slag entrapment, gas pores, lack of fusion and cracks.

- 1 Have the areas identified in this Alert examined if they have not already done so for any evidence of poor quality weld repair or fatigue cracking and have any defects repaired by a competent person.

- 4 It would be good practice for controllers to conduct regular visual checks of the areas identified in this Alert for surface breaking cracks. If any are found, the machine should immediately be taken out of use and the advice of their ride examiner sought.

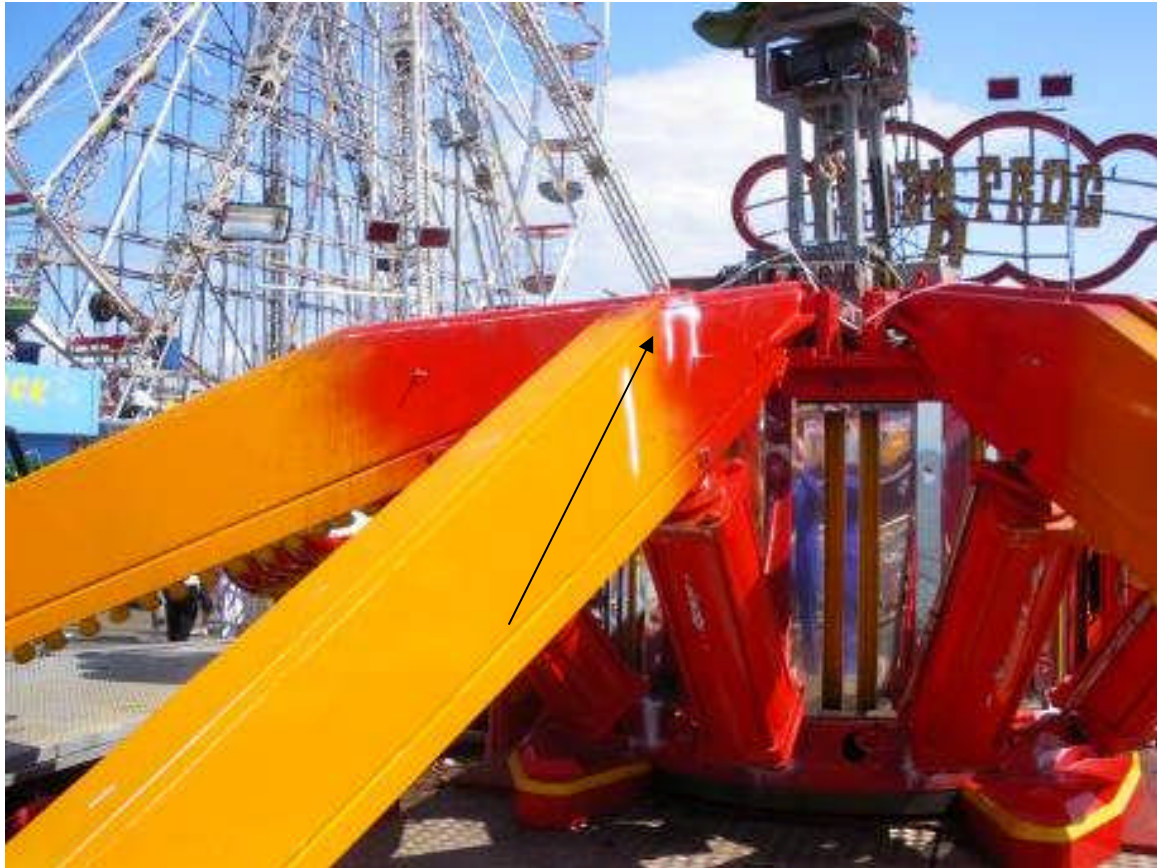
The repair welds were both along the arm (longitudinal) and across the arm (transverse) and the failure appears to have started at the point where two transverse welds met at the upper right hand corner of the arm box section at a point close to that shown in Fig 2.

During their in service annual inspection they should visually check all of the stress bearing longitudinal and transverse welds on the radial arms to ensure that any welding subsequent to manufacture has been done competently. The quality of the welds should be confirmed by NDT.
