SAFETY ALERT

SAFECO CRAZY FROG

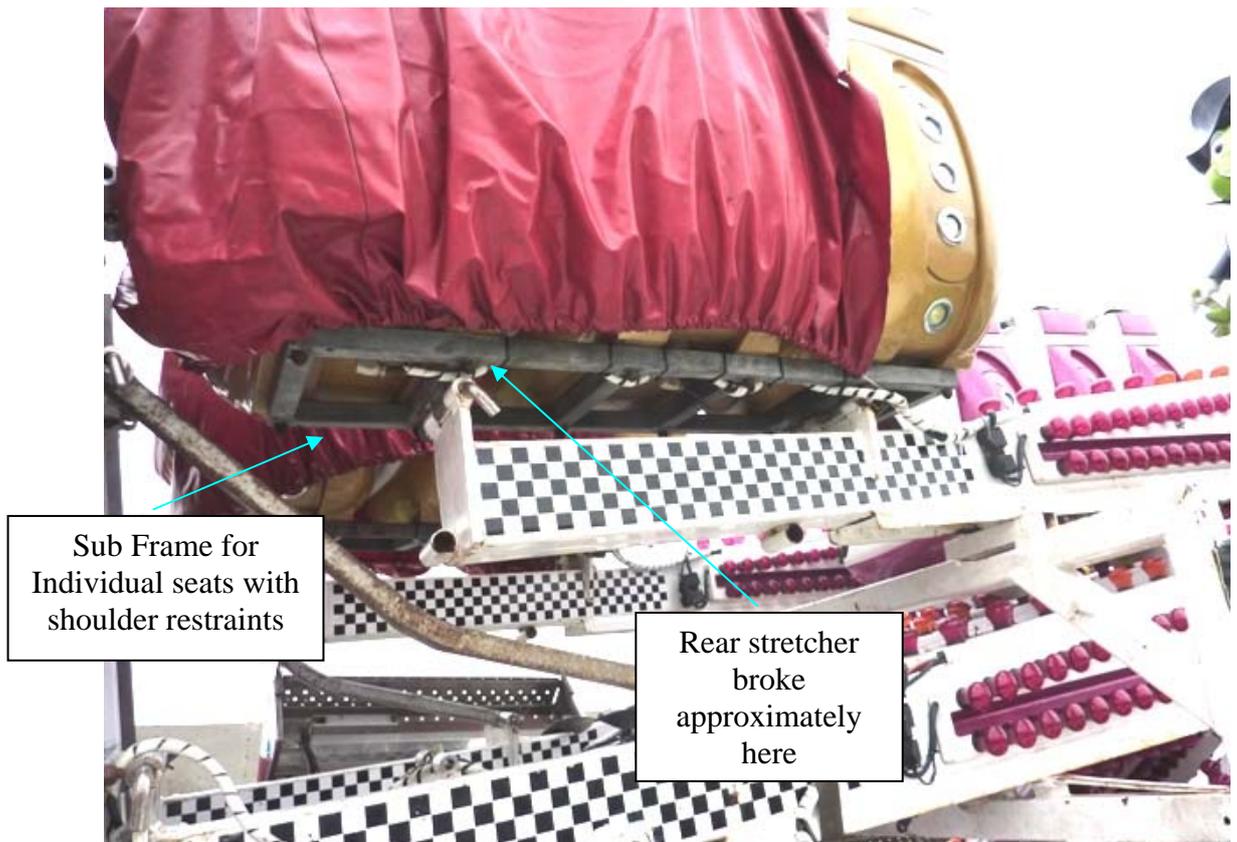
Fig 1.

A recent accident involving a Safeco Crazy Frog on the Isle of Wight has highlighted a potential problem with a welded sub frame on a version of the Safeco Crazy Frog. The sub-frame is at the end of the radial arms on the machines, which are fitted with 3 separate seats as shown in the photo at Fig 1 below. The separate seats are likely to be bolted through the sub frame.

The seat sub-frame is a simple box section ladder frame with two stretchers and four rungs with a mixture of full penetration welding and fillet welding. One of the two stretchers broke just inside the position of the outer seat which allowed the seat to tip. There were no serious injuries but it is probable that this would not have been the case had both stretchers broke.

From information gathered it is thought that the failure was due to a stress crack which may have been propagating for some time. It is not known whether the crack began from inside or outside the stretcher.

Controllers should conduct an initial visual inspection of all of the sub frames on their machines to identify any cracks. If any are apparent the machine should be taken out of use until these have been repaired/replaced as advised by their ride examiner (IB).

Controllers should then contact their ride examiners whether or not cracks are found to ensure that the correct non destructive testing method has been used to test these areas. As it is not clear whether the cracks started from inside the stretcher, ultrasound testing is recommended.

Any recommendations made by the ride inspector should be implemented before the ride is put back into service.

Inspection bodies should meet as soon as possible with owners of these machines for whom they have issued DOCs. They should also consult with the body that provided the NDT Report for the machine to ensure that the most appropriate method was used to test the sub-frames. The NDT Schedule should be reviewed to ensure that the test intervals are appropriate for the stresses on the sub frames.
