Bulletin No: B102CRM157-0
Release Date: April 2, 2008
Effective Date: April 2, 2008
Supersedes: N/A
Completion Date: June 2, 2008
Page: 1 of 4

SERVICE BULLETIN

Ride Name: C.P. HUNTINGTON

Air Compressor Bracket Rework

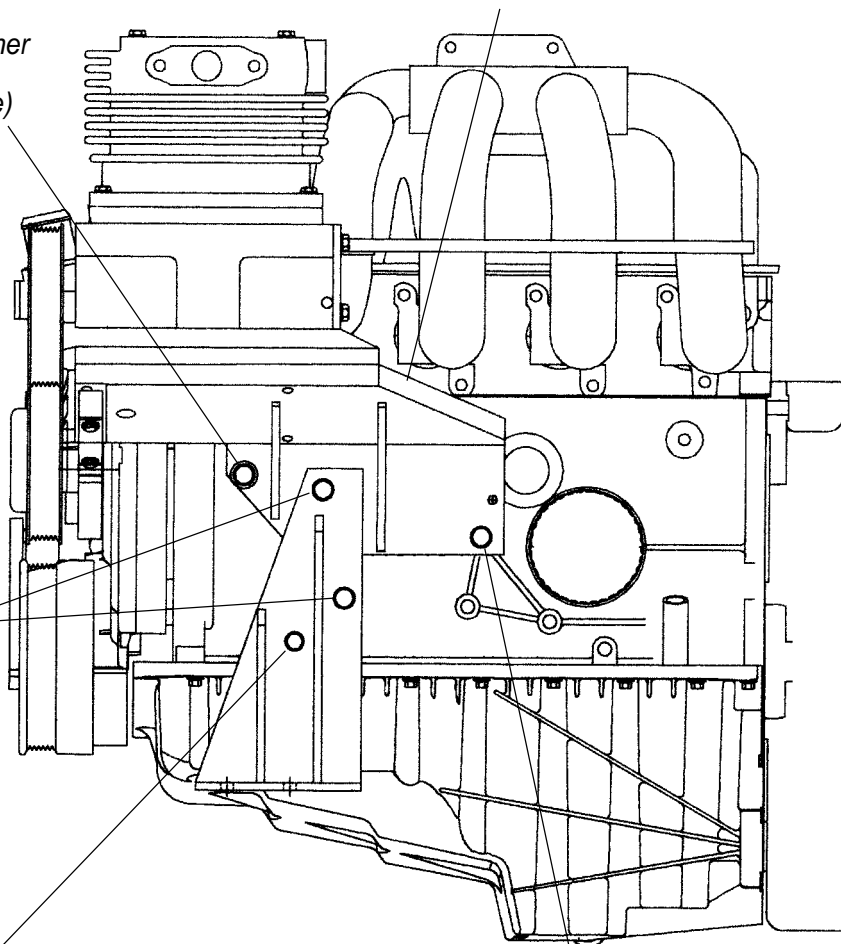
Air compressor bracket

The fasteners for the air compressor mounting bracket used on the above noted C.P. HUNTINGTON locomotives can become loose over time from vibration. Loose fasteners can result in possible damage to the bracket, compressor and even the engine block if the locomotive is operated in this condition.

1. Remove the old fasteners one at a time and replace with the fasteners exactly as shown in the following illustration. Discard the old fasteners - DO NOT RE-USE.

*M10-1.5 x 35mm capscrew
with 10mm special locking washer
at this location
(See Detail View on next page)*

*M10-1.5 x 40mm capscrew
with special locking washers
at these locations
See Detail View on next page*

*M8-1.25 x 40mm capscrew
with 5/16 special locking washer
at this location
(See Detail View on next page)*

*M10-1.5 x 92mm stud
with 10mm special locking washers
at this location
(See Detail View on next page)*
