CHANCE
MANUFACTURING CO., INC.

Service Information

Ride: YO YO RIDES 74-3300 THROUGH
76-3342

Subject: CYLINDER END CAP CHECK AND
REPLACEMENT

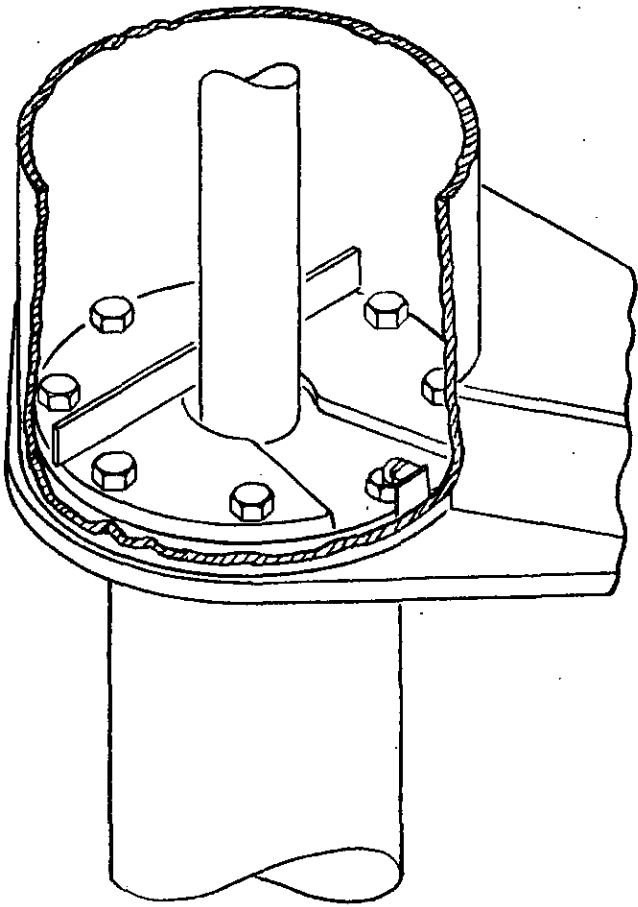
WITH TEMPORARY KIT

Place a straight edge across the end cap as shown in drawing. Check in at least two positions, 90° apart. Try to insert a 1/16" feeler gauge under straight edge. If end cap shows more than 1/16" gap, notify factory at once.
