CHANCE
MANUFACTURING CO., INC.

Number: 125
Date: 6-29-76

Service Information

Ride: YO YO

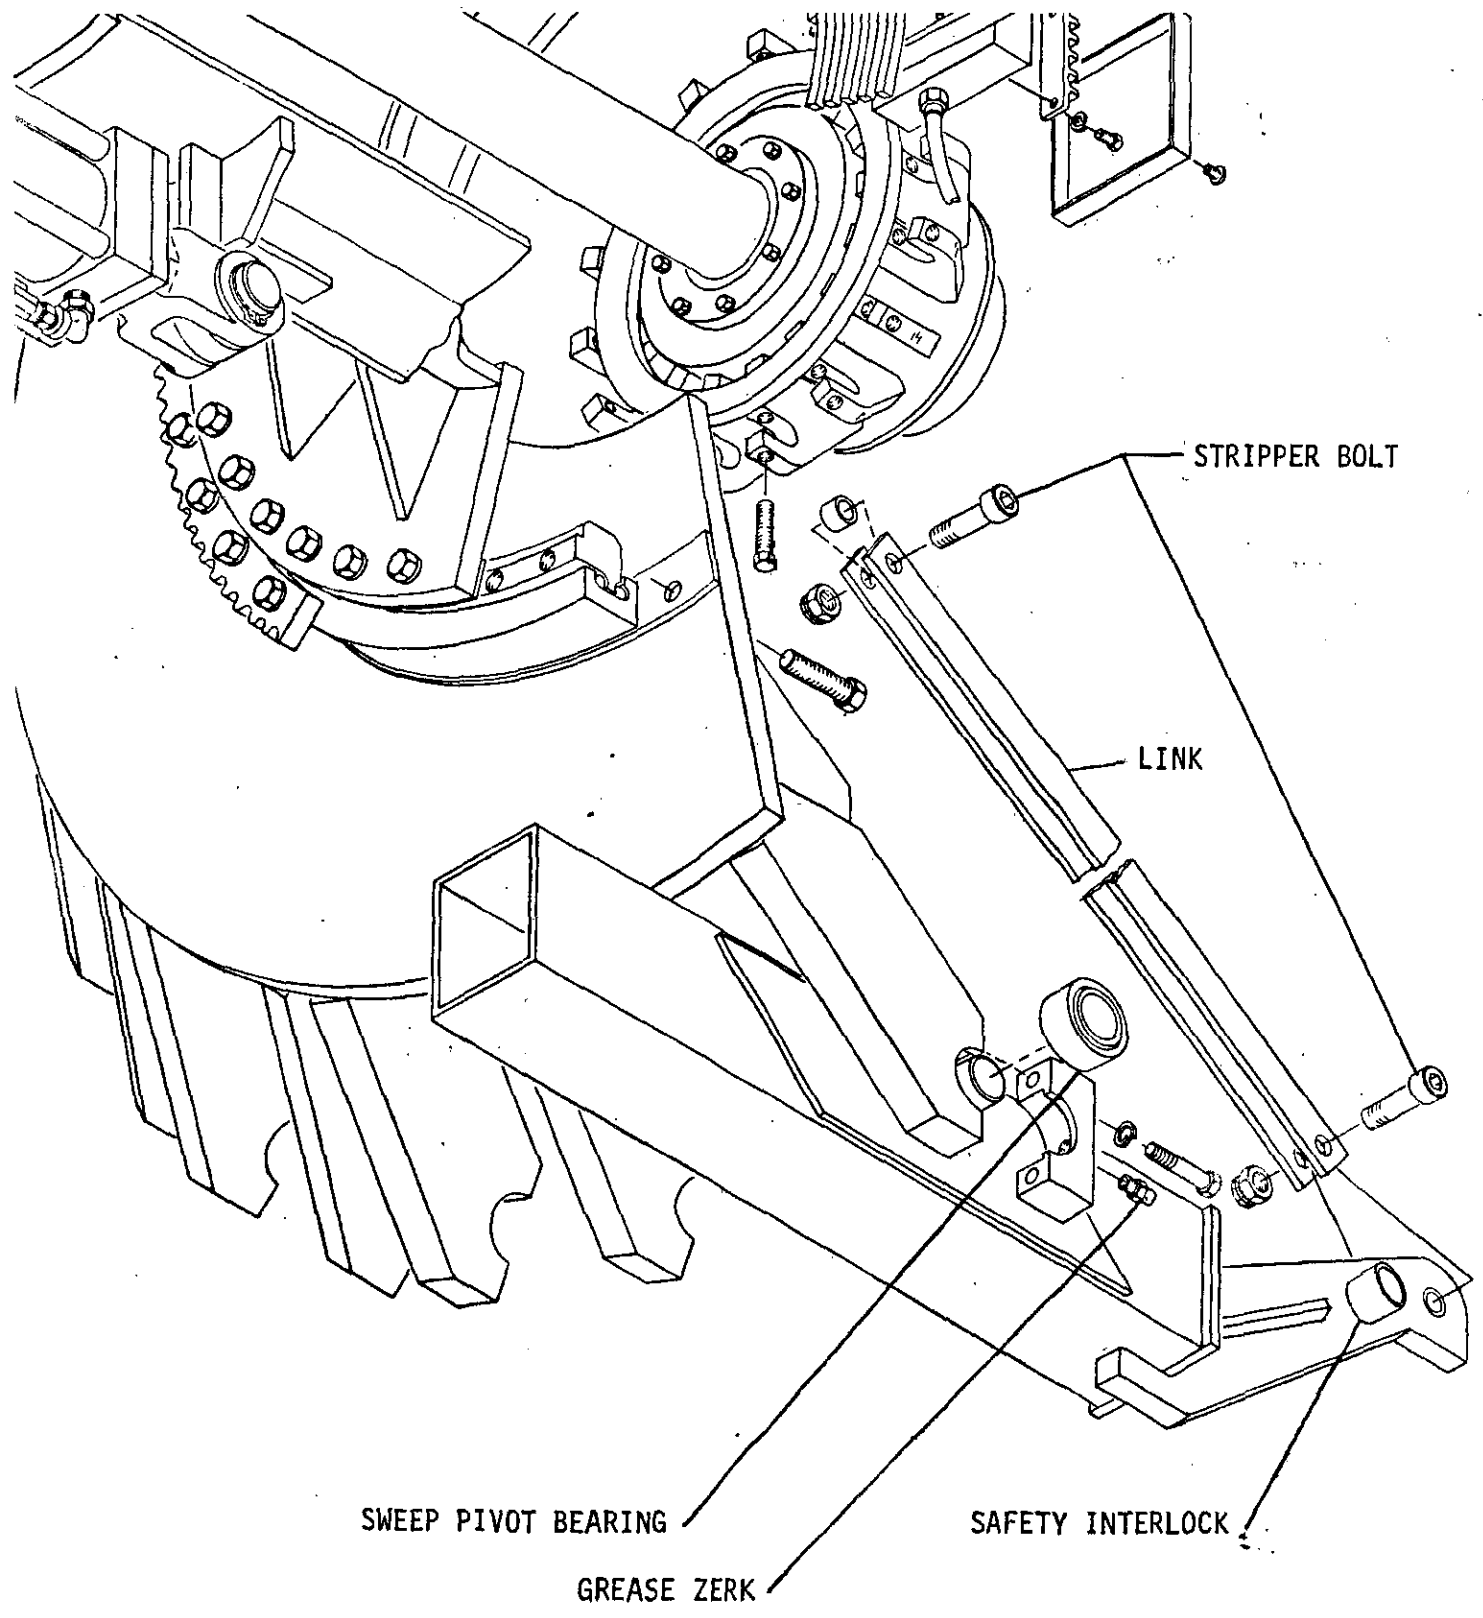
During set-up, pins securing sweep ends to tower must be removed before raising sweeps. Failure to do this has resulted in bent sweeps. If you cannot trust your help to remove the pins, leave them out when tearing ride down and wrap a chain around the sweeps securely.

On some rides the safety interlocks have been removed because of interference from bent sweeps. The interlocks are installed at the factory to help insure safe operation and should never be removed or altered.

The links and stripper bolts connecting the hub to the sweeps should only be replaced with factory purchased parts or parts meeting factory specifications.

The sweep pivot bearings should be greased weekly with the sweeps in full up, full down and several intermediate positions to grease the entire bearing. Teflon bearings which require no lubrication are available from the factory.
