Bulletin # SB-5K-001

SERVICE BULLETIN

Ride Name: Cliff Hanger

Abstract of Issue: Dartron is aware of Cliff Hanger rides that have developed cracks in the bearing base. The cracks may result from or be aggravated by transporting the Cliff Hanger without adequately supporting the sweeps and/or from unbalanced ride loading.

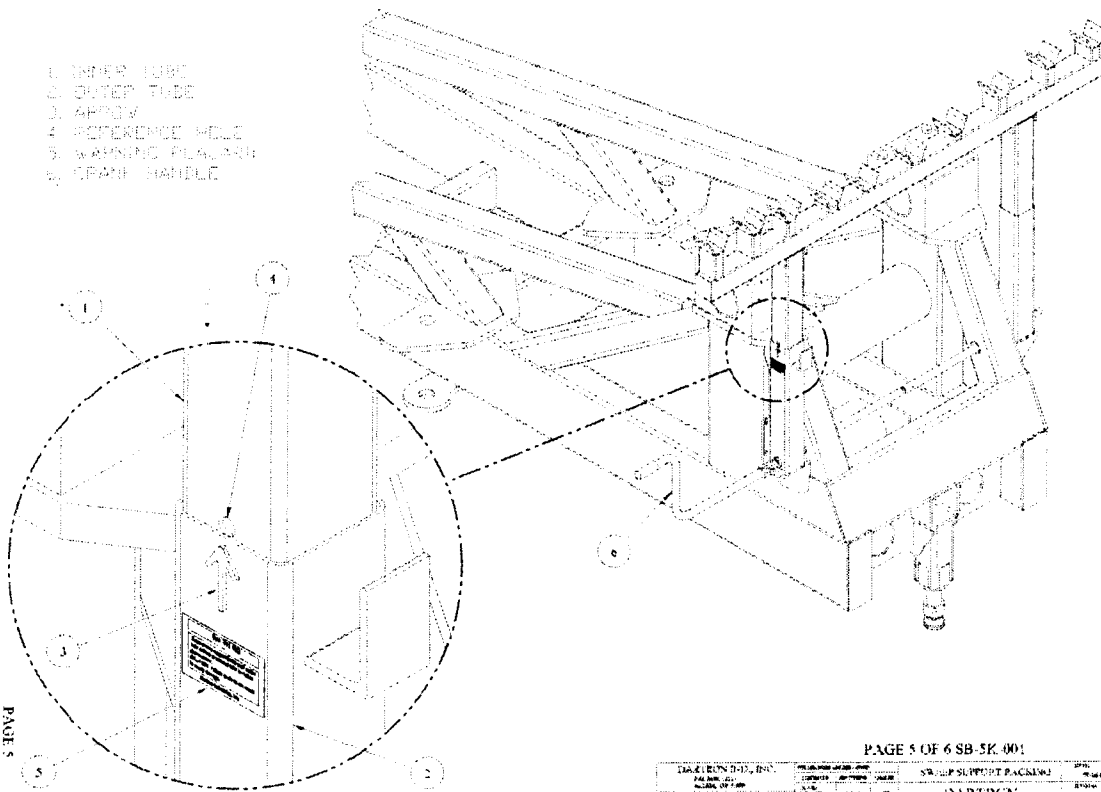
PAGE 5

- 1. INNER TUBE
- 2. OUTER TUBE
- 3. APPROX
- 4. REFERENCE HOLE
- 5. WARNING PLACARD
- 6. GRAB HANDLE

3. Visual references for the following steps are found on page five (5) of this document.
4. After the correct height is achieved, drill a 3/8 hole [Item #4] through the inner tube sleeve [Item #1] of the jack as indicated. The lower edge of the 3/8 hole should be even with the top edge of the outer jack tube.

5. Use a center punch or other permanent marking device and install an arrow [Item #3] on the outer sleeve [Item #2] of the jack as indicated.
6. Install the warning label [Item #5] below the arrow on the outer jack sleeve. Warning labels are available from Dartron Parts and Service.
