PRODUCT IMPROVEMENT BULLETIN

Ride Manufacture	r: Dartron Industries, Inc.	Affected Production D	Dates:
Ride Name:	StarTrooper	Affected Serial #'s	111141-5S
Model #

Abstract of Issue: StarTrooper bushing change

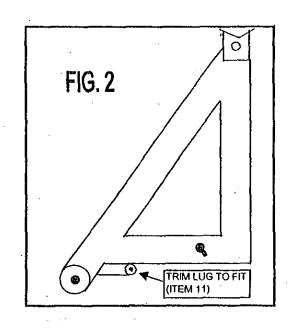
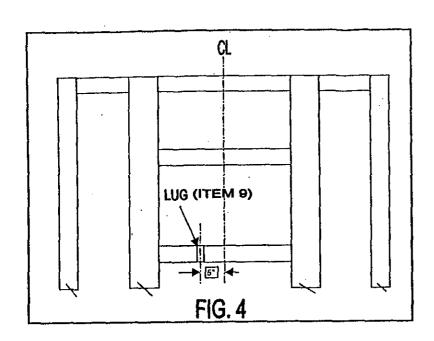
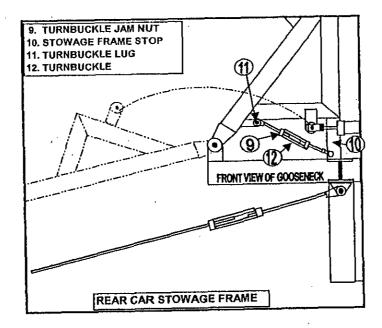
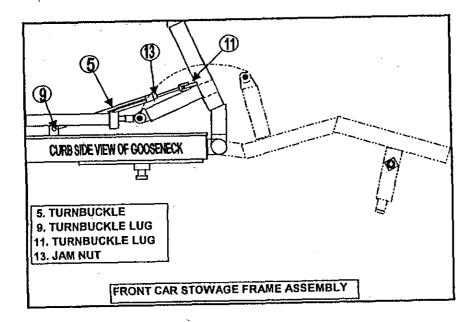
Reason for release: The StarTrooper has three car storage racks on the gooseneck platform. In the transport position these racks are hydraulically raised to a position above the gooseneck platform. The car storage racks are held in the transport position by (1) pressure from the hydraulic system (2) the over center position of the car storage racks and (3) a safety chain that attaches between the racks and the gooseneck platform.

Action to be taken: It has come to our attention in the event of a failure of the hydraulic system holding the carracks in position, if the safety chain is attached loosely, the safety rack could fall to the lowered position and cause the chain to break. Because of this possibility Dartron has developed a turnbuckle holding device that will ensure that the storage racks cannot drop to the unload position in the event of a hydraulic failure. Until the turnbuckle kit is installed, you must wrap a cargo strap or chain or similar device around all three car storage racks as a precaution against a hydraulic failure causing the racks to lower to the unload position. Caution: Failure to place a strap around all three storage racks during the transport mode or to install the turnbuckle kit could result in damage to the cars, the transport vehicle or other traffic.

- 1. Drill an 11/16-diameter hole in storage frame stops on trailer gooseneck (fig 1).
- 2. Trim supplied turnbuckle lugs (item 11) to fit storage frame (fig 2).
- 3. Establish centerline of frame. Weld turnbuckle lug (item 11) on center (fig 3).
- 4. Install short turnbuckle (item 12) with jam nut end (item 9) toward storage frame; install pin with R key. Install trailer side turnbuckle endpin; secure with cotter pin.

- 1. Unbolt and remove deck plate located at front of trailer.
 - 2. Measure and locate centerline of trailer gooseneck. Mark center on cross member approximate thirty inches from front of trailer. Measure five inches toward left (street) side of trailer and mark. Weld turnbuckle (item 9) lug to cross member on mark (fig 4).
 - 3. Weld supplied brace in cross member (structural channel) directly under turnbuckle lug.
 - 4. Trim deck plate (item 9) to fit and reinstall.
 - 5. Raise front storage frame to full upright position.
 - 6. Measure storage frame and mark centerline. Measure five inches toward left (street) side and mark (fig 5).
 - 7. Measure and mark center line of turnbuckle lug. Center lug on mark and tack in place. Install long turnbuckle and check fit. Weld permanently (fig 6).
 - 8. With jam nut towards storage frame and pins installed, secure with cotter pin and R key.

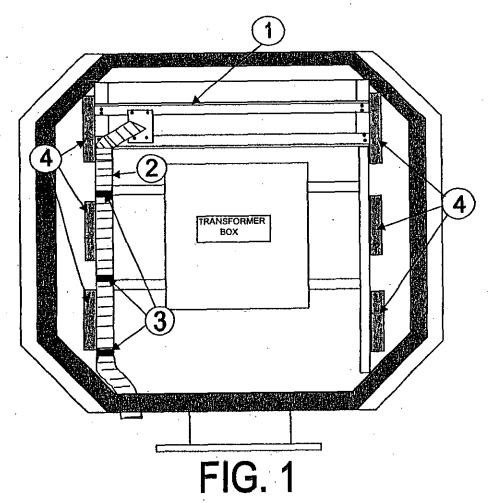
- 1 FAN MOTOR ASSEMBLY
- 2. DUCTING
- 3. CLAMPS
- 4. BALLASTS

<u>Reason for release</u>: Under certain circumstances i.e.: ambient temperatures, solar load, heat build up from electrical components, temperatures in the center ornament can cause deterioration of fuses, circuit breakers, transformers, etc. We recommend that the following procedures be sued to install a cooling system designed to reduce inside ornament temperatures.

- 1 Disconnect power to center ornament.
- 2 Remove ornament panels.
- Remove upper ballasts located in structural channels above and to sides of the electrical control panels (fig 1).

- 4. Fit fan motor housing assembly to structural channels with fan housing above lighting panel. Position as in (fig 1) and clamp in place.
- 5. Drill and tap holes to mount fan motor assembly drill size 13/64 tap 1/4-20.

- 6. Mount fan motor assembly with supplied bolts.
- 7. Drill and tap holes in structural channels for ducting mounting clamps (1/8 drill 8/32 tap) secure ducting to exhaust vent, attach to clamps on structural channel and run end of duct out bottom or ornament.

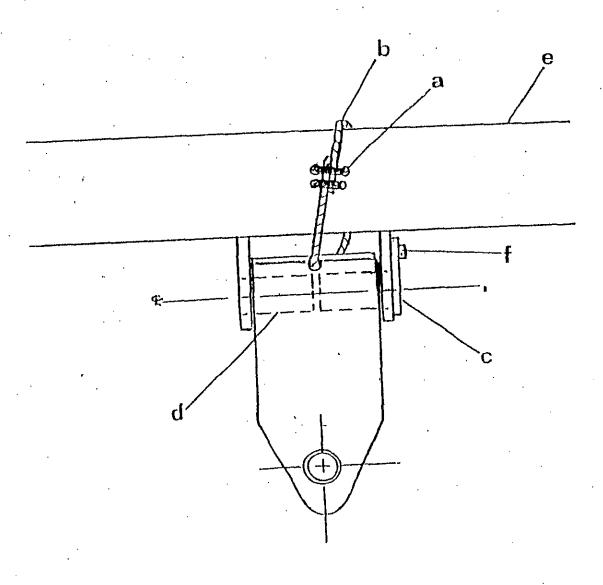
Reason for release: Dartron Industries, Inc. has recently been made aware of a problem with the hanger block pin and bushing design on StarTrooper's listed above. The graphite impregnated bronze bushings generally thought not to require periodic lubrication have in some instances become dry which causes the bushing and pin surfaces to squeal while operating. To correct this condition we recommend that you install a hanger block pin equipped with two zerk fittings. This pin will require periodic lubrication.

- 1. Remove car, stem, and bonnet.
- 2. Remove bolt (f) on attached drawing and remove pin (c) by carefully tapping end of pin with an aluminum bar and mallet so as not to damage the pin.
- 3. Install new pin into hanger block. Install bolt and zerk fittings into pin.
- 4. Using grease gun (equipped with Chevron Ultra Duty EP-2 or equivalent, (see attached chart) grease both zerks

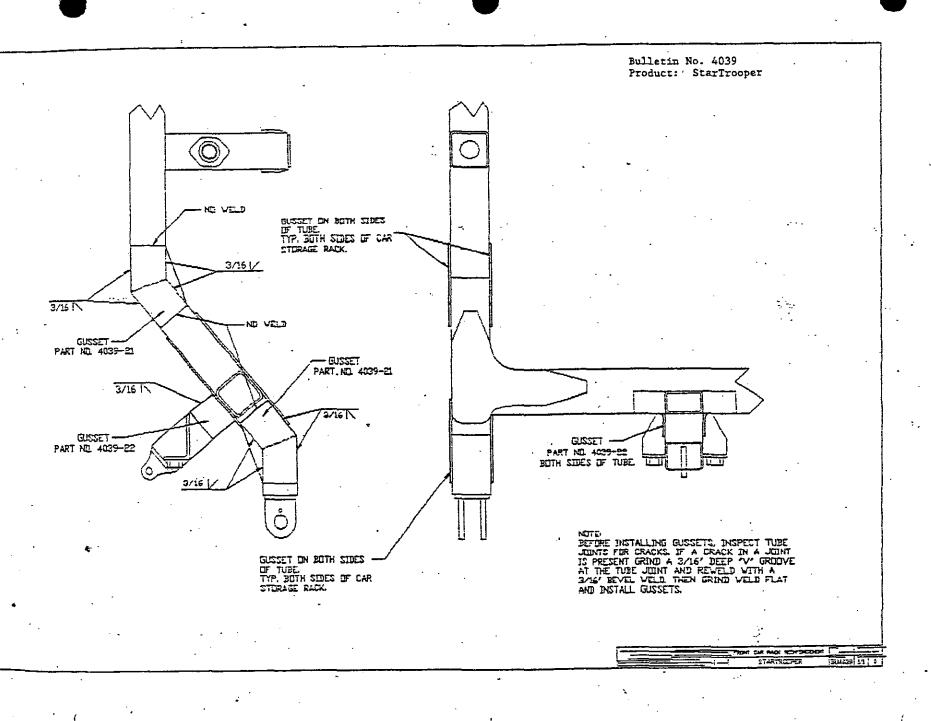
Reason for release: As a result of moving the StarTrooper long distances over rough roads, crack could develop in certain welded joints in the front car storage rack. If the cracks are not addressed, the joint could separate and cause the cars carried by this rack to drop during transit.

- > Immediately inspect area shown on the attached drawings for cracking.
- > If cracks are detected, immediately install gussets as shown in attached drawing.
- > If cracks are not detected, gussets still must be added no later than March 1, 1996.

elding Specifications: Weld with 70,000-psi filler.
