ALL STEEL PORTABLE
BIG ELI
FERRIS WHEELS

ELI BRIDGE COMPANY
INCORPORATED

Wheel Bulletin No. 950317-1

Subject: Rim Cable Turnbuckle Pins

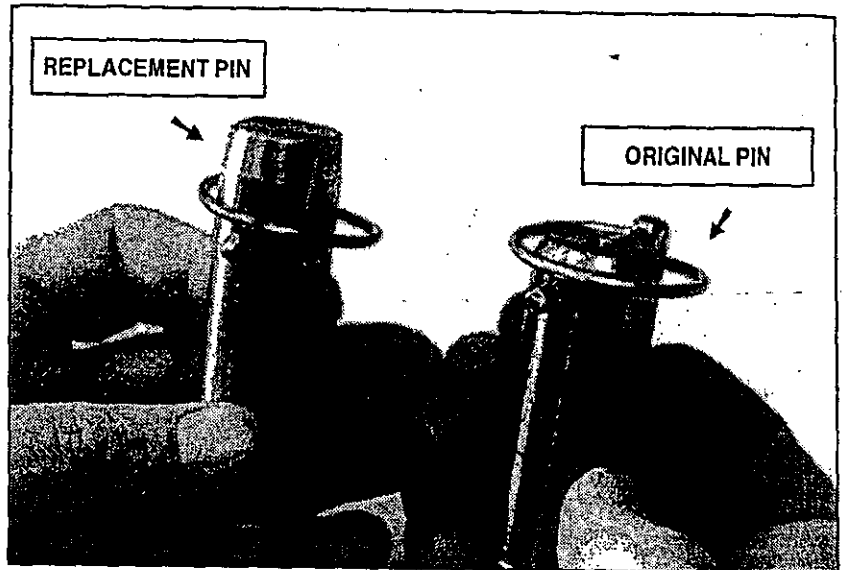
1. In the course of testing an Eagle at Eli Bridge Company a very serious problem developed with the turnbuckle pin used in the pair of rim cables which make the final connection when the Wheel is unfolded.

3. In our testing procedure, the Eagle had been running for approximately 9.5 hours when for some reason not explainable the Klik-pin apparently worked out of the pin, the pin fell out, and the rim cable came loose.

5. We are convinced the problem was with the pin. Therefore, we have prepared a new design pin with a longer tapered end. The Klik-pin cannot be removed unless it is first unlocked by pulling open the ring.

6. Each Wheel requires two pins of this new design. We are furnishing them to you at no charge. It is imperative that you get rid of the old pins and immediately install the new ones we are sending you.

7. We consider this modification to be mandatory, immediately on receipt of the pins. The pins are in production at the present time and will be shipped to you as soon as they are available.

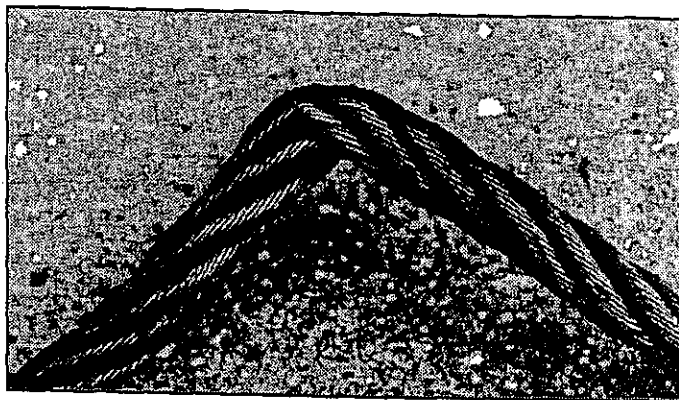
Picture No. 1

A. Kinking, as shown in Picture No. 1. Sometimes this has occurred when the winch cable has been pulled too tightly around the ends of the A-frames when folded for traveling.

A winch cable should be replaced any time obvious damage is found, but because of the importance of the winch cable in the safe operation of the ride it should be replaced every five years. We consider this to be a mandatory requirement.

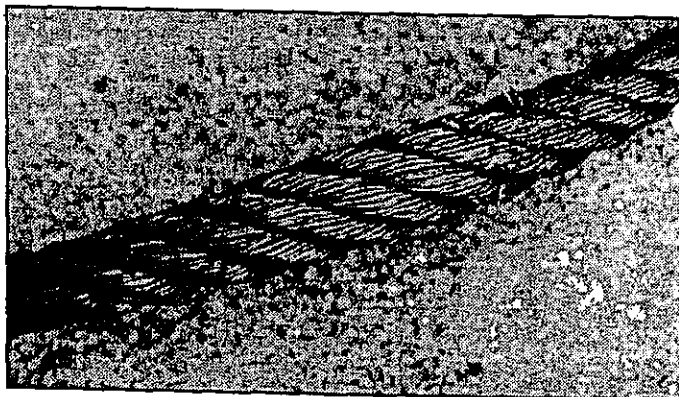
Picture No. 2

B. Crushing or flattening of the cable because it has not been wound evenly on the winch drum. See Picture No. 2.

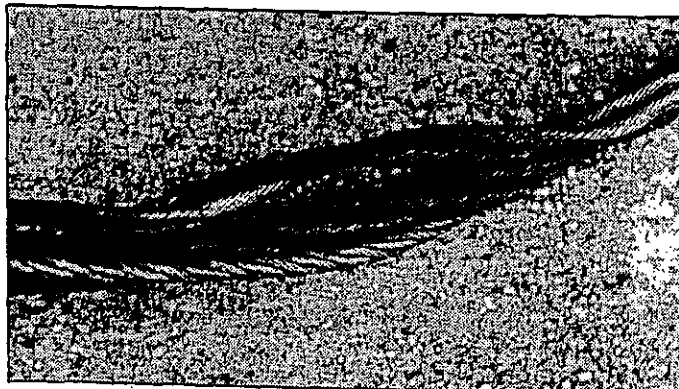
Picture No. 3

C. Bird caging, as shown in Picture No. 3, where the cable strands have expanded, leaving a "bird cage" in the middle.

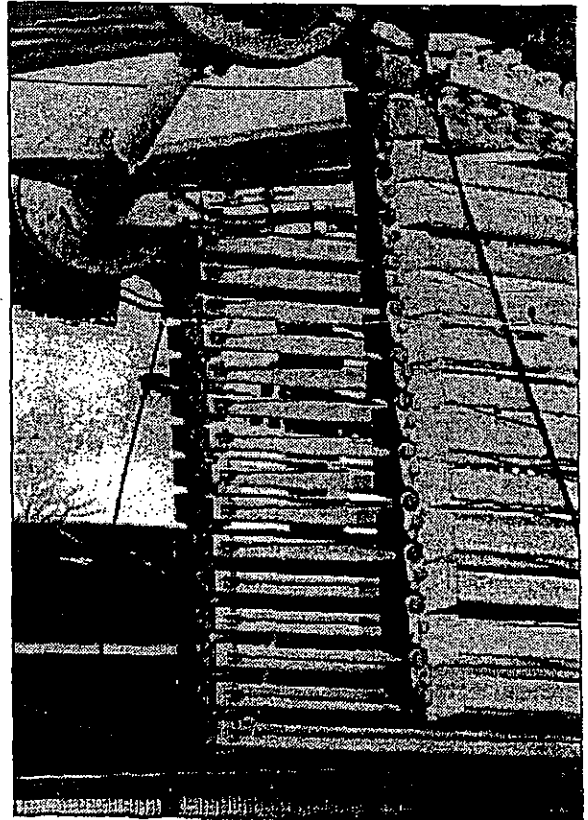
Figure 1

Initially inspecting for wear can be done easily with the Wheel folded for transport. The distance between the master spoke tenon and the next spoke tenon must be measured to the nearest 1/32" on each side.

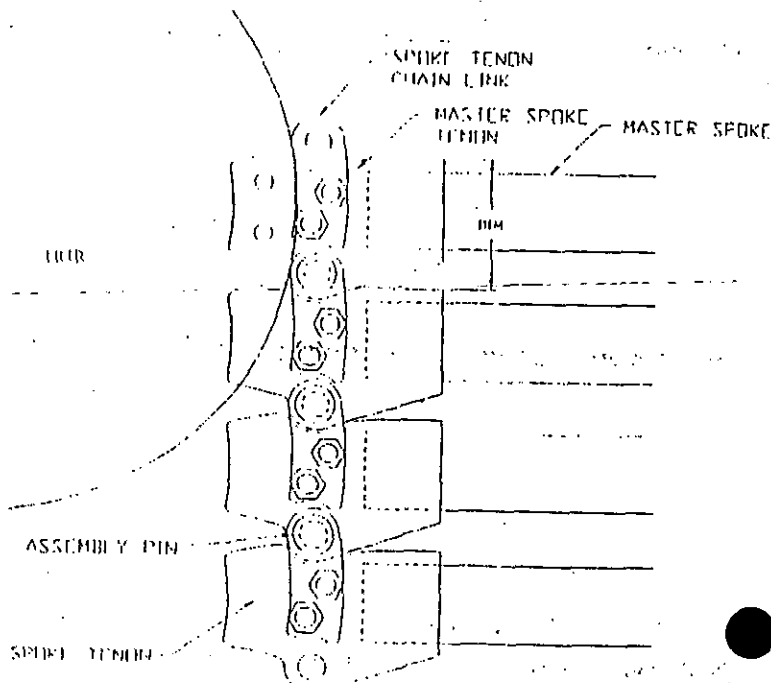
The drawing shown in Figure 2 shows where to take the measurement.

On an Eagle 16 or a Double Eagle 16, that dimension should be 5.0625" (5-1/16") to 5.125" (5-1/8").. On a HY-5 II, that dimension should be 5.15625" (5-5/32") to 5.21875" (5-7/32"). A measurement that is larger than the larger of the above dimensions indicates that the assembly pins are probably worn and require further inspection.

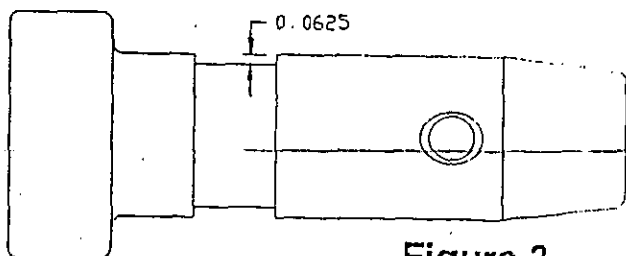
Figure 3

With the nuts loosened, pry the spoke tenon chain link on the inside of the Wheel back away from the spoke tenon enough so that the assembly pin can be seen where the spoke tenon bears against it. A worn pin will have a smaller diameter where the spoke tenon makes contact with it. The original equipment pin is one inch in diameter. If you can see that any part of the pin is worn by .0625" (1/16") as shown in Figure 3, the pin must be replaced. Be sure to retighten the nuts on each spoke tenon chain link before loosening the nuts on the next one to be inspected.

If the pin holes in the spoke tenon chain link or the spoke tenon have elongated .0625" (1/16") to a total length of 1.0625" (1-1/16"), then the spoke tenon chain links and the spoke tenon should be aligned as closely as possible and then reamed out to a diameter of 1.0625" (1-1/16"). Then an oversize pin should be installed.
