## Service Bulletin

04-07 KMG  
Fireball

Bulletin No.: FRB-SB01

Ride: Fire Ball by KMG International, b.v.

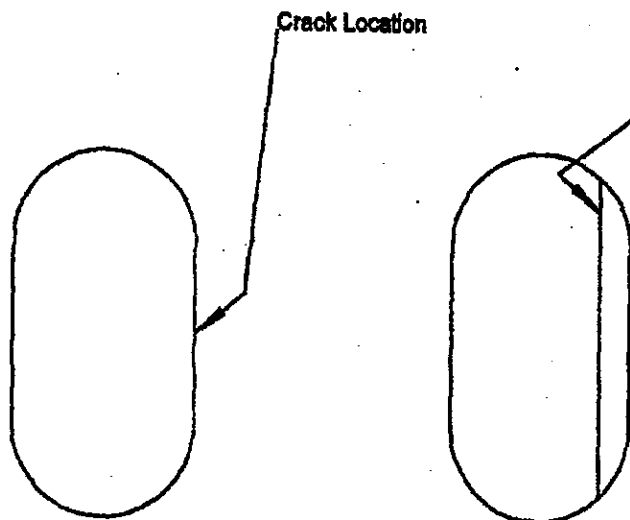
It has been determined through routine field inspections that a crack can develop at the location where the ends of the reinforcement bar meets inside the perimeter of the inspection hole. This is most likely due to an improper completion of the weld bead which can create a stress riser in the area.

**Manufacture: KMG Europe**  
**RE: Inspection Hole Crack**  
**Service Bulletin: FRB-SB03**  
**Date: October 2001**

**Gusset Material: 1" x 1/4" Bar, Cut to fit.**

**Preparation: Protect motor wiring and cover motor and hub bearing to prevent grind dust contamination. Remove paint from weld area.**

**Grind out existing crack. Reweld and grind smooth. Bevel weld edge of new gusset. Weld from top to bottom of gusset.**

**Use 7018 rod at highest setting possible.**
