Date; 19-3-2014.

For your information, defects as below found on a number of mini Miami rides , manufacture ; danum uk / f stokes.

adips/naflic inspection body

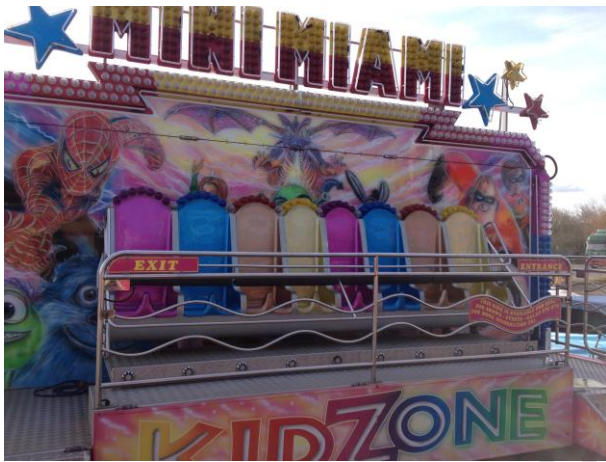
1) general overview of device.

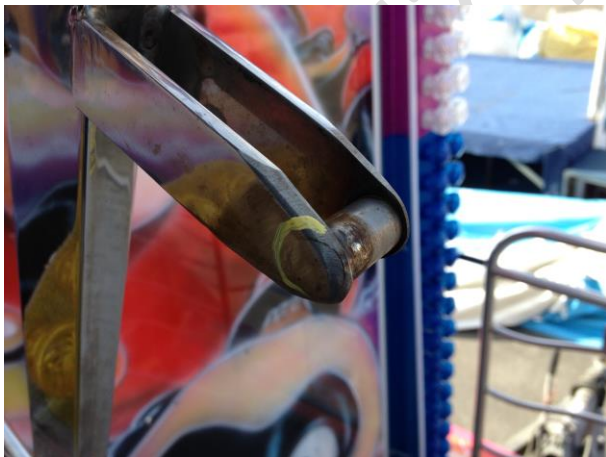
locator peg.

2) weld/ material defect found on lap bar lock

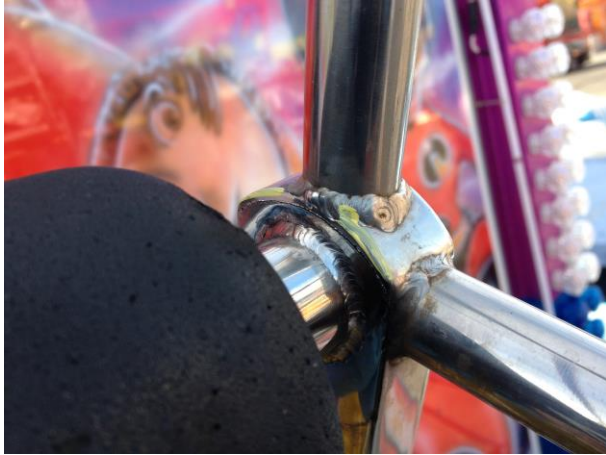
3) weld defect lap bar control arm right hand side, protective padding is required to be partially removed for access.

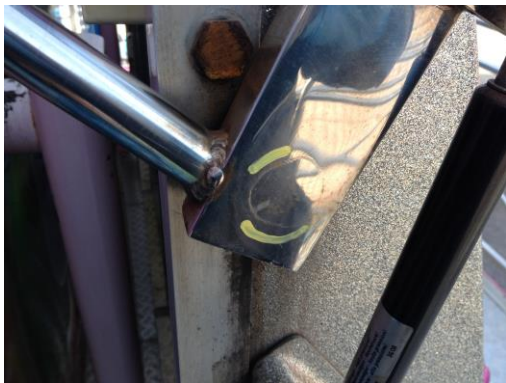
4) weld/ material defect, lap bar left hand side control arm, outside (connection between control peg & stainless box section).

After speaking with the controller & witnessing operation of the device, it appears the lap bar is release via the control pedal & electric switch situated on the left hand side of the gondola , the opening / closing procedure I believe is contributing to the twist and uneven locking due to the length of the lap bar & containment issue which prevents opening / closing from the central position, I have advised the controller to visually monitor the area as part of the weekly inspections, and report any further defects.
