Service Bulletin #2003-139

Applicability: All Riblet Chairlifts.

Subject: Chair Clearance Issues.

Compliance: Preventive Maintenance.

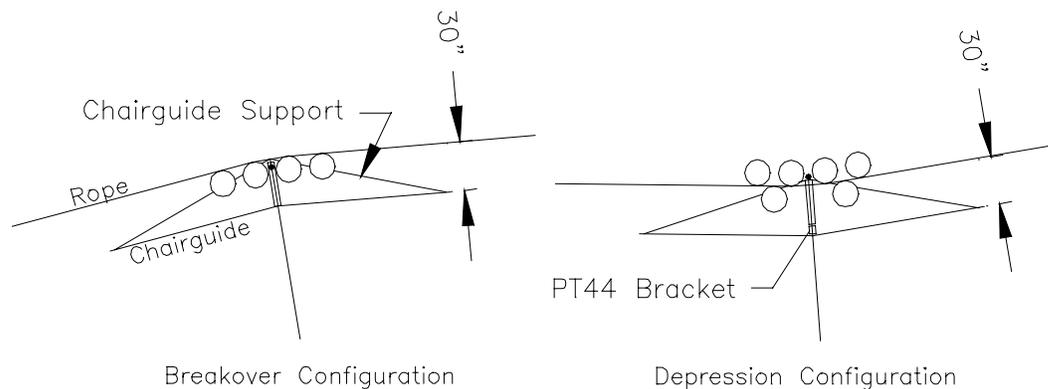
The tower chairguides on those Riblet chairlifts so equipped are designed to be approximately 30 inches below the level of the haul rope, and to be parallel to the rope. Chairguides must be bent at the center, if required, and adjusted to parallel the rope by adjusting the length of the chairguide supports on the uphill and downhill sides of the tower.

Chairlifts built prior to 1965 (and any pre-1965 towers which may have been transplanted to newer lifts) incorporate chairguide mounts which are adjustable in height. 1965-model and later chairlifts use a crossarm which mounts the chairguide at a fixed distance below the rope. When depression assemblies (CC, KK, RC, CRC, RK) are installed on these towers, a depression chairguide bracket (Riblet part no. PT-44) must be used.

describing proper installation and adjustment of the tower chairguides. Please refer to those drawings, and, as a reminder, to the sketch below, which illustrates the proper installation and adjustment of chairguides on 1965 and later Riblet chairlifts using chairguides. Pre-1965 lifts are similar, but the adjustable chairguide mounts on these lifts obviate the need for the depression chairguide bracket.

We remind you to, as part of your regular maintenance program, inspect the chairguides on each tower of all Riblet lifts equipped with chairguides to be certain that they are properly installed and adjusted.
