ACTION NOTE

SAFECO CRAZY FROG

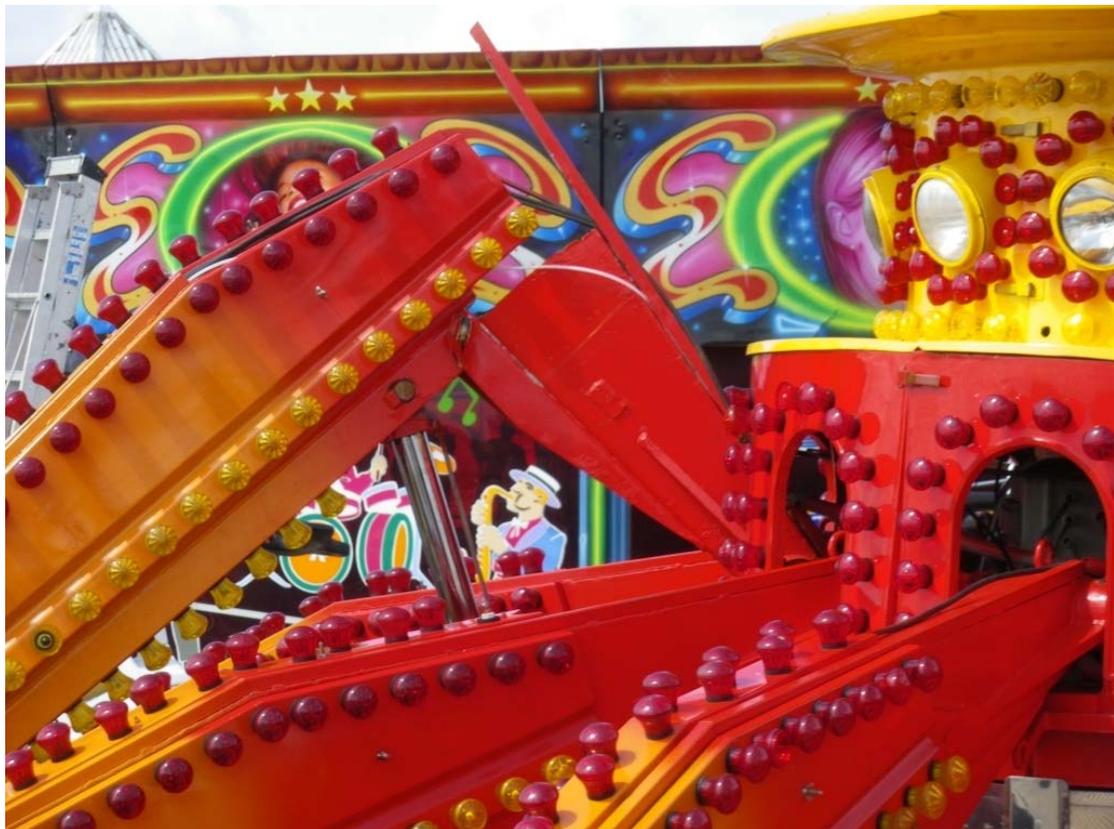
The ride affected is the Safeco Crazy Frog and the area that failed can be seen at Fig 1:

Following a similar failure on a machine in Ireland approximately 5 years ago the requirement for NDT in this general area was promulgated and all design reviews for this machine should now contain this requirement as part of the inspection schedule.

I stress that it is not at present clear whether the crack began in the area requiring NDT. Neither is it clear how the crack resulting in the failure began, propagated or indeed at what speed it propagated though initial investigations suggest this happened

rapidly. It is further stressed that this cannot be confirmed until HSL have conducted their examination.

1. Operators are to visually and regularly inspect their rides in the areas shown in Figs 1 & 2 to ensure there is no sign of any crack propagation or other obvious damage in the area. This will mean removing the lighting boards to ensure a proper examination can be made and may require removal of a small amount of paint to ensure any crack can be seen.
2. Operators are to ensure that their rides have received testing in accordance with the NDT schedule required by their design review and that this testing is in date.

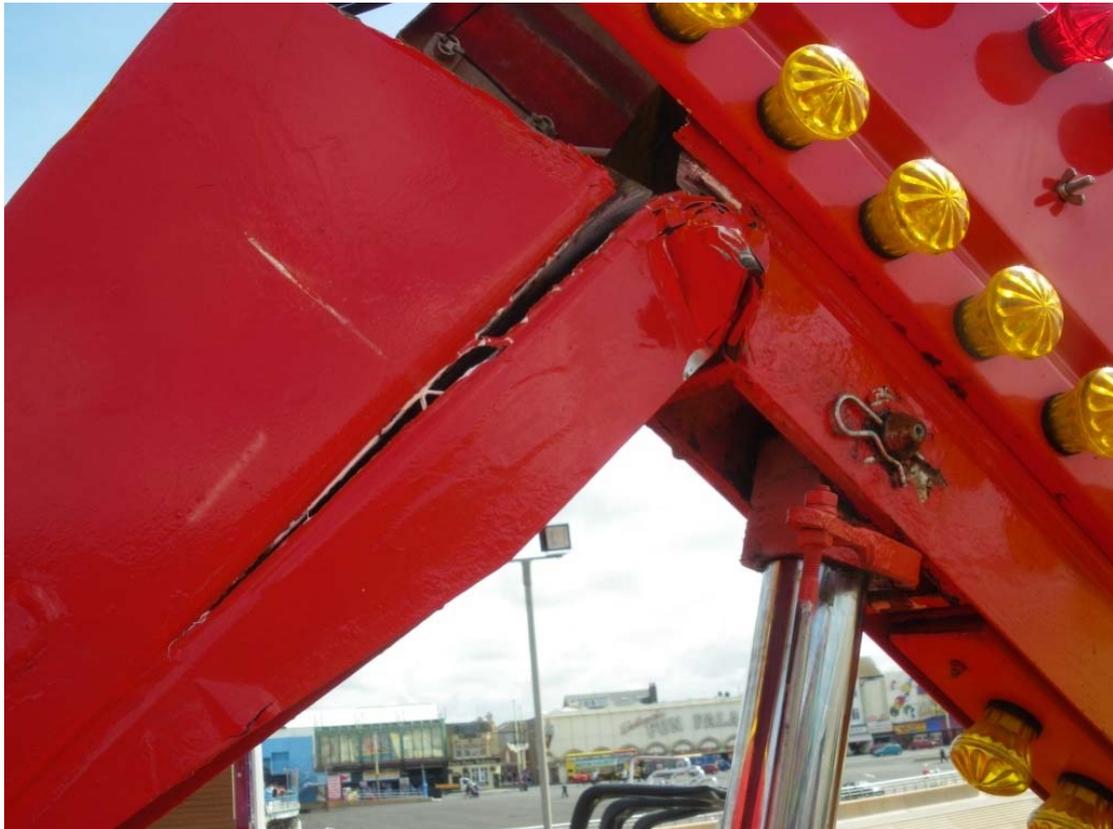
Fig 2:

A closer picture of the failure can be seen at Fig 2 and it will be readily seen by operators/controllers that the area where the failure occurred would have been hidden behind the lighting boards during normal operation.
