## ACTION NOTE - UPDATE

### SAFECO CRAZY FROG

On 3 July 2009 a Crazy Frog suffered a collapse in one of its arms at a fair in Blackpool. An investigation is underway by HSE. Parts of the ride have been removed to the Health and Safety Laboratory at Buxton. The ride was 6 years old and had been in the current owner's possession for approximately 5 years. This is an update to the Action Note issued on 31 July 2009.

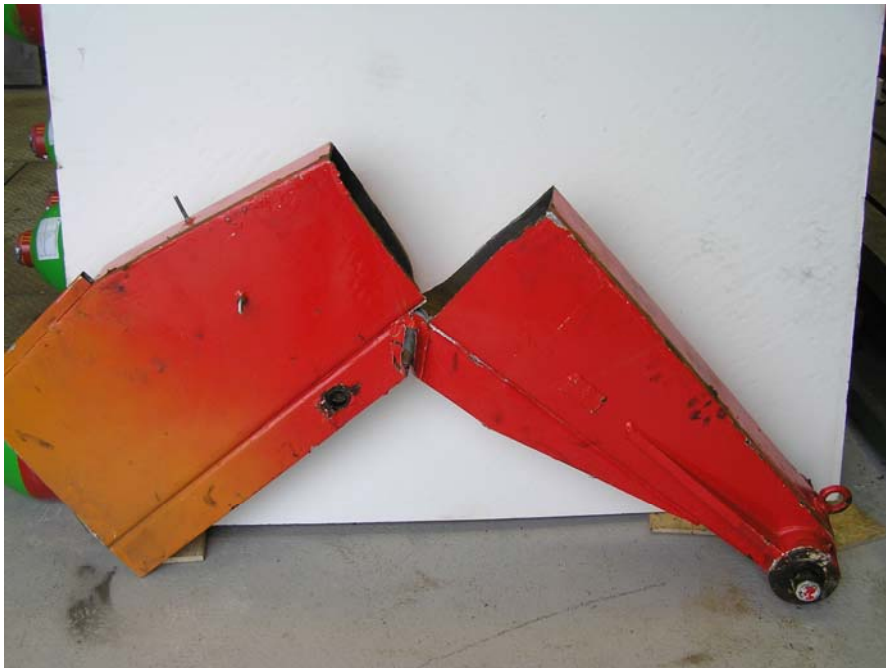
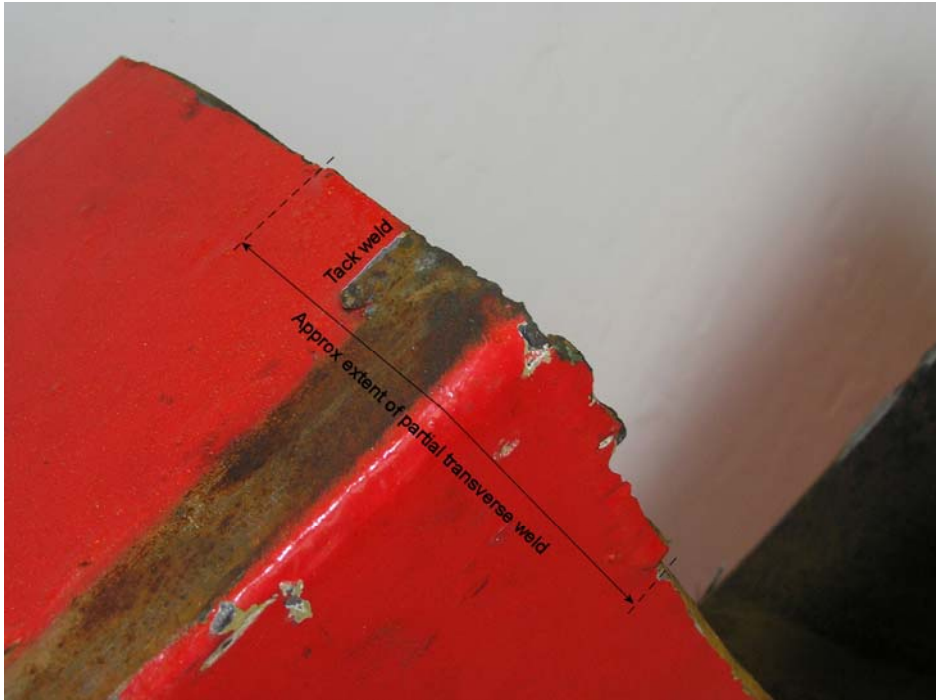
- The failure occurred at a partial transverse weld at the upper right corner of the box section arm, looking down the arm towards the pivot.
- The presence of the partial transverse weld in the incident arm suggests a weld repair of a previously identified defect. It is not clear yet when this weld was made.
- The nature and cause of this previous defect can only be speculated on at the present but it is possible that it may be associated with and have been possibly initiated by one of the tack welds to the cable conduit.

Further inspection of the affected ride has identified further cracking in another arm at approximately the same location (460mm back toward the pivot from the widest part of the arm) but this time through clean, un-welded material. This is not related to any tack welds for conduits. This was revealed during a thorough inspection where the light boards were taken off to reveal the suspect area and some paint was removed from the metal of the arm. The arm has been removed to HSL for examination.

Following are more photographs which will allow operators to accurately identify the areas requiring close attention:

1. As soon as possible, rides should be subject to an NDT test as per the ride's respective schedule. This should include the areas shown in the photographs.
2. Controllers are to consult their AIB about an ongoing, regular inspection regime to ensure that any crack is identified quickly and any subsequent propagation is picked up and stopped. It is stressed that the speed of propagation of any cracks is not known but is thought to be rapid.
