TECHNICAL BULLETIN

V90-3

Subject : Corkscrew trains type MK 1200, MK 900 and
Suspended Coaster trains

SAFETY ALERT MESSAGE

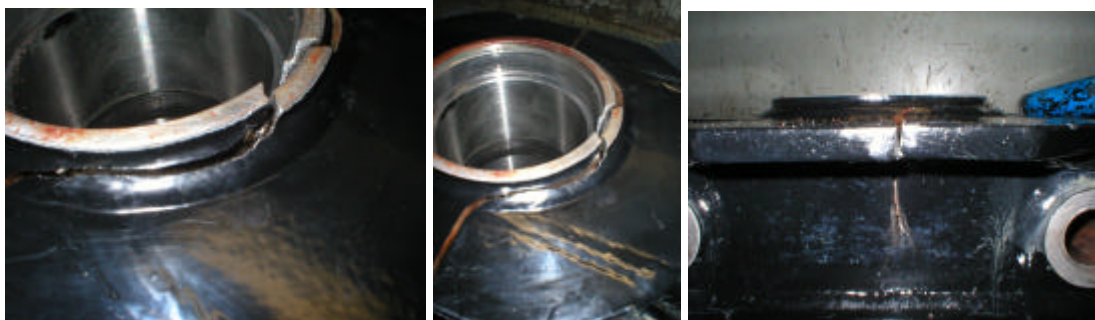
During the ride a strange noise was heard. Inspection immediately after the ride learned that one main axle was broken during or just before start of the ride. No passengers were hurt due to this incident.

See pictures below:

The line of the break originated from a crack in the center of the main axle. This crack, due to fatigue and, based on the rust patterns, was already in place for a considerable amount of time. The owner has applied powder paint to preserve the main axle. As a result of this flexible paint cracks could not be discovered in an early stage.

Based on our knowledge at this moment we would like to advise owners and operators of the MK1200 type of train to carry out regular maintenance and inspections as described in the owner's manual. For your convenience the required actions are clarified below:

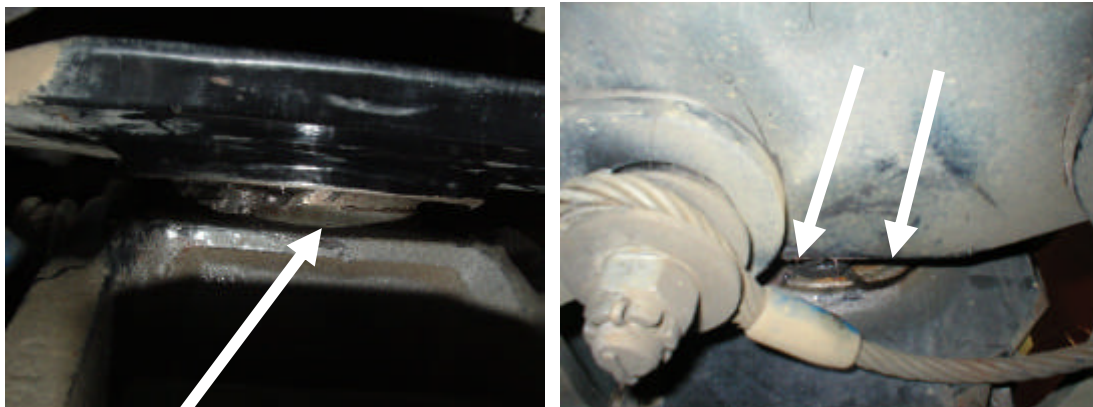
- The picture below shows that the weld itself is visual for inspection.

- Carefully weekly visual inspection as described in the manual to all welds on the axles, with special attention to welds as indicated with arrows on the pictures above and on the drawing below.
- Make sure that the actual paint is brittle, so the paint will crack when the surface below cracks.
- Make sure that the surface is clean and preferable painted in a lighter paint. This makes it easier to see indications.
- When there is any doubt, an additional NDT (UT and ET, or MT) inspection will be needed.
- We strongly recommend performing a major NDT (UT and ET, or MT) examination on these parts during the next winter stop.
- If there are any indications, please contact Vekoma Rides Parts & Services.
Tel.: +31 475 409 222
