Bulletin No: 2008 PS01
Release Date: 23 June 2008
Effective Date: 23 June 2008
Supersedes:
Completion Date: As soon as possible
Page: 1 of 2

SERVICE BULLETIN

Ride Manufacturer: Zamperla SPA	Affected Production Dates: all
Ride Name: Power Surge	Affected Serial Nos.: all
Model Number: all

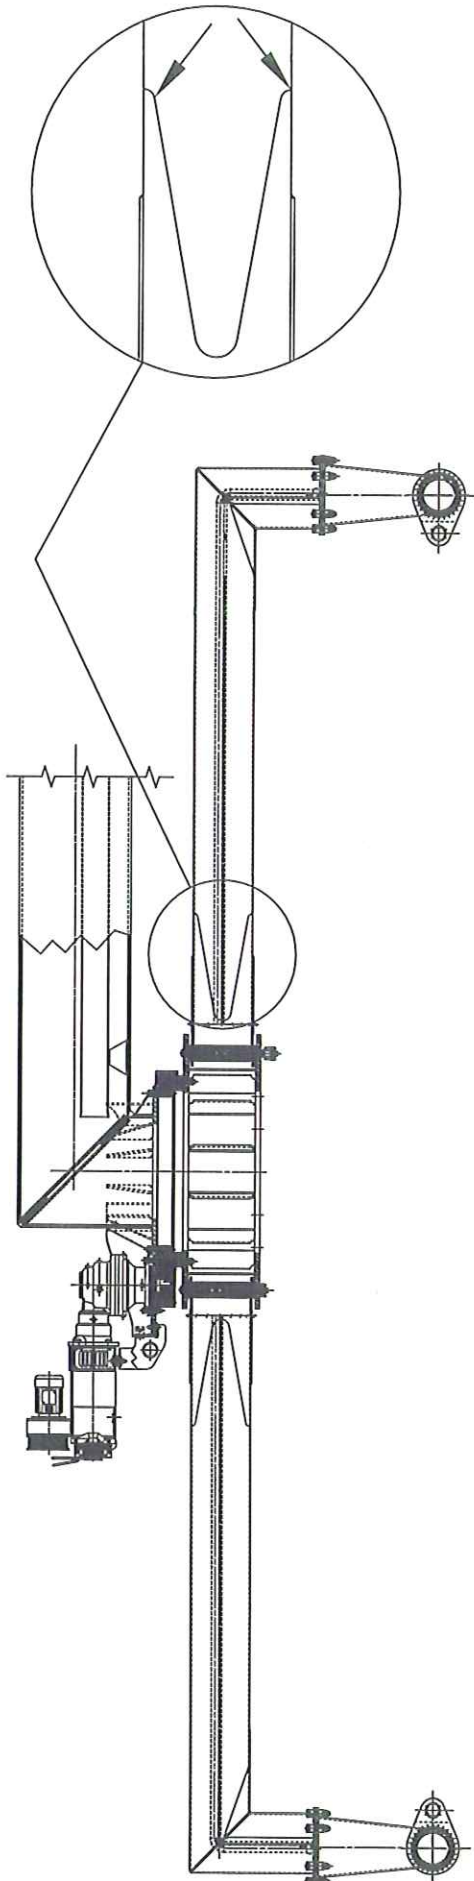
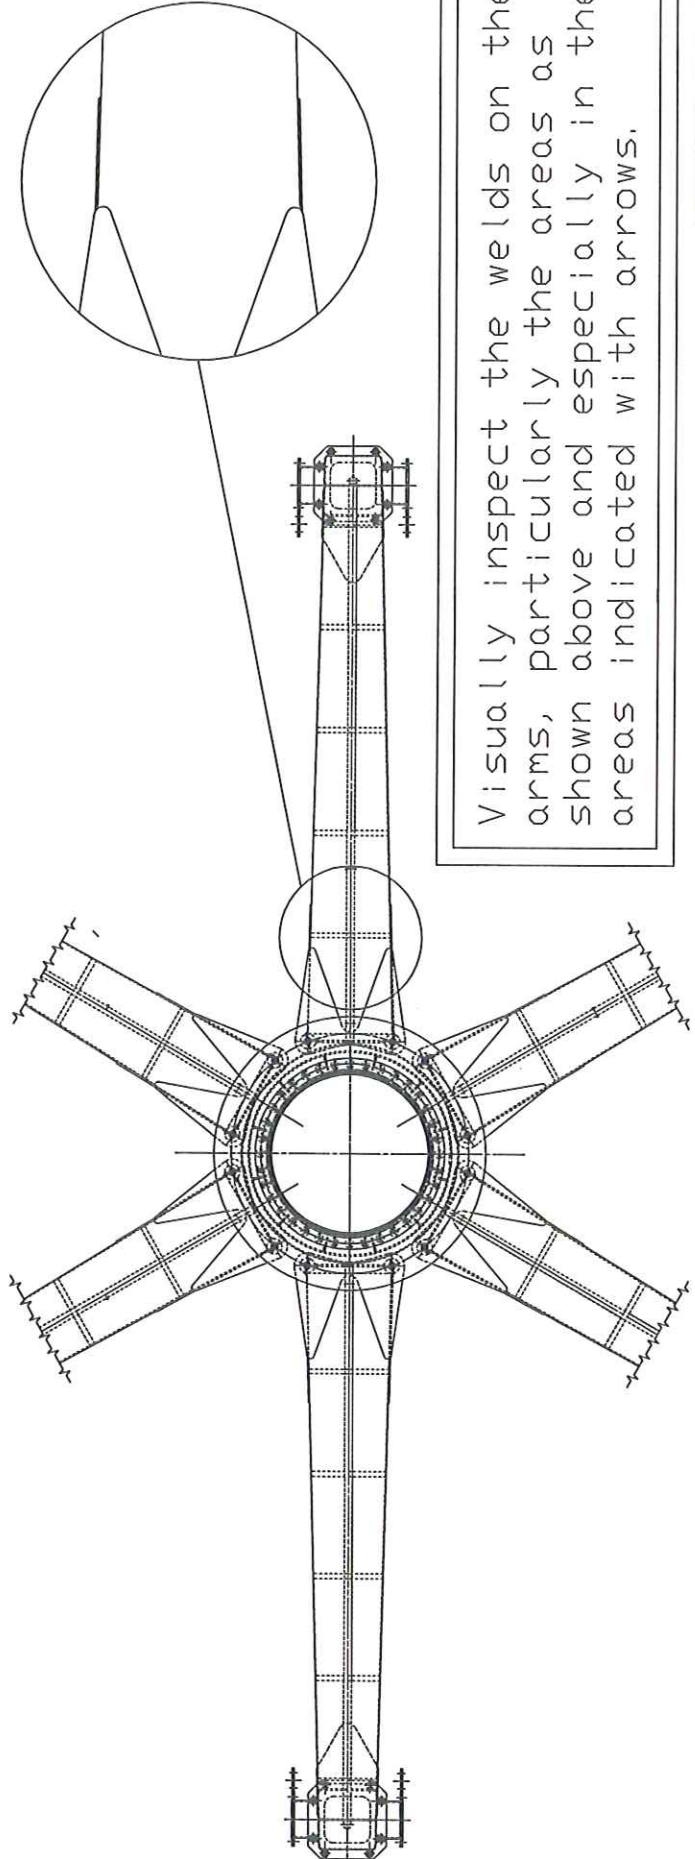
Abstract Of Issue:
Based on the development of cracks found in the field, additional maintenance is required.

Visually inspect the welds on the arms, particularly the areas as shown above and especially in the areas indicated with arrows.

Action To Be Taken:
Monthly visually inspect the welds on the arms, particularly the areas as shown in the attached drawing.
Inspections have to be carried out by removing the decorative light panels fixed to the arms.

1. Stop immediately the operation of the ride.
2. Carry out NDT (magnetic particle or equivalent) control.
3. Contact Zamperla in order to allow an appropriate evaluation of the problem.
