Service Bulletin

Zierer Bulletin #	Revision:	Page	System	Description:	Date:	Issued:
SB-WS-1001_rev1	1	1 of 4	Wave Swinger	Service Bulletin	17.01.2013	wmt
Original Ride Manufacturer			Release Date	Affected Production Dates:	Ride Name:	
ZIERER – Karussell und Spezialmaschinenbau			18.12.2012	2011 and earlier	Wave Swinger

3.1. Monitoring Devices at Lifting Cables

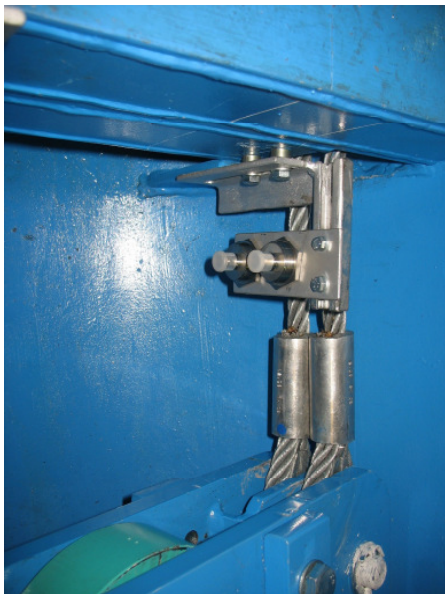
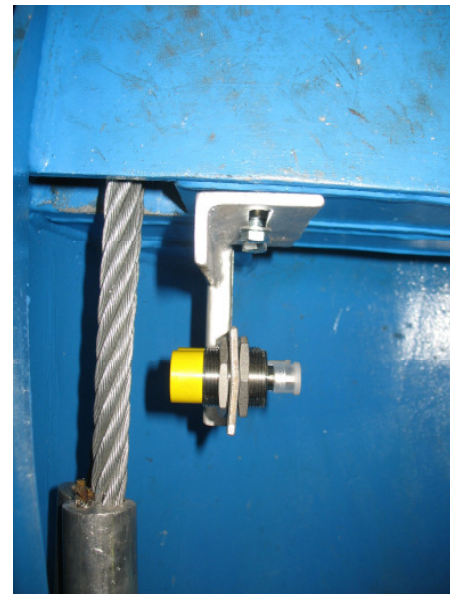
Rope Monitor Zierer Article No.: VK080063

2 sets of sensors monitoring the smooth movement of the lifting cables. The sensors are mounted on a bracket which is bolted to the bottom of the sheave compartment right next to the entry hole of the lifting cables. Their signals need to be integrated into the ride control system subsequently.

If for any reason a cable moves out of sensing range the control system will initiate a “Fast Stop” function .

This modification requires at least three additional slip rings at the slip ring assembly in the lower mast portion. If spare slip rings are available on your unit we recommend the addition of the rope monitor to your Wave Swinger on the next occasion (e.g. winter rehab).

It is no need to take any action if the slip ring assembly on your unit does not have this requirement. Just make sure a thorough daily visual inspection on both sets of lifting cables prior to public operation as well as the required monthly checks over the entire cable length gets carried out.

In case the slip ring assembly on your unit is worn and needs to be replaced soon we would recommend purchasing a slip ring assembly with more slip rings, so that the rope monitor can be added.

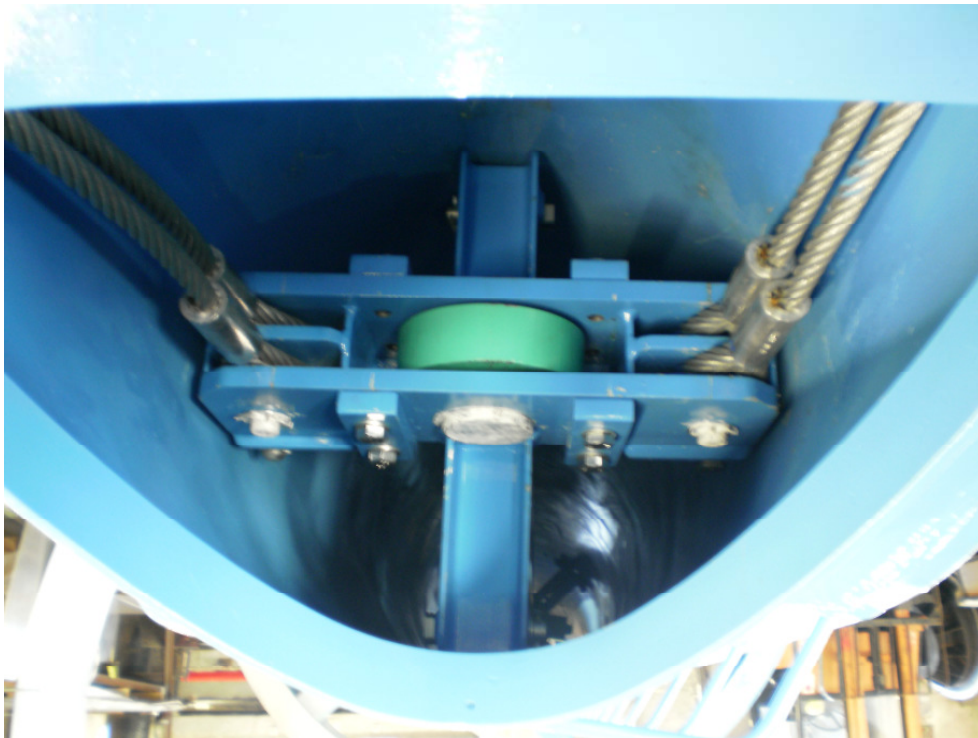
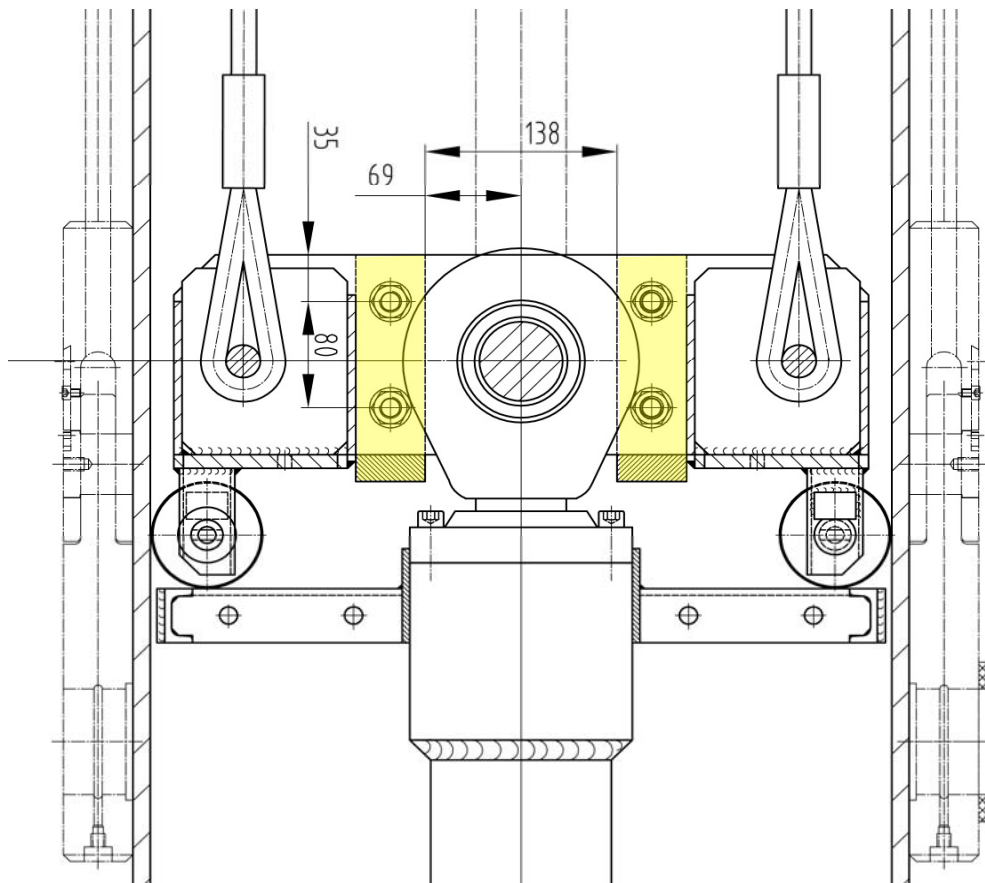
3.2 Lifting Cylinder Retaining Elements [Cylinder Rod] Zierer Article No.: HZ020078

In case of a break of the suspension pin 2 pieces of fork shaped retaining elements preventing the rod end from slipping through the guiding cross. The retaining elements are mounted axially at a distance of 138 mm with 4 bolts to each side of the guiding cross.

We recommend proceeding with this modification on the next occasion (e.g. next winter rehab), provided that the suspension pin has been inspected and documented as requested in the NDT requirement

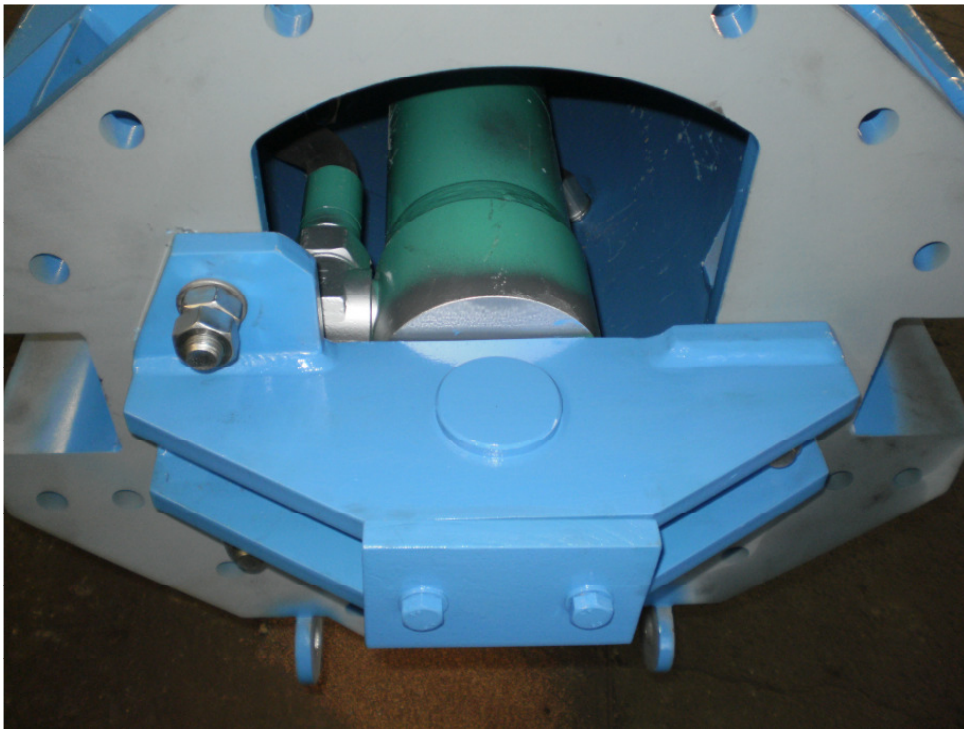
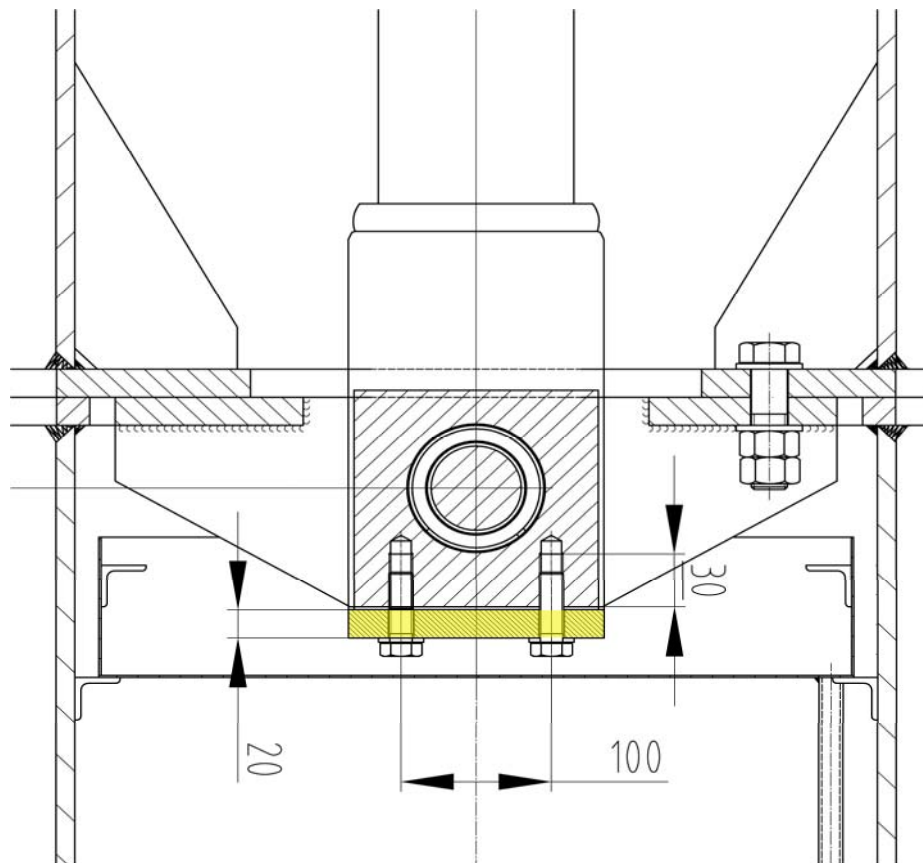
3.3 Lifting Cylinder Retaining Element [Cylinder Barrel] Zierer Article No.: HZ020079

In case of a break of the suspension pin a striker plate prevents the cylinder from slipping out of the clamping device. The striker plate is bolted concentric to the cylinder eye by means of 2 bolts.

This modification requires a rectangular shape of the eye on the cylinder barrel. This can be found only on cylinders built in 2010 or later.

If you have purchased a new cylinder during or after 2010 we recommend proceeding with this modification on the next occasion (e.g. next winter rehab) provided that the suspension pin has been inspected and documented as requested in the NDT requirement.

If the lifting cylinder on your unit does not have this requirement please proceed as usual. By purchasing of a new lifting cylinder the striker plate will be included in the shipment.
