NAFLIC

TECHNICAL BULLETIN — October 2015

401. Zamperla Jump Around bolt failure and lower radial arm cracking

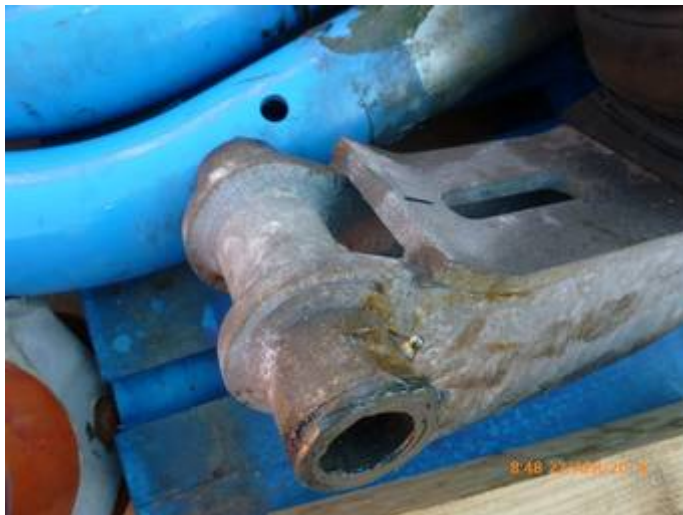
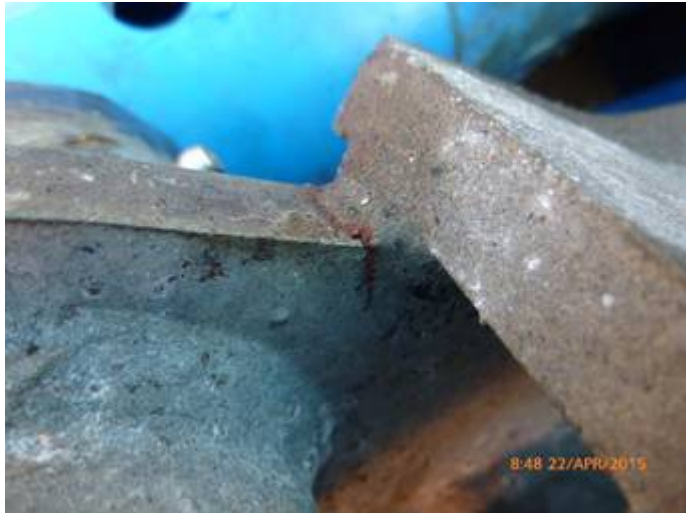
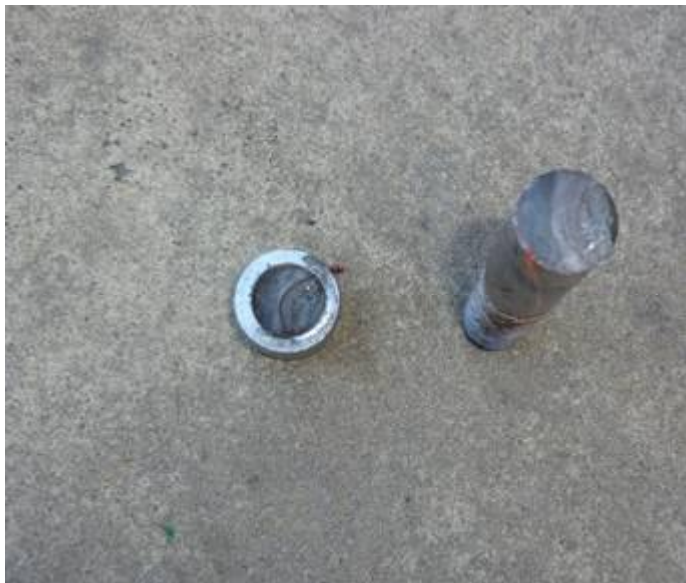
Whilst Technical Bulletin 379 described cracking at the pivot areas on the main radial arms (i.e. the arms to which the carriages are mounted), cracking has since been detected adjacent to the pivot on the lower radial arms (i.e. the arms which travel over the ramp to initiate the bouncing motion). See photo(s) below.

Controllers and inspection bodies are urged to pay particularly close attention to these known problem areas.

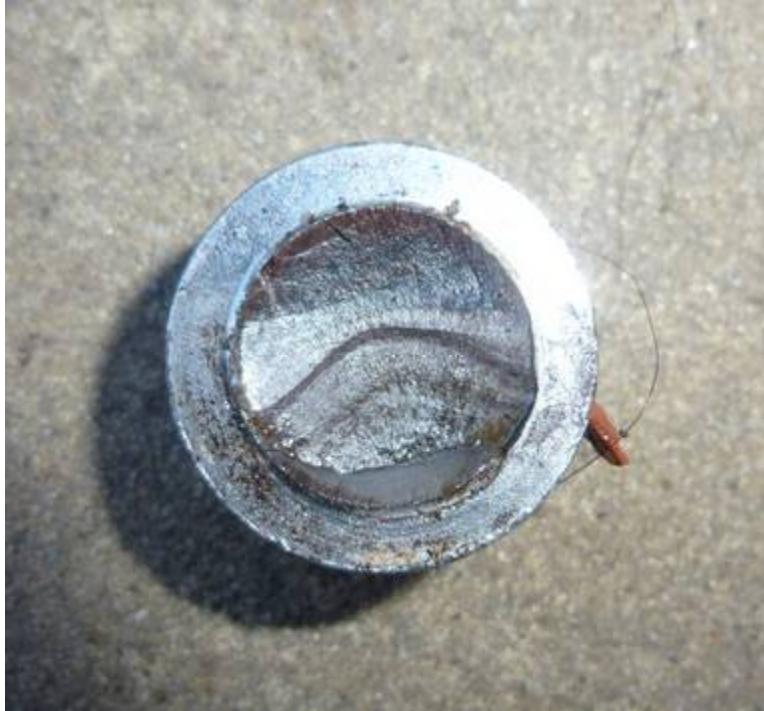
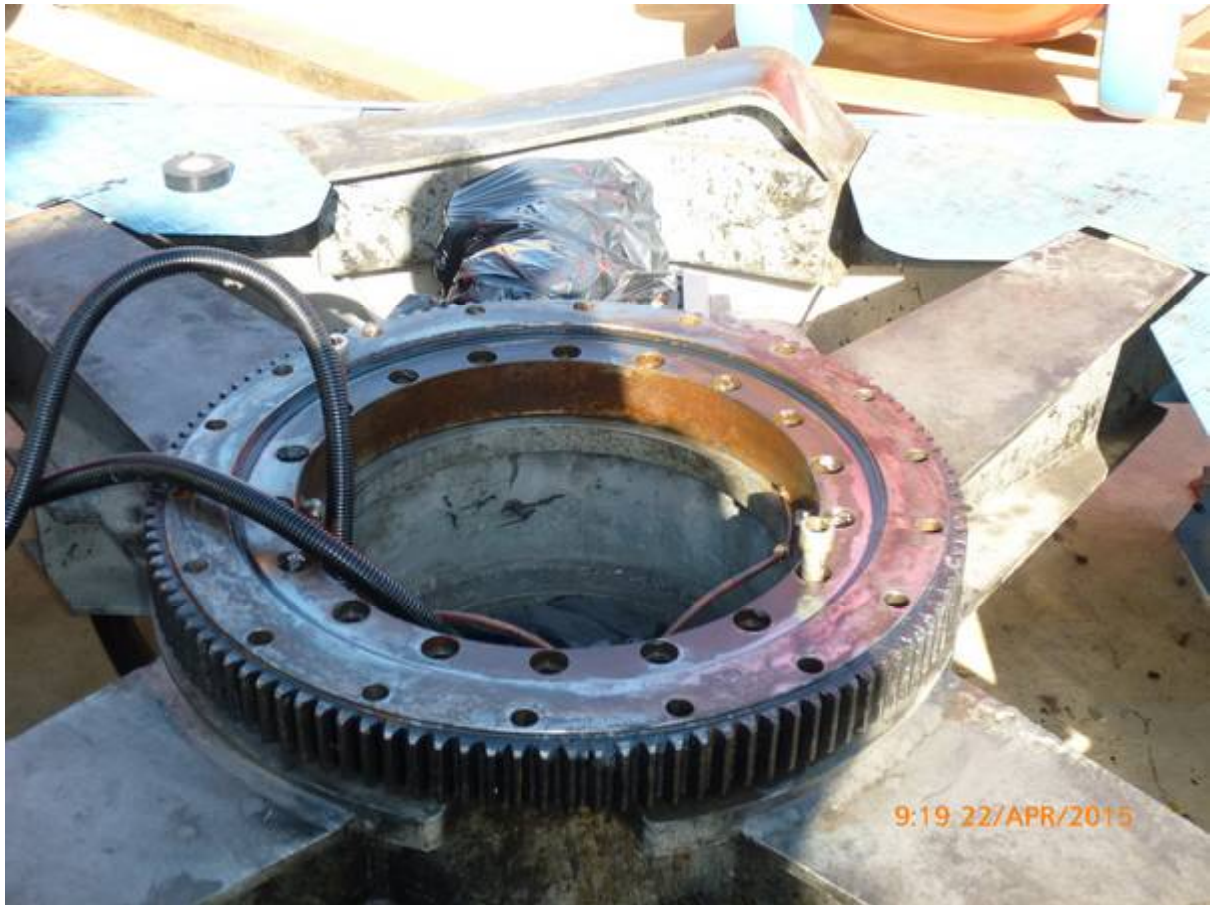
Problems have also been reported regarding the slewing ring bolts. The slewing ring has two rings of bolts. During inspection of the device a number of bolts on the inner ring were found to have completely or partially failed. See photo(s) below. Note that these bolts are not accessible for inspection without stripping down the device.
