## 409.

# Zamperla Watermania main drive pinion failure

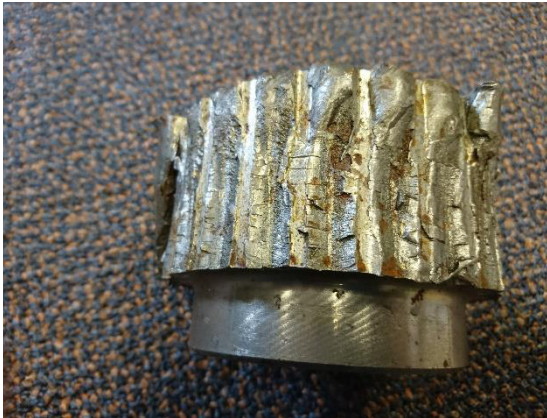
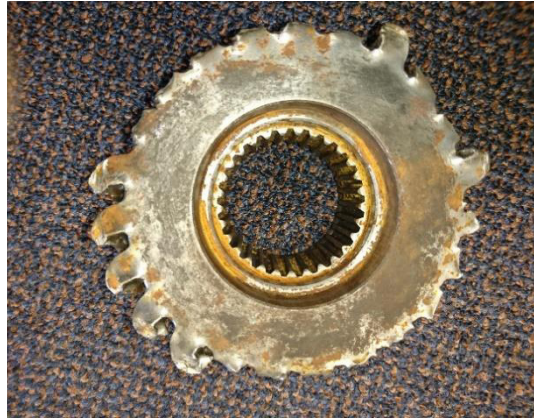
We have received a report from a UK registered inspection body that a main drive pinion on a Zamperla Watermania ride failed within two months of operation. The pinion was subjected to hardness testing and it was found to have not been surface hardened by the manufacturer. A new pinion was obtained from the manufacture but this also failed within two months of operation owing to numerous areas of cracking.

▲ Failed original pinions

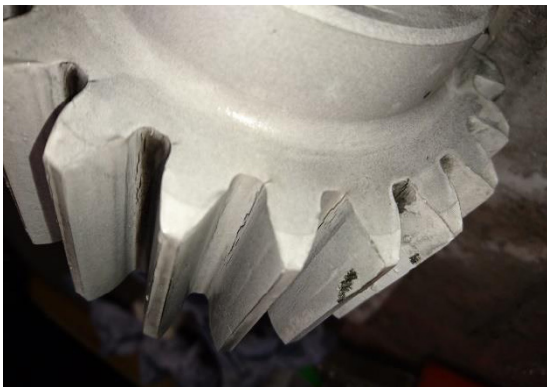
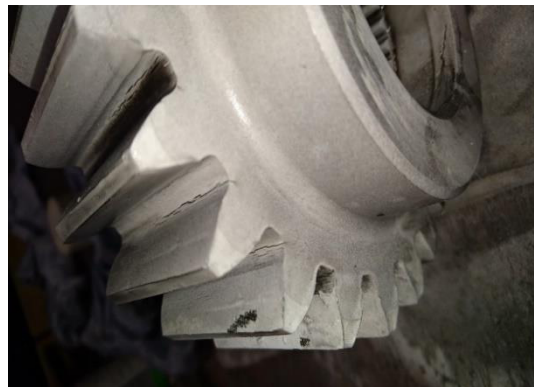
▲ Failed replacement pinions
