## 413.

# Nottingham UK Miami - corrosion to over the shoulder passenger restraints

Date; 10-3-2016

Device; Miami – notts uk – year of manufacture 2009.

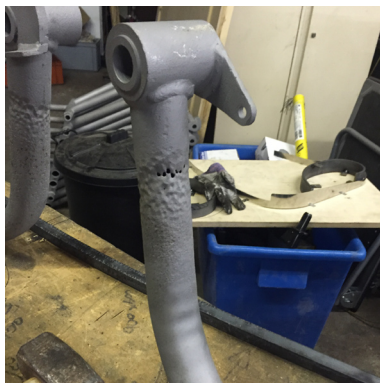
2. The remaining units were stripped down and 14 out of 16 were found to be in varying stages of extreme corrosion.
3. The manufacture has supplied 16x new units of which the steel work is galvanised.

4. Contact with the manufacturer of the polyurethane covering has confirmed the moulding is weather proof until the outer membrane / finishing is damaged or broken, the other point of entry for water is the sealing between the tube and top of the covering.

2) Showing corrosion of tube steel section.

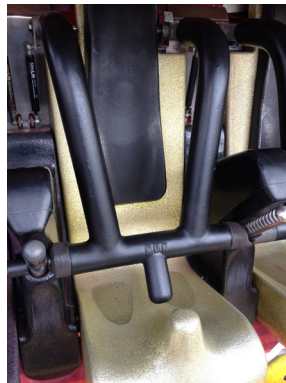
3) Showing new safety restraint bars fitted.
