430.

## Huss Pirate Ship hub, axle, A-frames and main leg cracking

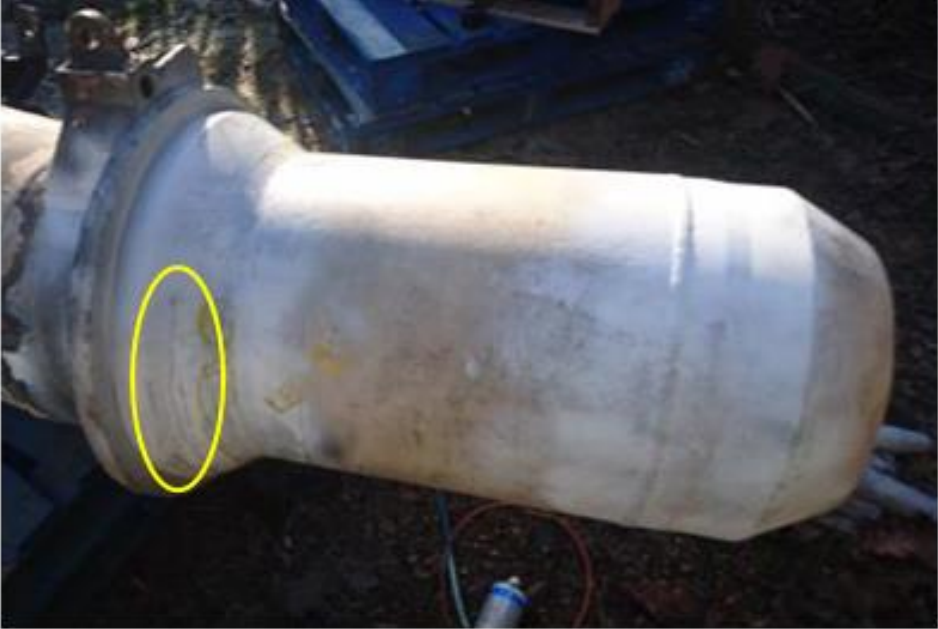
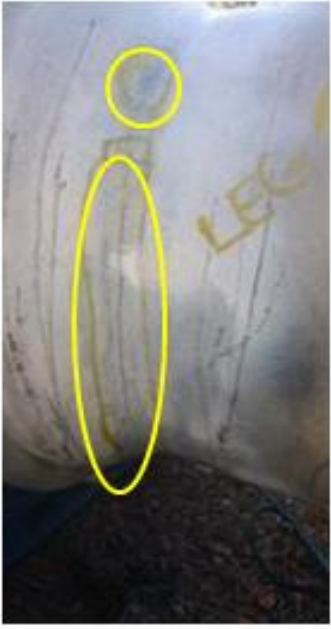
**Main leg spigot cracking (visual, mpi & UT)**

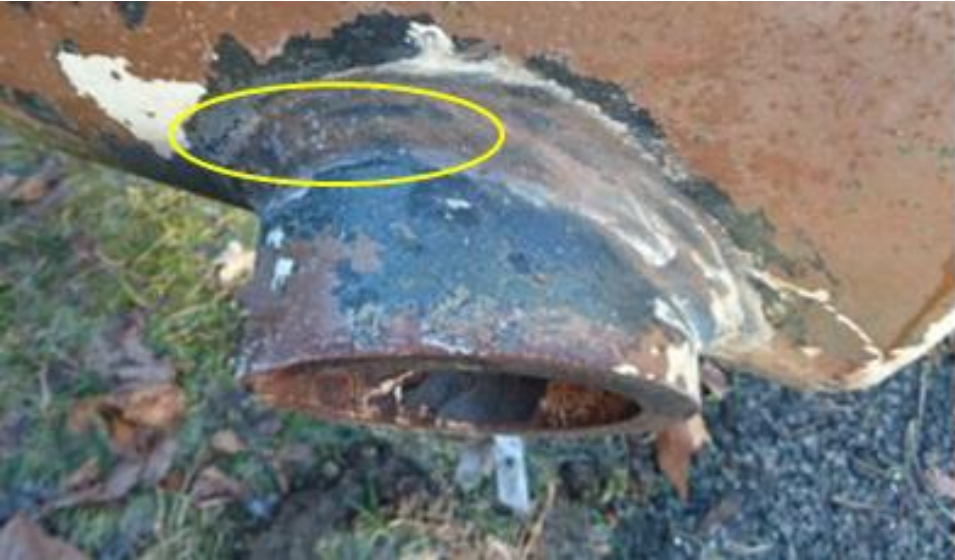
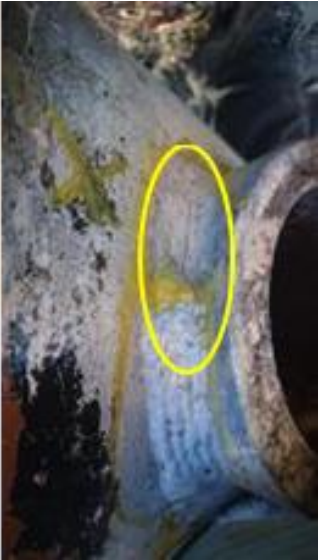
**Lower support leg bore circ welds cracking (visual & mpi)**

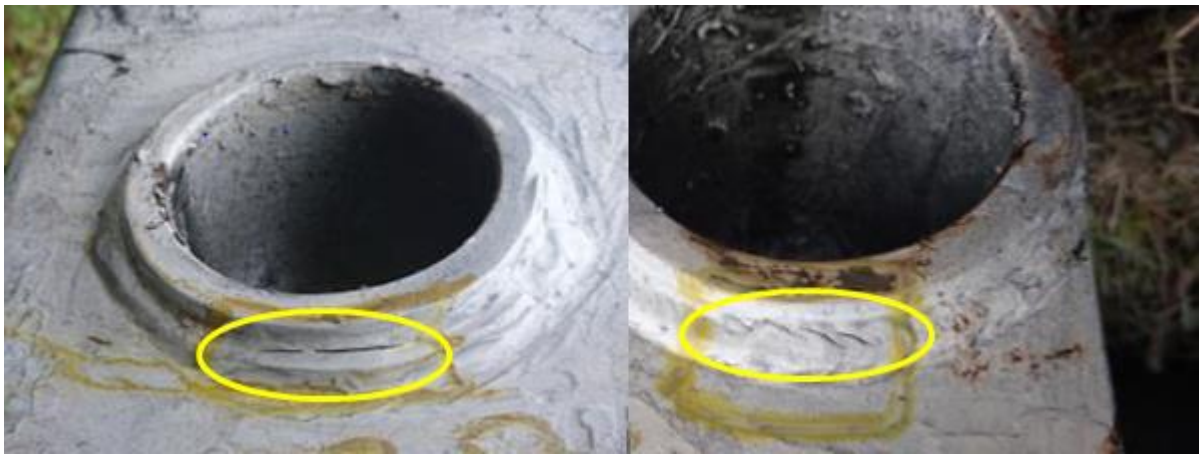
**A-Frame pin circular bore cracking. (visual & mpi)**

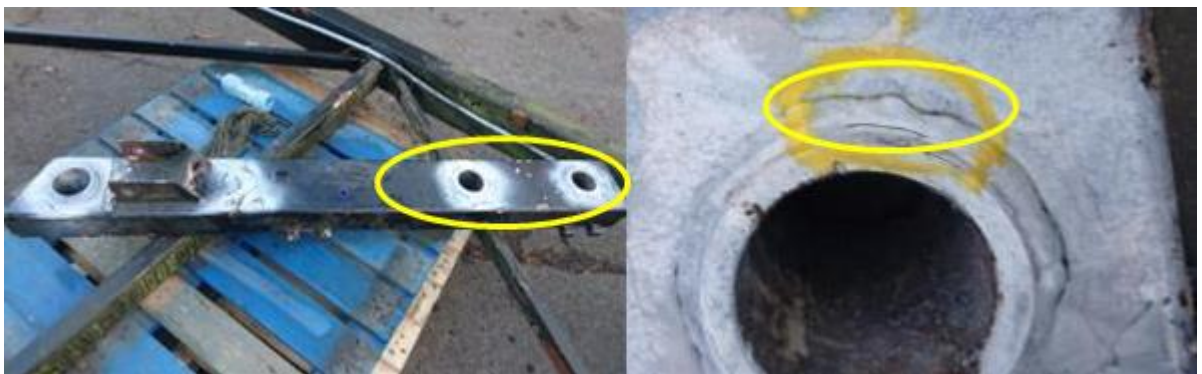
**Intermediate lower A-Frame pin circular bore cracking. (visual & mpi)**

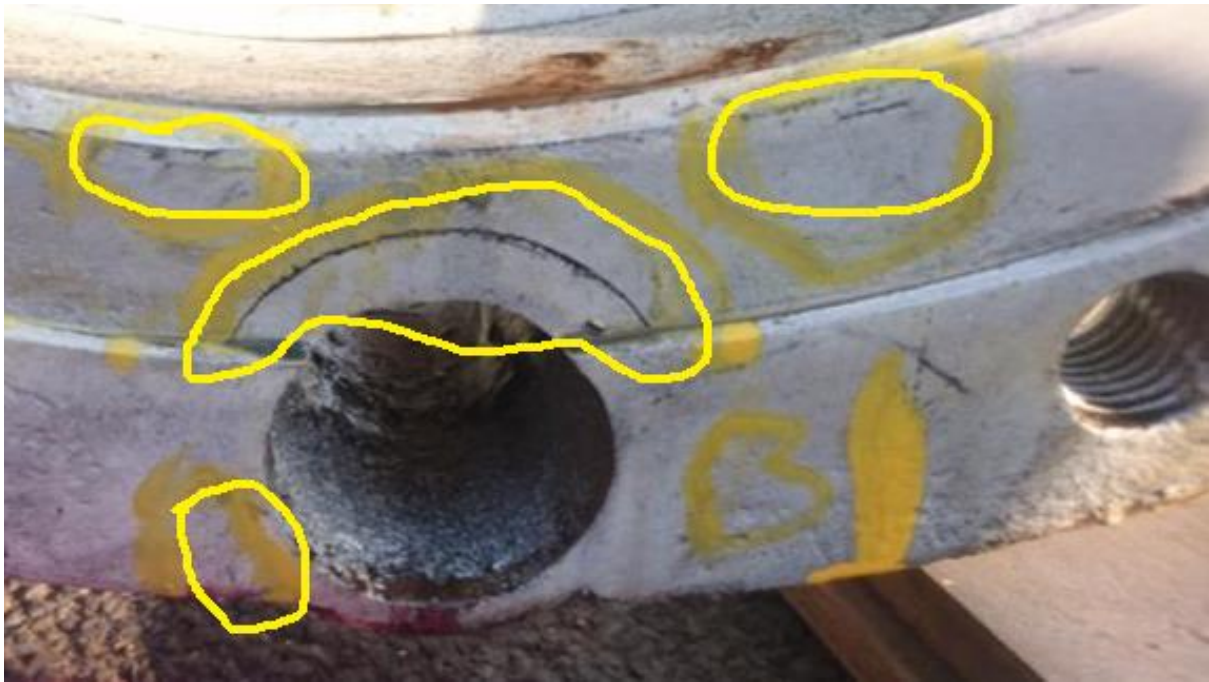
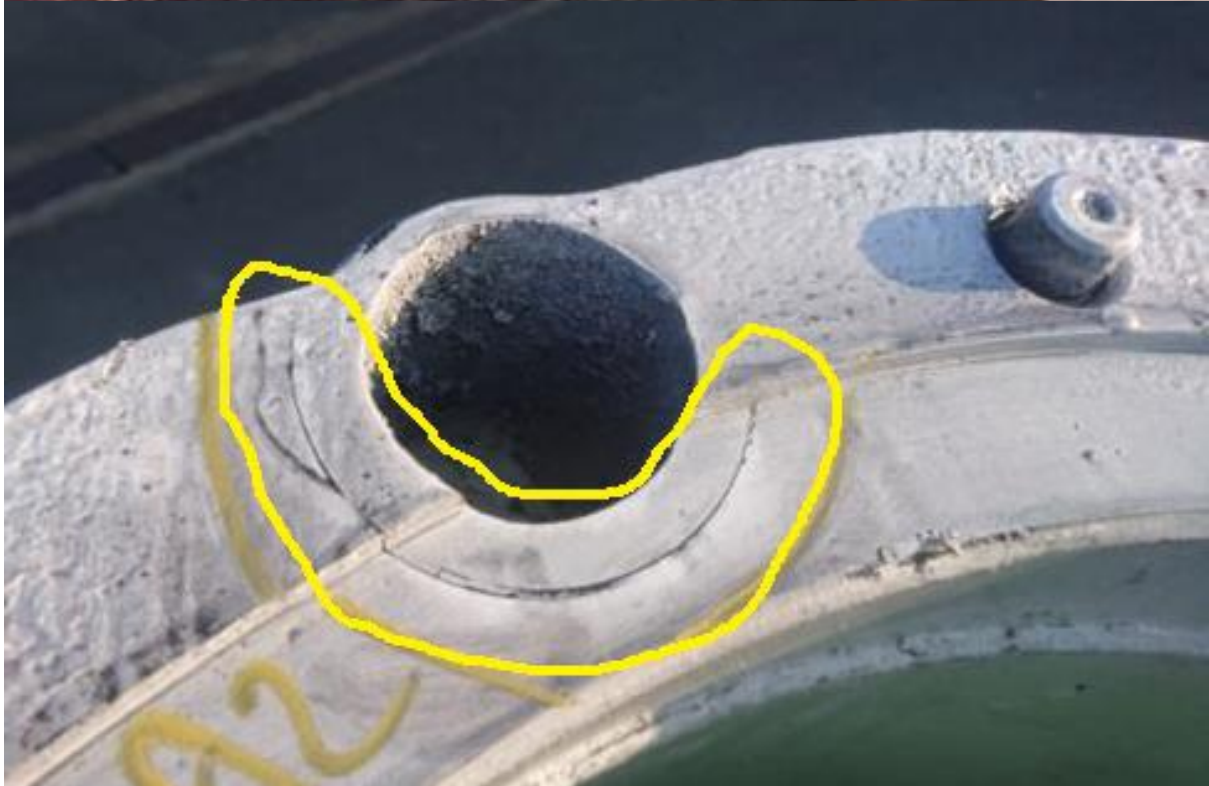
Axle A-Frame spring bolt boss cracking (mpi)

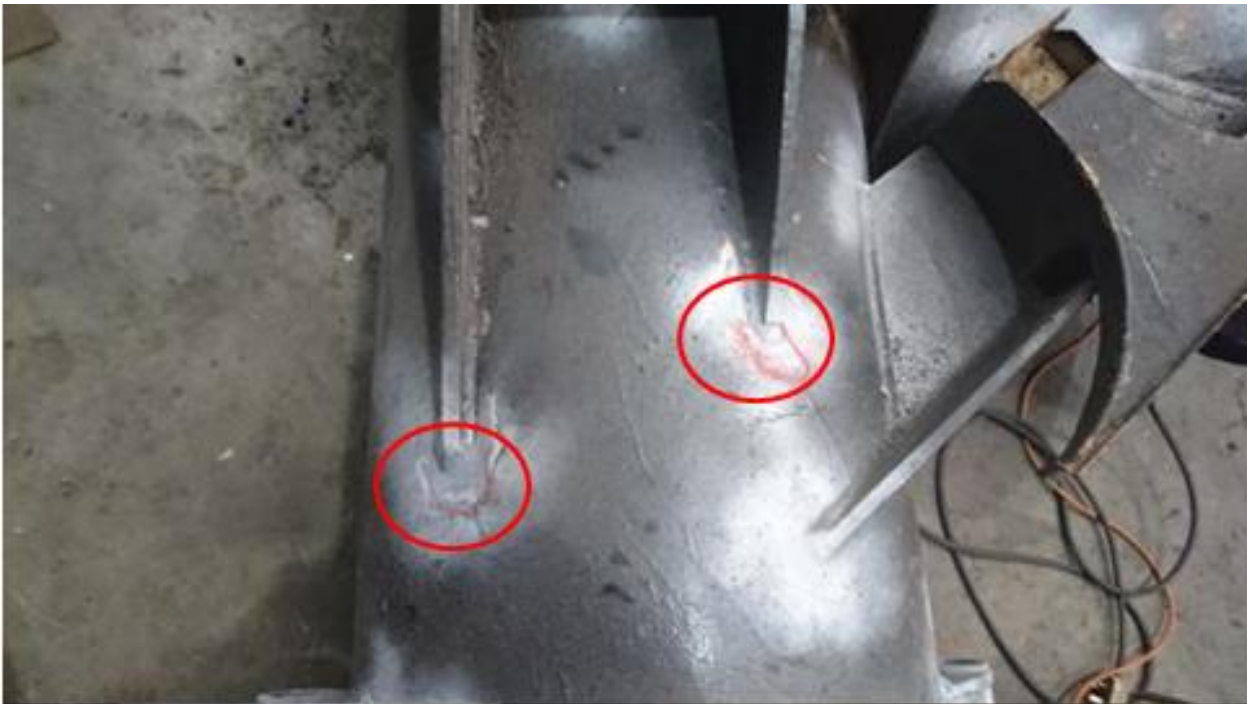
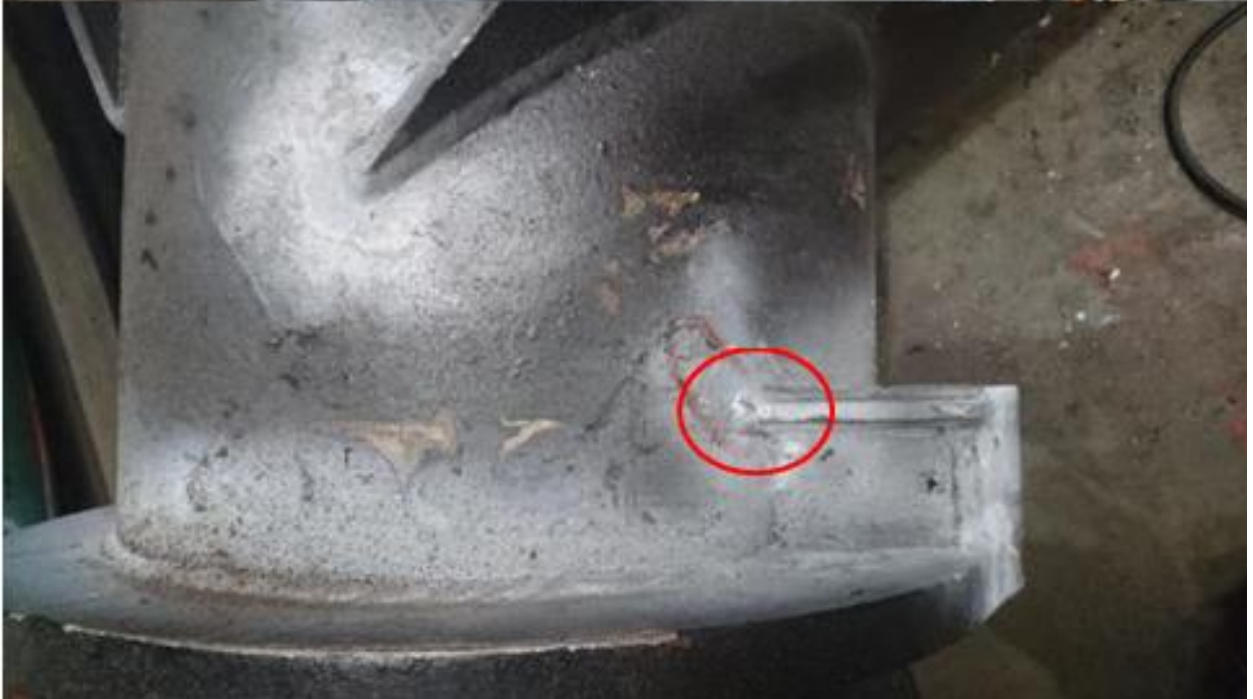
**Axle A-Frame external weldments**

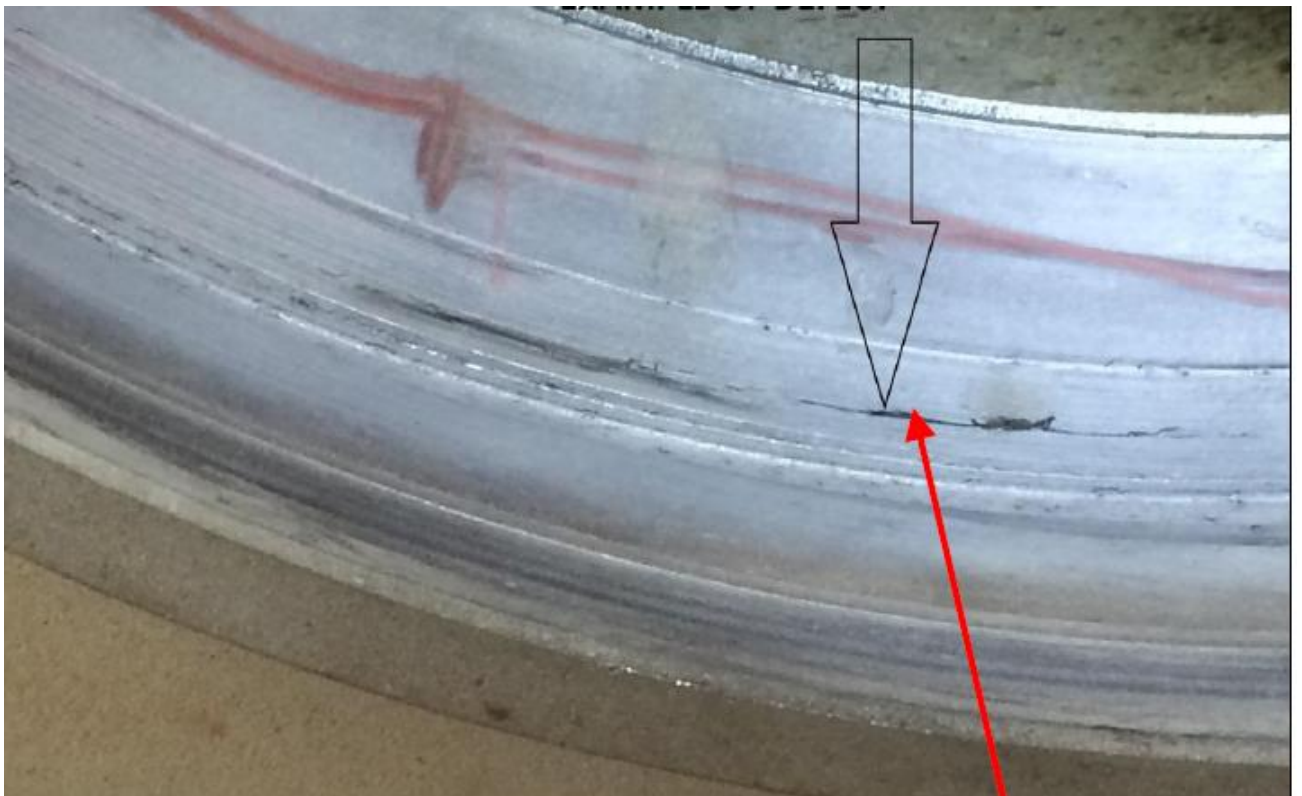
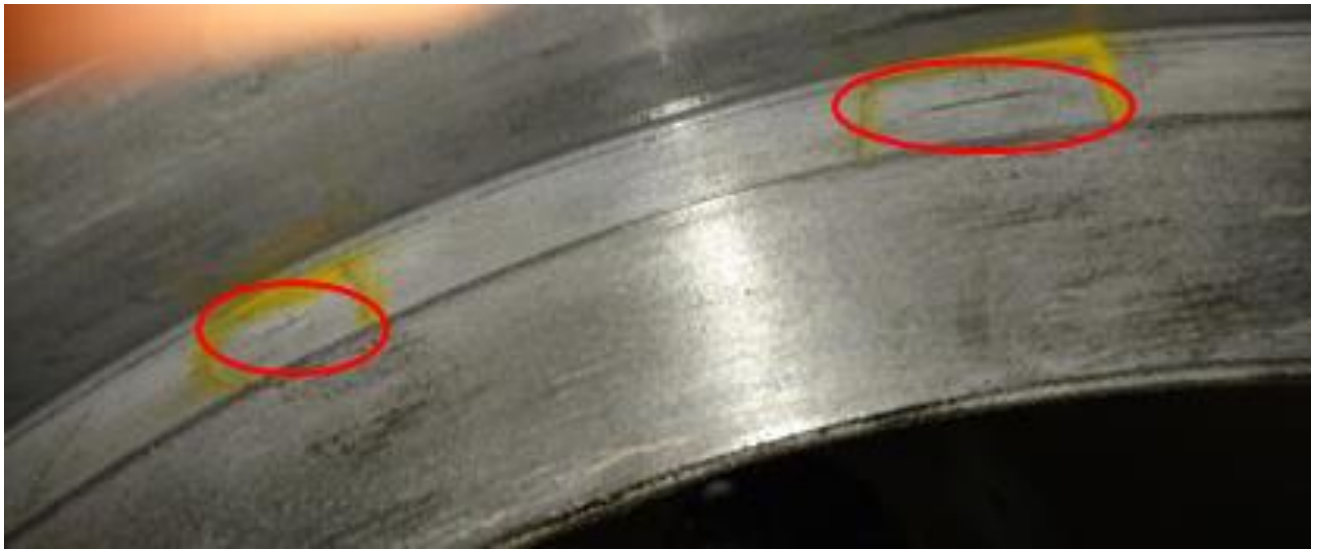
**Axle bearing face cracking (mpi)**
