## ARM Super Shot safety alert

**Bulletin No: SA20170222**  
**Release Date: Feb 22, 2017**  
**Effective Date: Feb 22, 2017**  
**Supercedes: N/A**  
**Completion Date: Immediate**  
**Page: 1 of 3**

# SAFETY ALERT RED

Manufacturer: A.R.M. (USA), Inc.  
 Ride Name: Super Shot

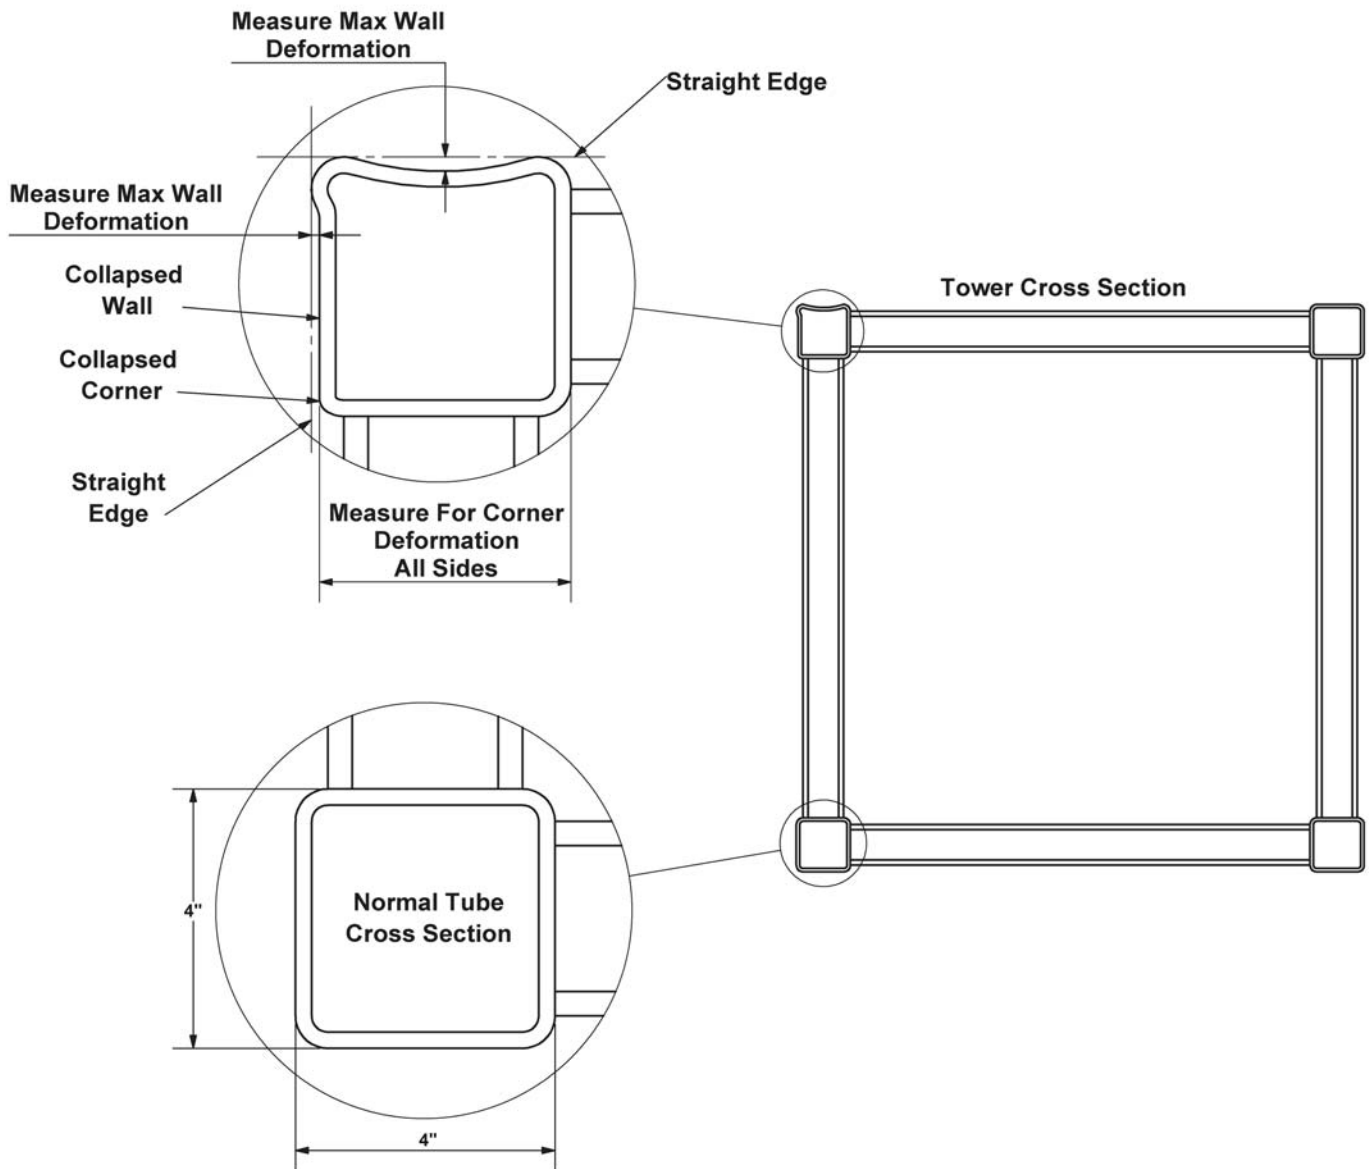
Precise alignment of the magnetic breaking system is crucial for safe operation and requires accurate tracking of the guide wheels along the tower frame. Collapsed portions of the tower frame tubes will allow the passenger carriage to shift on the tower resulting in misalignment of the magnetic breaks in relation to the conductor rails affixed to the tower. Even slight misalignment will alter the performance of the magnetic brakes - and possible failure.

In the event that the lift trolley hooks are not properly engaged to the passenger carriage, the carriage will be lifted on one side only - thus causing disproportional forces on the guide wheels around the carriage and trolley frames. The excessive force on the wheels will gradually deform the walls and/or corners of the vertical tube members on the tower.

Immediate inspection of all tower structural tubes with emphasis on the four corner vertical tubes that the passenger carriage guide wheels contact. Any collapse of the tube walls or corners to be measured and reported to A.R.M. (USA), Inc. prior to continued operation.

Prior to continued operation, all tower corner tube members must be visually inspected for deformation, excessive wear, cracks or other damage. The depth of any collapsed portion of the tube members to be measured and reported to A.R.M. (USA), Inc. for review and possible repair advise.

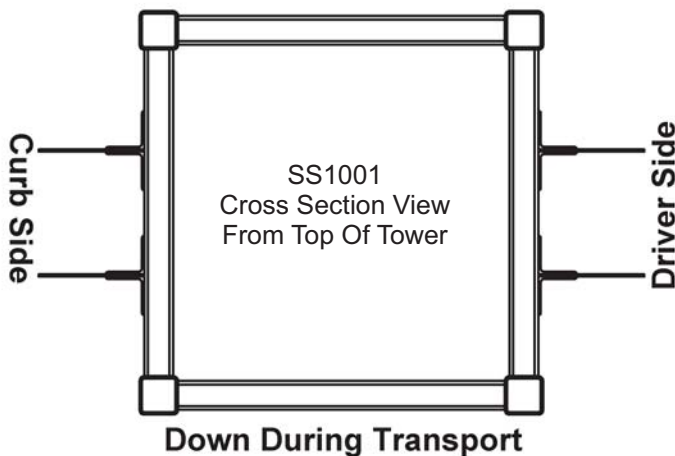
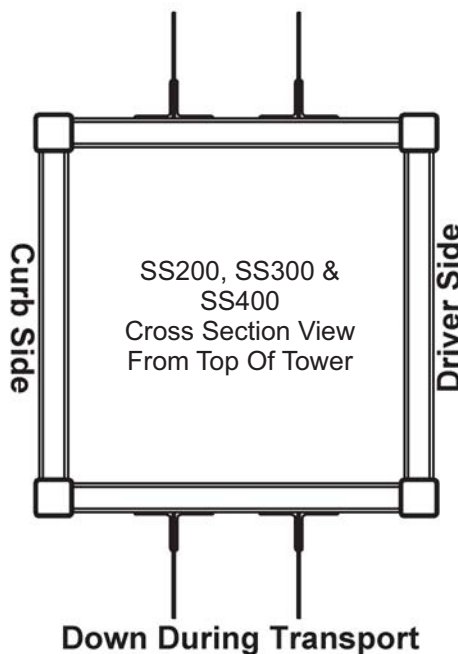
With Tower Wings Extended, Visually Inspect Entire Length Of The Tower & Measure Depth Of Any Tube Deformation. Indicate Position & Extent Of Most Severe Deformation And Return This Page To A.R.M. (USA), INC. For Repair Advise.

REPAIR TO TOWER STRUCTURE IS NOT RECOMMENDED OR APPROVED UNLESS SPECIFIED, IN WRITING, BY A.R.M. (USA), INC.
