433. PWS Sizzler Twist

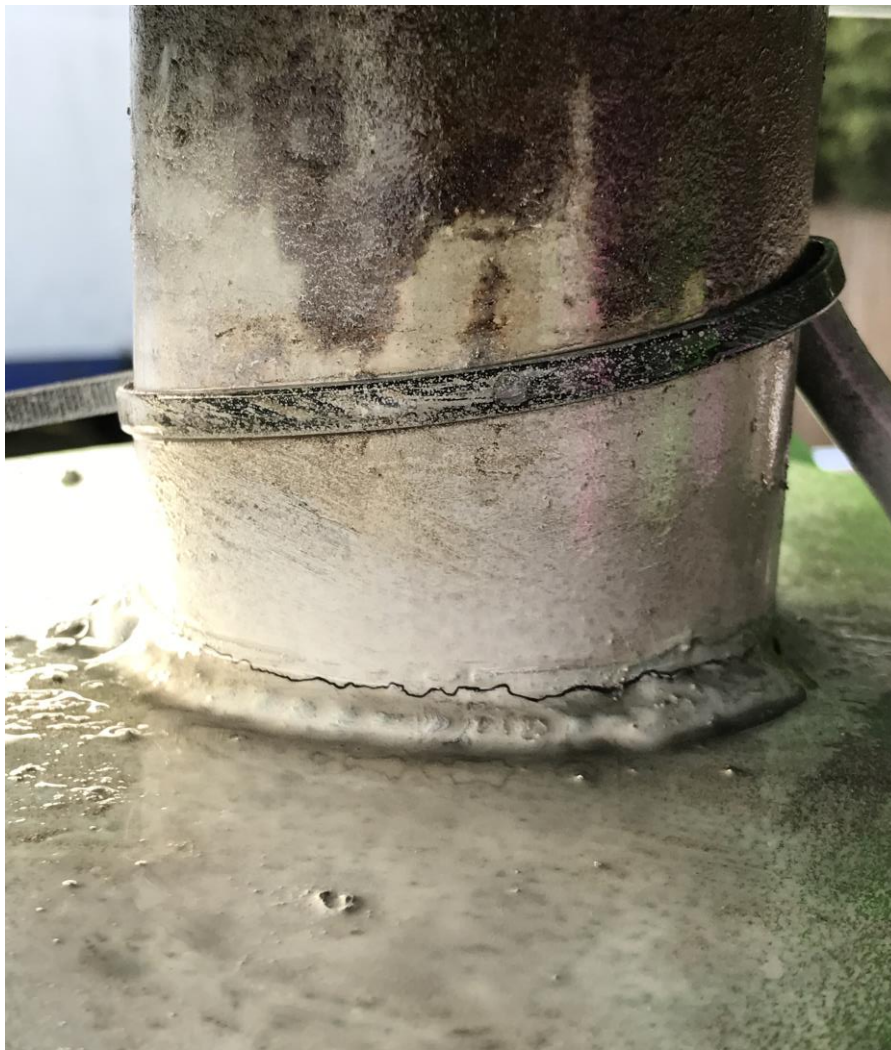
We have received a report from a UK registered inspection body relating to cracking on the capstan shaft of a PWS Sizzler Twist. The committee understands that the cracking was found on all three shafts and that the ride was only a year old.

This is a well-known area that can fail on these devices and we would refer IBs to previous NAFLIC Technical Bulletins relating to these rides. IBs are reminded to look at these areas when carrying out inspections.
