From : Albert Kroon
Subject : Manufacturer statement on Fireball ride accident on Ohio State Fair
Affected serials : FRB24 (serial numbers 01 up to and including 39)
FRB24P (serials 01, 02 and 03)
MVT24 (serials 00, 01, 02, 03 and 04)
MVT32 (serial 01)

Bulletin No:	FRB24-SB008
Release Date:	August 2 nd , 2017
Effective Date:	August 2 nd , 2017
Supersedes:	none
Completion Date:	See text
Page:	1 of 7

SAFETY ALERT

Abstract of Issue: Inspection of gondola support beam and joint

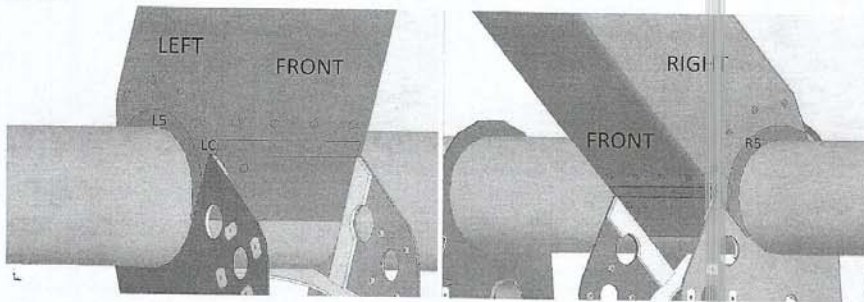
Areas:

- Gain access to all four sides of the gondola support beam and around the joint. The secondary lock solenoid can be left in place.
- Remove all parts and paint in below mentioned areas L5 and R5 on both sides of the beam joint and on both corners LC and RC of the support beam joint:

- Test for cracks using magnetic testing following ISO 17638.

Accepted: Magnetic test results are meeting class 1 criteria as per ISO 23278.
 Rejected: Magnetic test results are not meeting class 1 criteria as per ISO 23278.
Do NOT return ride to service.

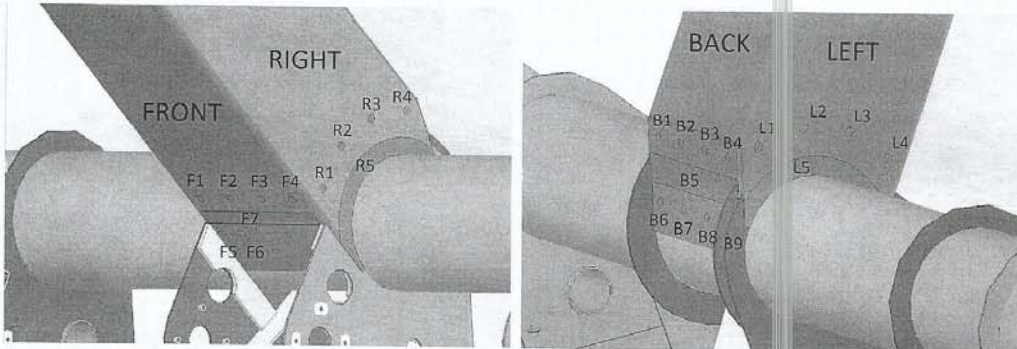
Areas:

1. Remove all parts and paint in below mentioned areas L, R, F, B following the specific locations in below drawings.
 2. Do a wall thickness measurement in all numbered areas L, R, F, B following the specific locations in below drawings.
- Applicable standard for inspection: EN14127. Equipment: Ultrasonic thickness measurement equipment with minimum an A-scan. Probe: GE / Krautkrämer DA312, TruSonics TS-400 or equivalent.

Spots L1, L2, L3, L4:

Take measurement on described position.

Spots R1, R2, R3, R4:

Spots F1, F2, F3, F4, F5, F6:

Spots B1, B2, B3, B4, B6, B7, B8, B9:

Areas L5, R5, B5, F7:

Test complete area and take smallest measurement over area.

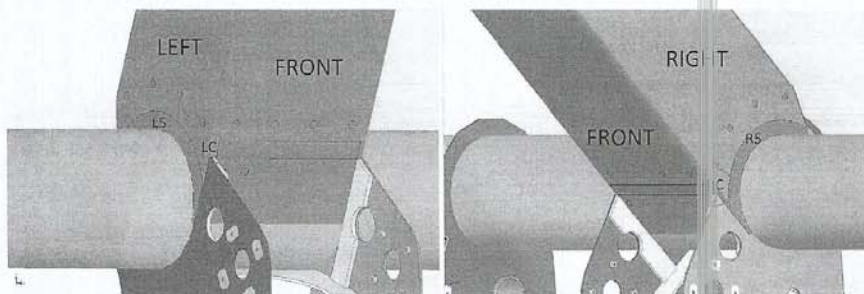
1. Gain access to areas described in below images.
2. Visually inspect areas L5 and R5 and corners LC and RC, looking for cracks. Applicable standard for inspection is ISO 17637 and acceptance criteria following ISO 5817 acceptance class B.

Accepted: Visual test results are meeting class B criteria as per ISO 5817.
 Rejected: Visual test results are not meeting class B criteria as per ISO 5817.
Do NOT return ride to service and consult KMG.
