## 437.

# Passenger restraints with padding

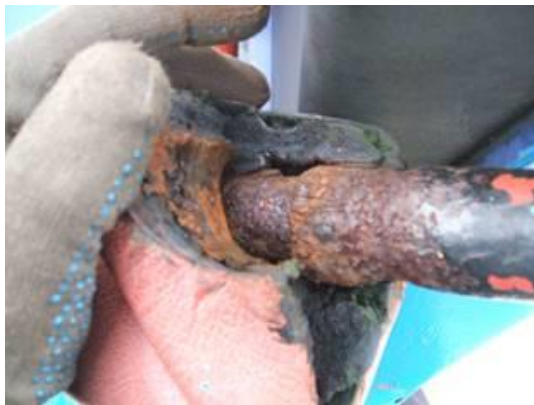
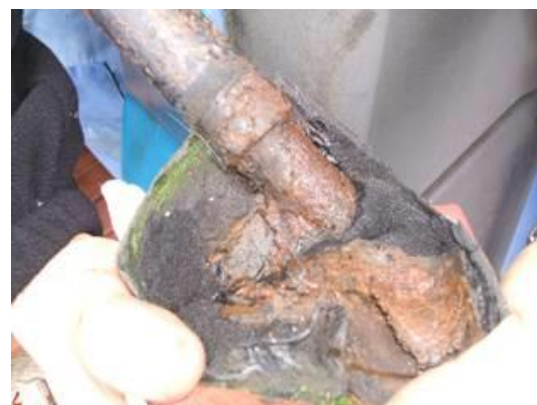
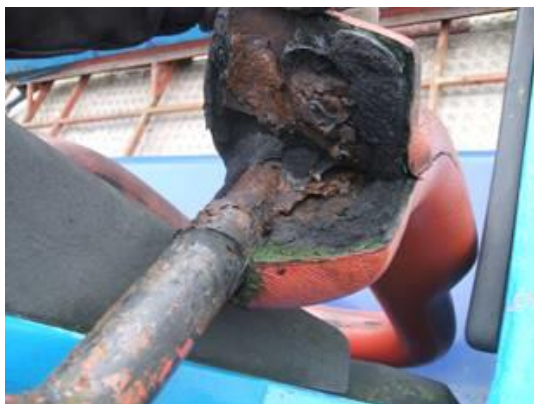
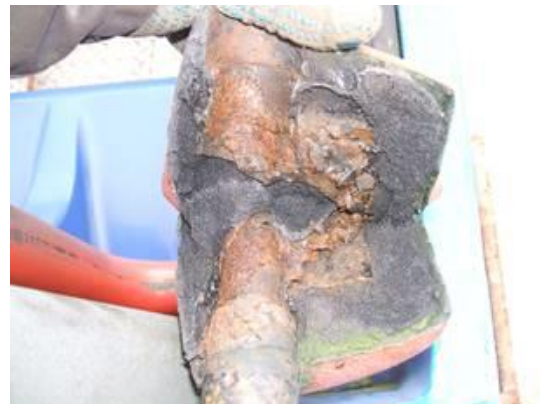
A number of instances of passenger over-the-shoulder and waist restraint failure have been brought to NAFLIC's attention and it is felt the following advice would be useful for IBs.

Some examples of restraint corrosion/failure can be seen in the images below.

For reasons of assessing restraint structure under the moulded padding a sample removal of padding may be required. Alternatively, radiography could be used and it is recommended that if the condition of the restraint looks like it is suffering from corrosion, the padding be removed completely to allow detailed inspection.
