TECHNICAL BULLETIN — AUGUST 2010

366. “Fairmatt” Type Miami Cracking

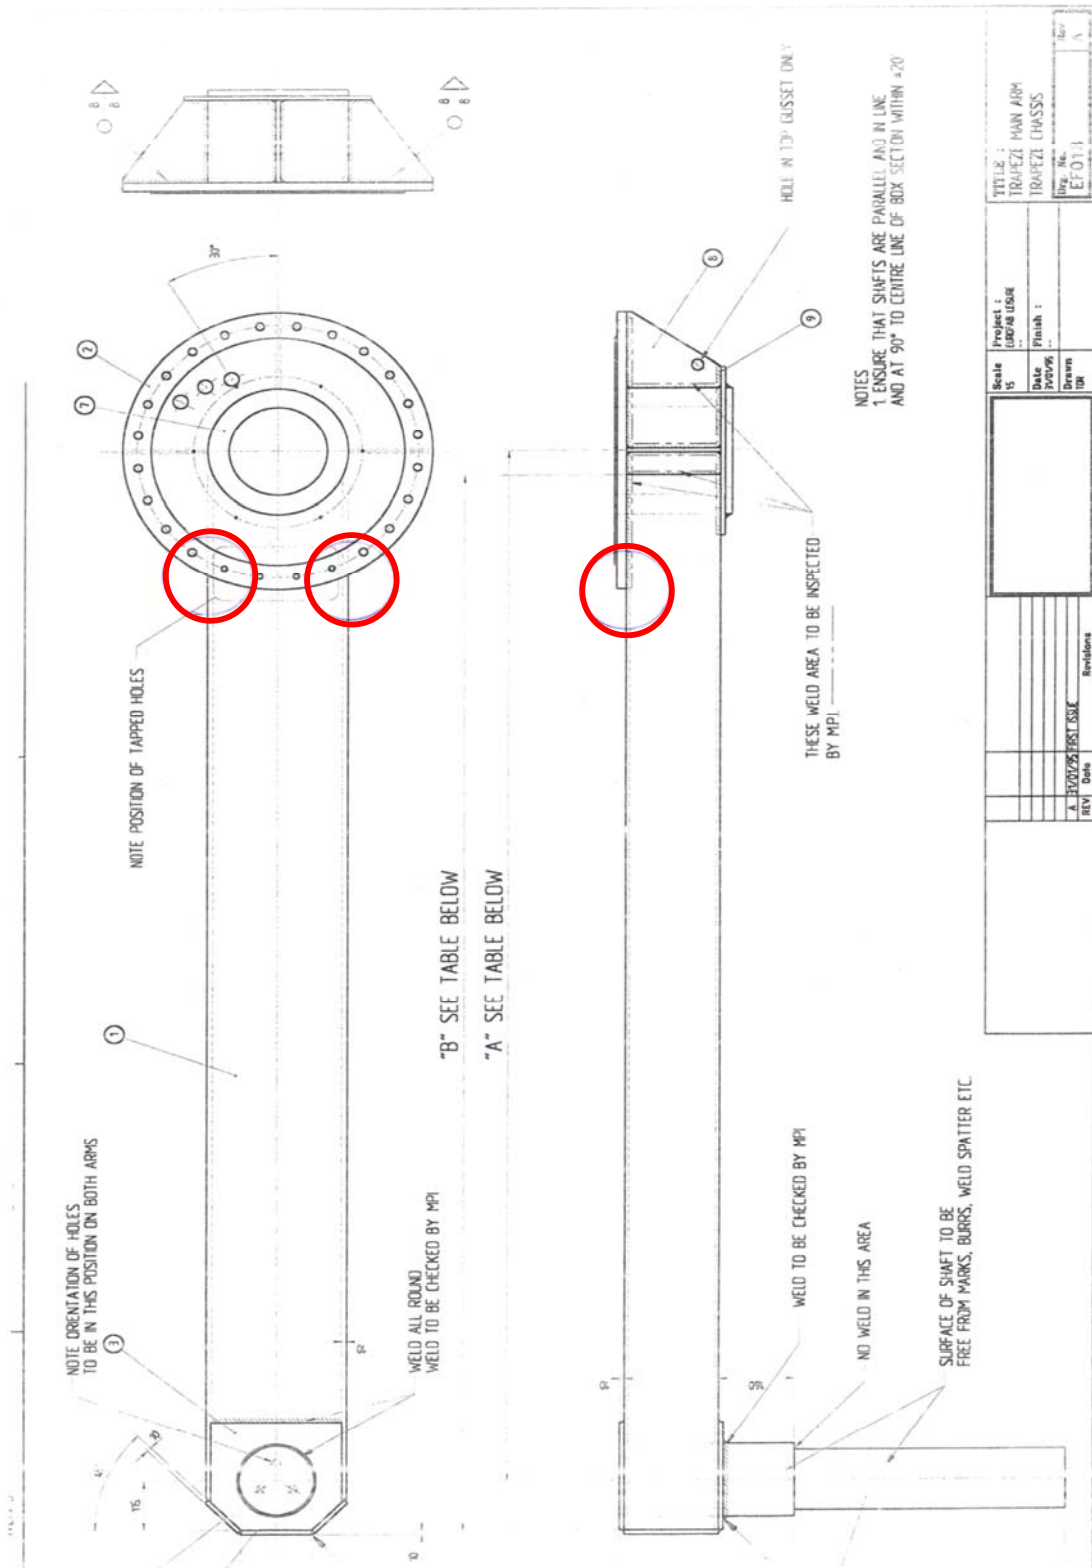
The location of the cracking is indicated in the figure 2.

Figure 2. Corner cracking as indicated within the circles.

Controllers are reminded that any weld repairs in safety related areas should be carried out by a suitably qualified welder and subsequently subjected to an appropriate NDT examination.
