NAFLIC

TECHNICAL BULLETIN — AUGUST 2010

366. “Fairmatt” Type Miami Cracking

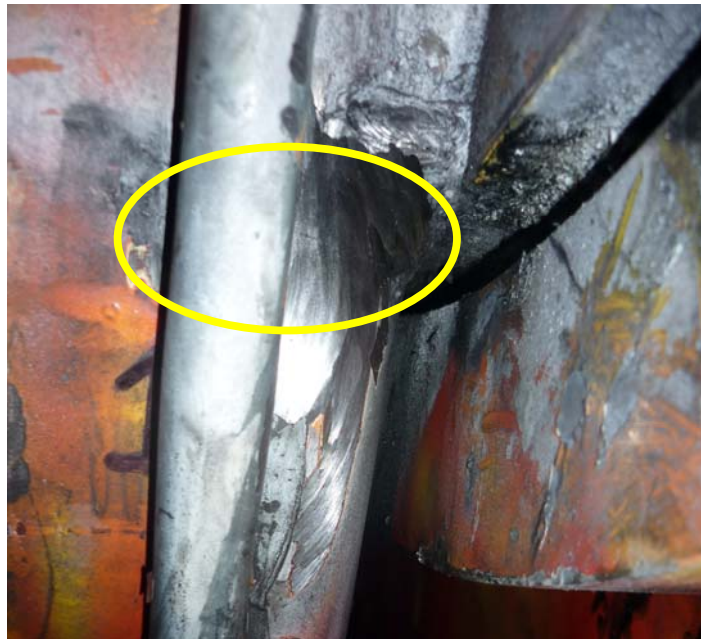
Figure 1.

We have received notification of defects on a Miami Trip rides manufactured by Fairmatt Ltd, Eurofab Ltd, Nottingham (UK) Ltd & FGL. Cracks have been found at the junction of the spur wheel mounting plate and the main arm box-section as shown in figure 1.

Controllers are reminded that any weld repairs in safety related areas should be carried out by a suitably qualified welder and subsequently subjected to an appropriate NDT examination.

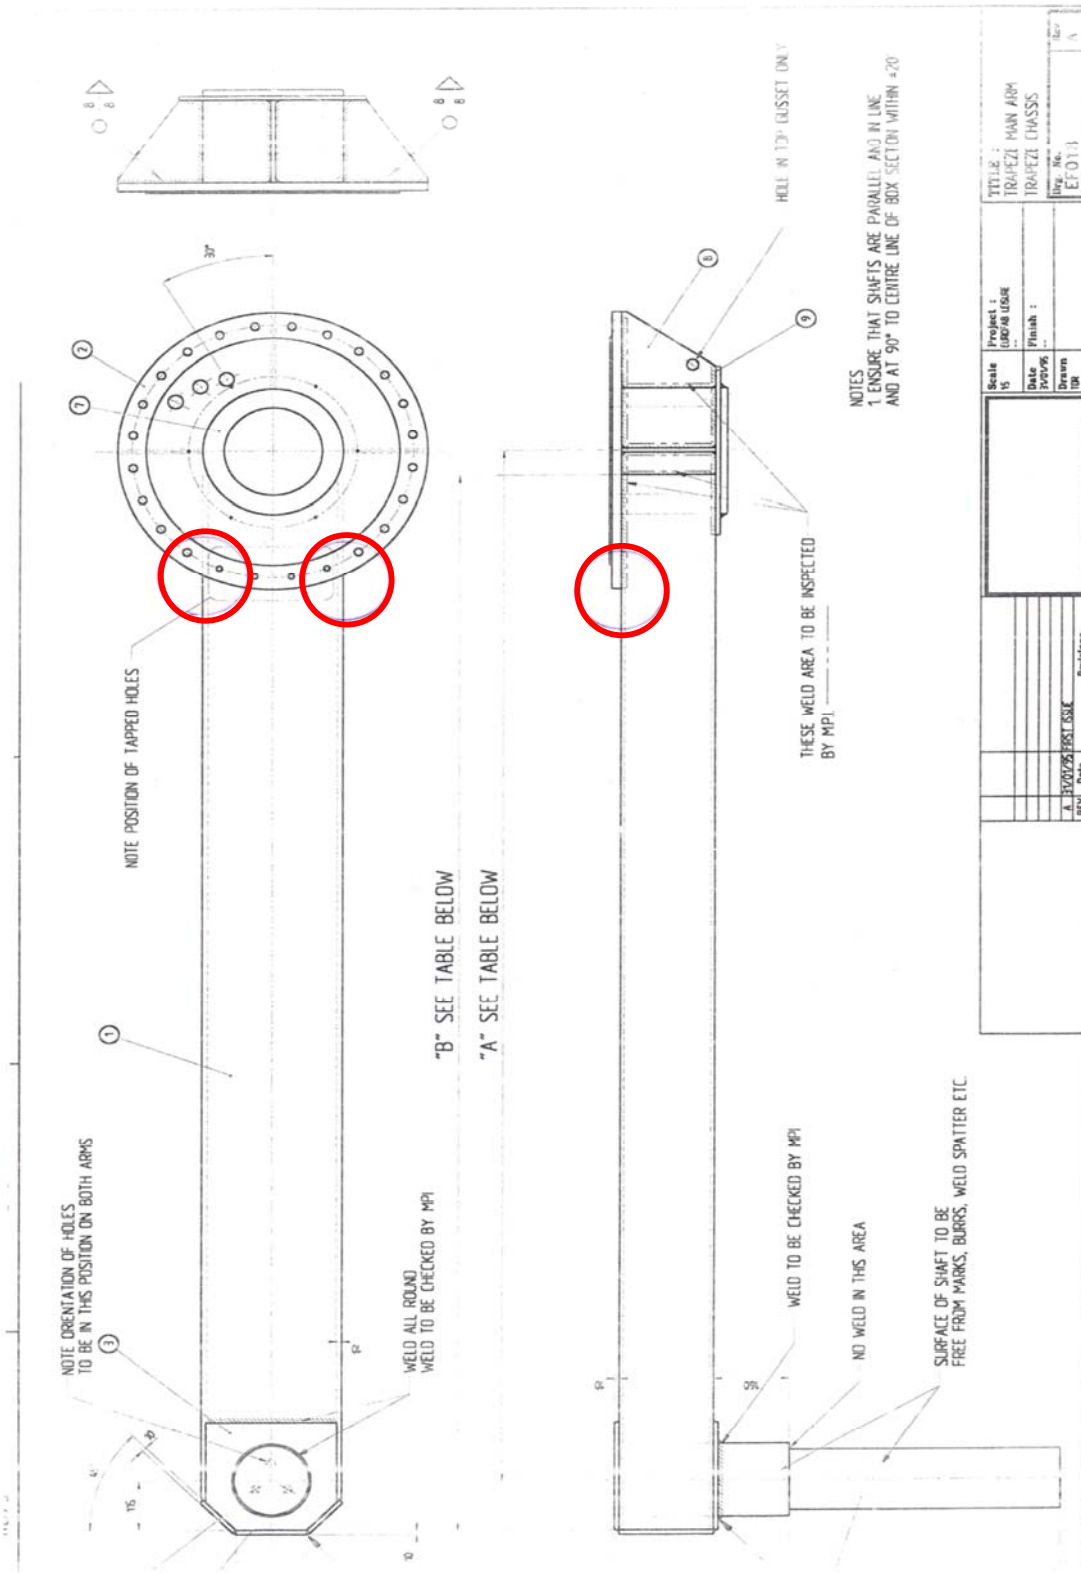
The location of the cracking is indicated in the figure 2.

Figure 2. Corner cracking as indicated within the circles.
