Bulletin No.: S.A. 2012-01  
Release Date: 10-24-12  
Effective Date: 10-24-12  
Supercedes: All  
Completion Date: 10-24-12  
Page: 1 of 1

# SAFETY ALERT

Ride Name: Musik Express

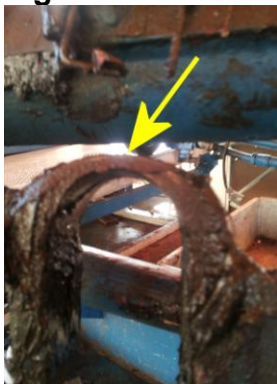
Figure 1:

Musik Express spreader ears have become damaged or worn beyond acceptable tolerances for operation.

The reason for this safety alert is to notify all inspectors, owners and, operators of a safety concern with the Musik Express spreader ears. We have found that over time the Musik Express spreader ears can become damaged or worn beyond acceptable tolerances for operation. This can be caused by the Musik Express spreader ear bushings are worn or the spreader ear bushings are not present.

This is a picture of a Musik Express spreader ear that is damaged and worn beyond acceptable tolerances.

All Musik Express amusement rides should be inspected for damaged or worn spreaders ears that are beyond acceptable tolerances for operation. Any Musik Express amusement rides that are found with damaged or worn spreaders ears that are beyond the acceptable tolerances must be replaced before operation.

The lowest acceptable tolerance for the material thickness for the Musik Express spreader ears is 85% of the original material thickness.

Original material thickness is 15 mm.
