# Safety Alert – Hill/Valley ‘Tram’ based rides

## Background & Scope

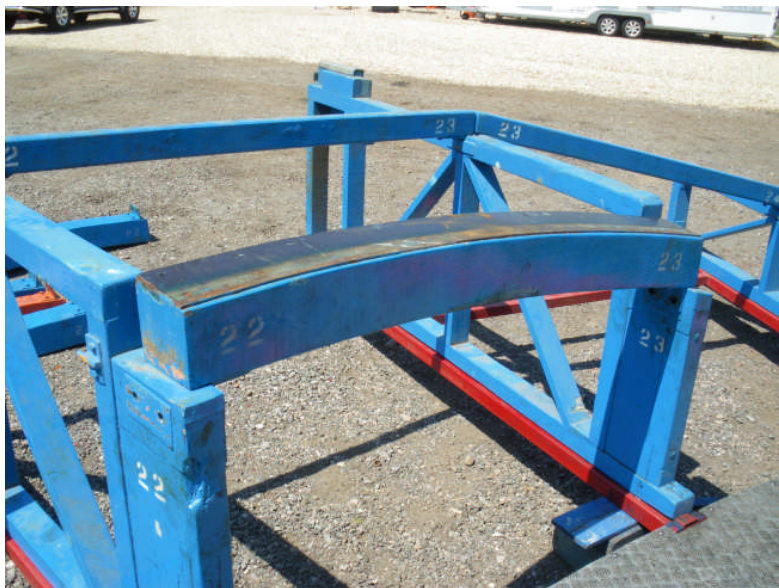
**Fig 1**

This alert refers specifically to those rides with a metal tram top running on a wooden frame. An example of a section of such a tram is shown at Fig 1:

For trams to break like this is not unknown and the possible outcomes of such failures could, on the evidence of this incident, be serious for riders, those watching and attendants/operators.

Ride controllers should conduct a thorough visual check of the condition of both the metal rail and the supporting woodwork to ensure there are no obvious signs of any deformation or rot around new or old fixings. Particular attention should be paid to areas where repairs have been made. Any future repairs to the tram, a safety critical part, should be discussed with your ride examiner and a design review conducted.

Ride examiners should, when conducting the normal annual inspection, thoroughly check the entire tram for structural integrity, paying particular attention to areas where repairs have been conducted, to ensure decay is not propagating from old fixings. Any tram repairs should be treated as repairs to safety critical components and reviewed as such.

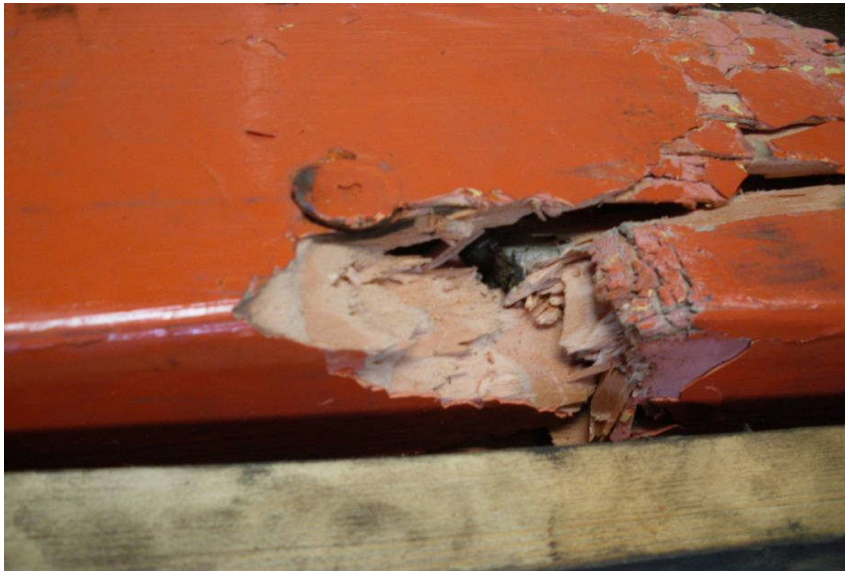
**Fig 2**

Whilst investigations are ongoing, initial investigations suggest that the failure may have occurred close to a site of a previous repair where a redundant bolt had not been removed. It is possible that this bolt corroded within the wood to which the metal tram top was attached, and caused the wood to decay, weakening it.

When the tram is painted bolts such as this can appear identical to knots in the wood. See Fig 2

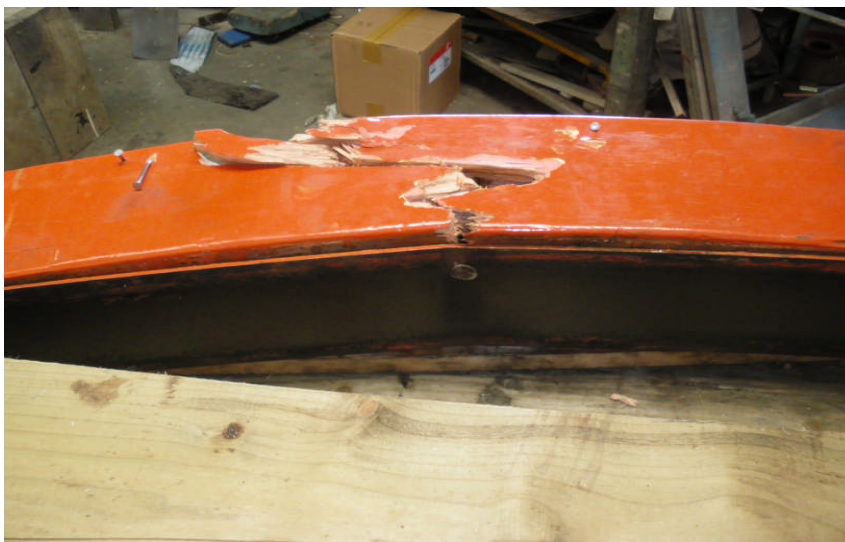
This weakening then resulted in a catastrophic failure of the timber support and the rail collapsed. See Fig 3.
