SAFETY NOTE

ZIP WIRE AND FAN BRAKE ACCIDENT

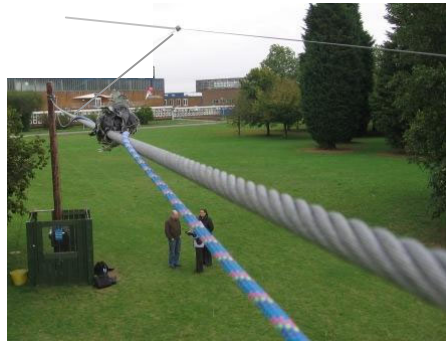
The ride consists of a high tensile steel wire rope (SWR) 208m in length, descending to the ground from a height of 36.5m. The SWR was double connected securely at both ends. A double wheeled pulley carriage system is safely fixed to the SWR and runs along it. The rider hangs below wearing a full body harness which is connected to the pulley carriage with twist lock karabiners and adjustable webbing straps. See photo below:

Photograph showing the zip wire [modified].

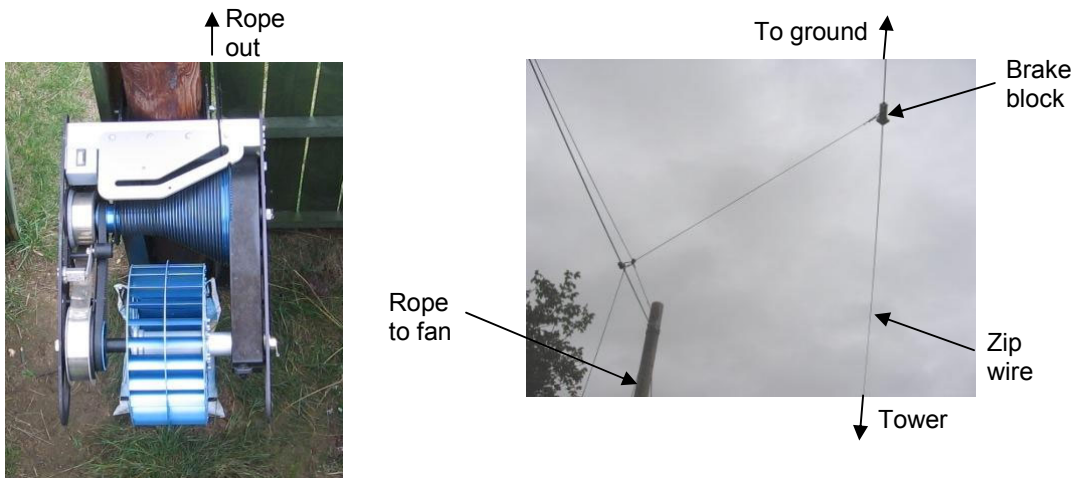
As the pulley from which the rider is suspended reaches the last 26m of the SWR it meets a running block on the SWR which is attached by a fibre rope to a parallel run of rope (guided by a SWR) which is in turn connected to a fixed post at one end and a spring loaded fan brake at the other. As the pulley from which the rider is

suspended pushes the running block along the SWR, this in turn pulls rope from the spring loaded fan brake drum which slows the whole assembly. See photos and diagram below.

Photograph showing the rope as it is pulled out of the fan brake and connection from the brake block on the zip wire to the fan (from below).

In order for a person to descend and stop safely the running block must be at its proper start position (in this case approximately 26m from the end of the SWR). The rope must be correctly wound back around the drum on the fan brake. There must also be no obstruction to the pulley, the running block or to any other moving part or the brake may not function correctly and slow the rider to a safe speed.

In some set ups it is possible for the process of resetting the braking system to be automated but in any case and given the hazard presented to riders if this fails, it is considered necessary for there to be a system in place for physically checking that the brake has actually reset correctly and an emergency arrester system.

Operators of zip slide equipment should ensure that the following are in place and that they are regularly checked to ensure they remain effective and valid:

- A risk assessment for the operation of the slide which takes into account and controls the serious risks presented by the failure of all components.
- A manual for the maintenance and operation of the equipment and all of its component parts. This should include detail of lifespan and replacement cycles for components.
- A system of checking that the braking system is set and effective prior to every slide. No slide should begin until positive confirmation has been received at the launch point from the person checking the brake that it is set correctly.
- A training regime for all operators and ride staff.
- An emergency passive backup system to absorb some or all of the energy in the event the braking system does not operate correctly.
