SAFETY NOTE

ZIP WIRE AND FAN BRAKE ACCIDENT

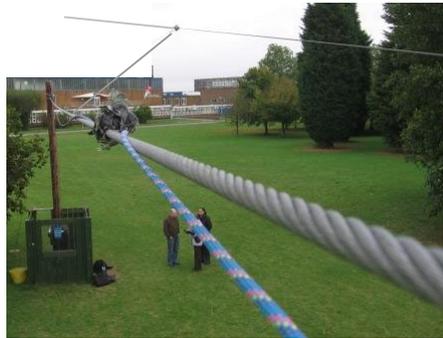
The ride consists of a high tensile steel wire rope (SWR) 208m in length, descending to the ground from a height of 36.5m. The SWR was double connected securely at both ends. A double wheeled pulley carriage system is safely fixed to the SWR and runs along it. The rider hangs below wearing a full body harness which is connected to the pulley carriage with twist lock karabiners and adjustable webbing straps. See photo below:

Photograph showing the zip wire [modified].

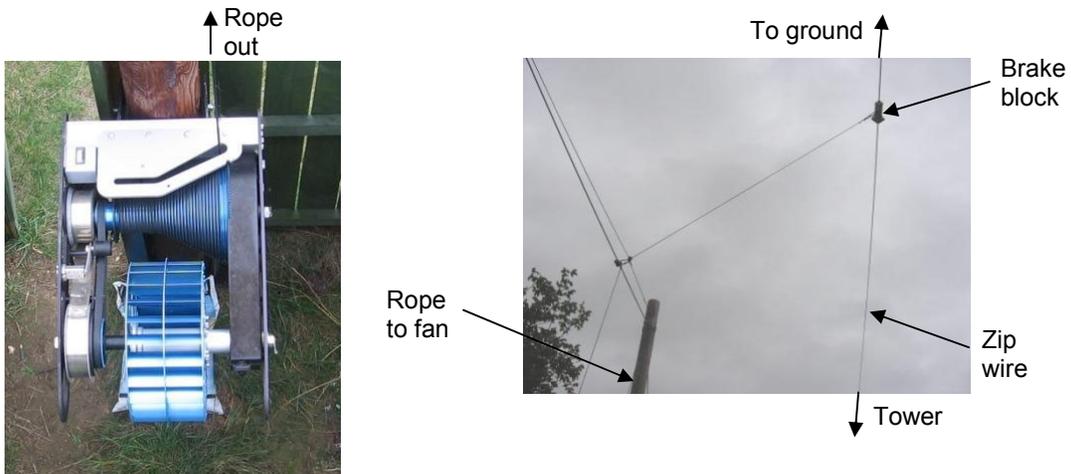
As the pulley from which the rider is suspended reaches the last 26m of the SWR it meets a running block on the SWR which is attached by a fibre rope to a parallel run of rope (guided by a SWR) which is in turn connected to a fixed post at one end and a spring loaded fan brake at the other. As the pulley from which the rider is

suspended pushes the running block along the SWR, this in turn pulls rope from the spring loaded fan brake drum which slows the whole assembly. See photos and diagram below.

Photograph showing the rope as it is pulled out of the fan brake and connection from the brake block on the zip wire to the fan (from below).

In order for a person to descend and stop safely the running block must be at its proper start position (in this case approximately 26m from the end of the SWR). The rope must be correctly wound back around the drum on the fan brake. There must also be no obstruction to the pulley, the running block or to any other moving part or the brake may not function correctly and slow the rider to a safe speed.

In some set ups it is possible for the process of resetting the braking system to be automated but in any case and given the hazard presented to riders if this fails, it is considered necessary for there to be a system in place for physically checking that the brake has actually reset correctly and an emergency arrester system.
