| Bulletin No: | B410CRM126-B |

# SERVICE BULLETIN

Ride Name: AVIATOR Affected Serial Nos.: 410-00399 and on

Abstract of Issue:  
Vehicle Frame Inspection

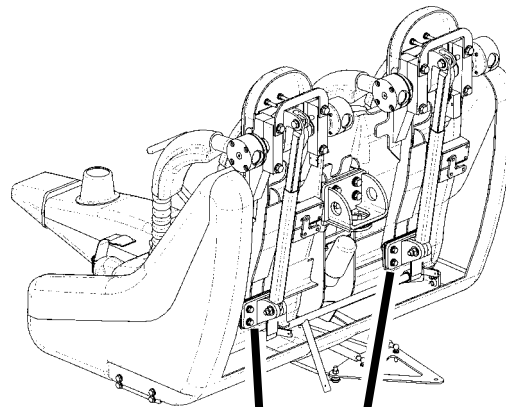
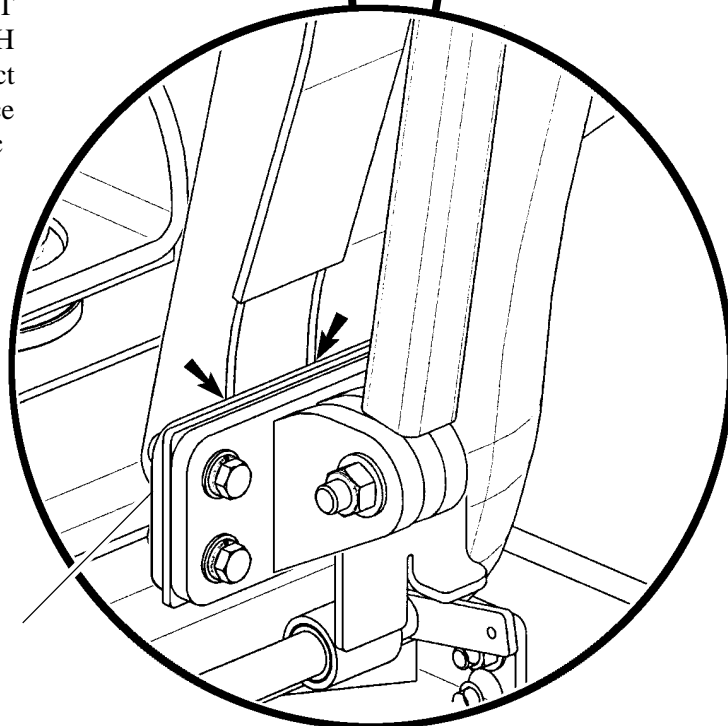
Remove the back covers from all vehicles to gain access to the mounting plates for the restraint bar primary lock mechanisms as shown. Visually inspect the joint between the frame and mounting plates. Look for indications in the aluminum plates and check the welded joints for indications in the welds and the parent metal. An inspection mirror is necessary to see these areas.

Make sure the mounting plates are not bent or distorted.

*Use an inspection mirror to inspect this area on both sides of each vehicle frame. See DETAIL on next page*

*Mounting plate for restraint bar primary lock mechanism (welded to vehicle frame)*

**IMPORTANT:** *A kit (part number K410CRM126-0) has been developed to repair the vehicle frame. The kit includes parts and instructions required to repair the one vehicle frame. Contact Chance Rides Manufacturing, Inc. to help determine if the kit is appropriate to repair the indications found.*

If any indication is found, DO NOT OPERATE THE RIDE WITH PASSENGERS IN THAT SEAT. Contact the Customer Service Department at Chance Rides Manufacturing, Inc. for specific instructions on further action to be taken.
