# SAFETY ALERT

<b>Ride Manufacturer: I.E. Park s.r.l.</b>	<b>Affected Production Dates: 2003 to 2012</b>
<b>Ride Name: Roller Coaster JR 30</b>	<b>Affected Serial Nr:</b> 10AC 0001 year 2003 10AC 0002 year 2005 10AC 0003 year 2010 10AC 0005 year 2012
<b>Model Number: 10AC</b>	
<b>Abstract of issue:</b> Potential initial crack in the main support shaft of wheel boogie (see details below in the figure)	
<b>Reason For Release:</b> A failure occurs in one shaft wagon of a train. Reasons under investigation. For prudence it's necessary an urgent inspection and NDT	
<b>Action To Be Taken: (Inspection, Modification, Replacement, NDT, Order Parts, Manual Revision, Procedural Change, etc.)</b>  Urgent unscheduled Inspection and NDT on 100% of the wheel boogie main supports. It's necessary to conduct the following NDT tests by qualified personnel: UT Ultrasonic Test MT Magnetic Particle-Test.  In addition particular attention to check the regular wear of the wheels, as per paragraph 6.11 of the Operation Manual. We remind the planned regular inspection and maintenance as per Operation manual Chapt. 6, in particular, but not limited to, paragraph 6.9.7.

**Bulletin No: 01-2014**  
**Release

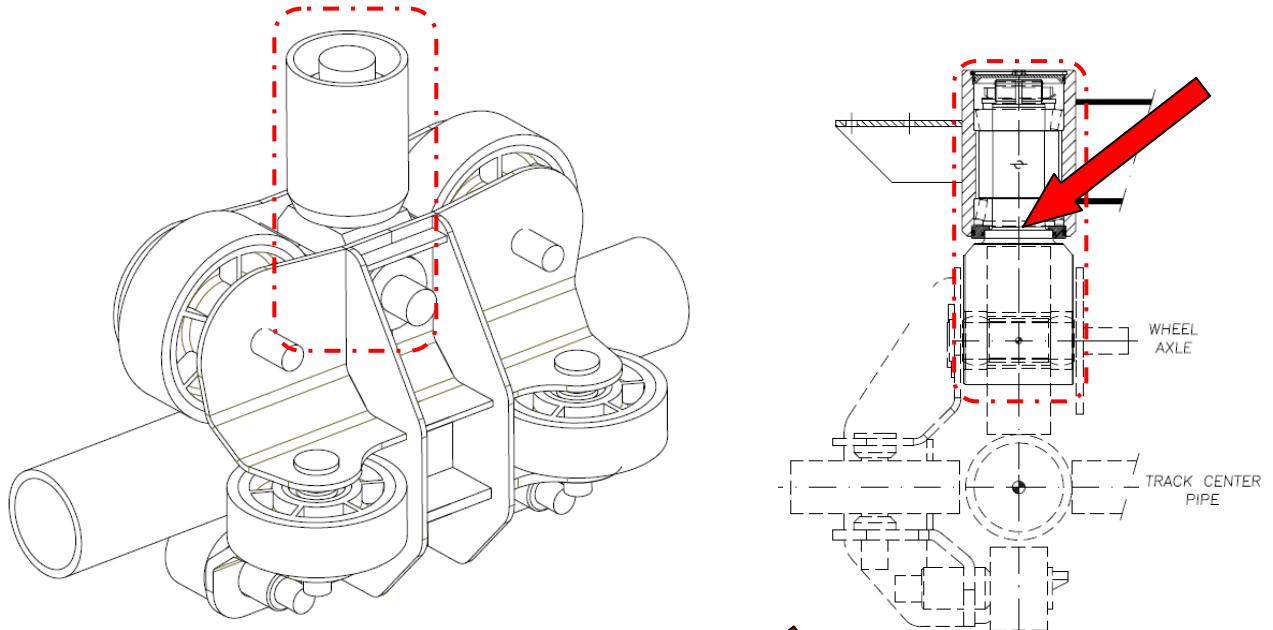
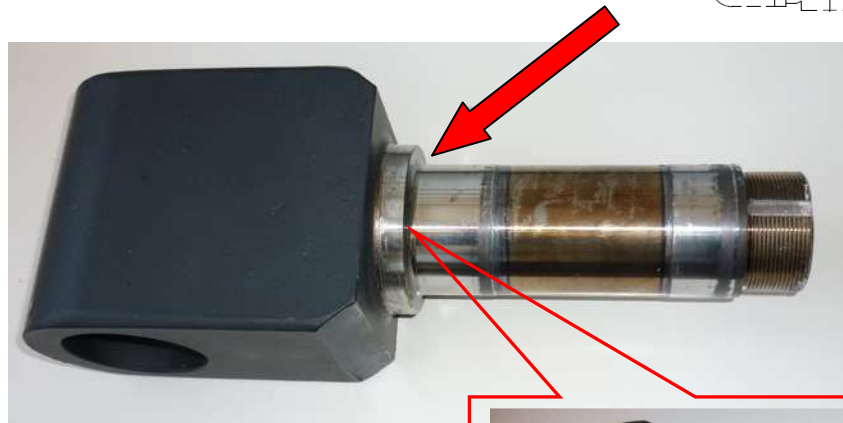
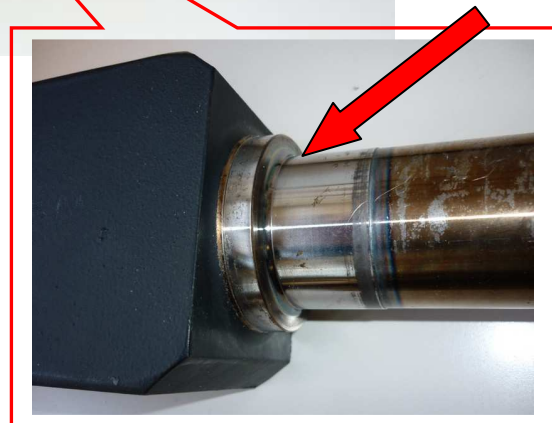
**Detail of Issue:**  
**(Text/Drawings/Schematics): NDT in the position indicated by red arrow in the figure**
