TECHNICAL BULLETIN — October 2015

400. Hydraulic cylinder problems

Service Bulletin

Action required in relation to attention items as described by Hoerbiger Micro Fluid GmbH.

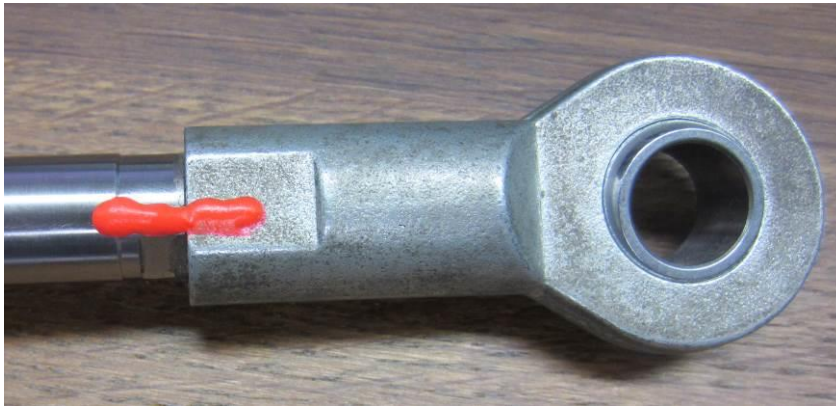
Figure 1: how to apply torque striping on the rod end.

Issue	: In the past the Supplier could not guarantee that the piston rod could not come loose at the joint head.
Action Supplier	: With the newly delivered HLU’s, the production process was changed by adding Loctite 243, a locknut and torque striping. This way they are able to guarantee that the piston rod can not come loose at the joint head.
VRP&S’ advice	: Add torque striping to the piston rod at the joint head (see figure 1) and perform a weekly check on this area. HLU’s that are not installed yet (such as spare cylinders) need to be checked for Loctite 243 before installation. See the remarks next to Table 2 for the correct torque values of the rod ends for both the LE 25 and LE 32 units.

Note: *in case of old configuration HLU (without locknut).*

Apply Loctite 270 and torque striping. In case no locknut is applied, the torque values for the LE 25 and LE 32 unit are respectively 25 ±5Nm and 30 +5Nm.

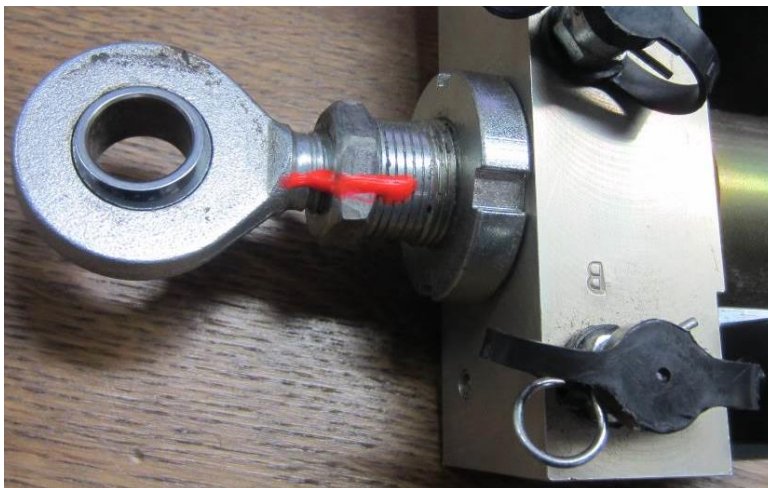
Figure 2: how to apply torque striping on the threaded screw assembly at the bottom.

- Issue : The supplier added an additional requirement on the length of the threaded screw assembly. Due to the adjustment function of this connection it is not guaranteed that the threaded screw assembly is within the specified range.
- Action VRP&S' : Checking this connection was included during installation of the HLU in the vehicle.
- VRP&S' advice : Check the length of the threaded screw assembly. If applicable it needs to be corrected. For the correct settings, please refer to the text below for the LE32 units and table 2 for the LE25 units (these values are created from the Supplier's document). Add torque striping to the connection (see figure 2) and perform a weekly check on this area.

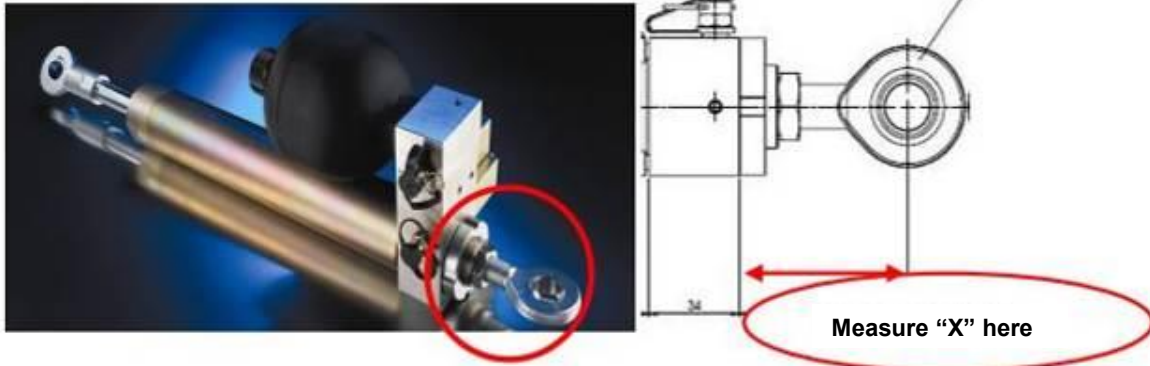
Figure 3: information for LE32 and LE25 screw connection at the bottom.

The following data apply for all LE32 versions:

For the LE 32 versions the screw thread depth is correct when the rod end length “X” is below 65 mm. ($X < 65\text{mm}$)

The following data apply for all LE25 versions:

For the LE 25 versions the screw thread depth is correct if the rod end length “X” is below the value as stated behind the product number in de table below. The small x at the end of the product number indicates the version number.

We strongly urge you to immediately check the measurement set out above on all Personal Restraint Systems in your possession and advise your technicians to adjust and maintain the measurements specified when installing the unit into a Personal Restraint System or during routine maintenance.

We recommend that the joint rod heads be secured at the specified dimensions and tightened with a torque wrench. The LE 25 version should be tightened to **80 Nm ±10 Nm**. The LE 32 version should be tightened to **90 Nm ±10 Nm**.

The correct measurement must be set and checked when installing or performing maintenance on the Cylinder Accumulator unit. In this way the required minimum screw thread depth engagement (as set out in VDI 2230) is maintained.

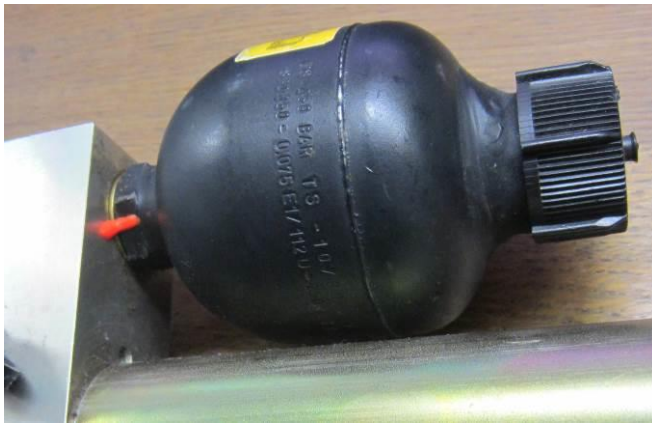
Figure 4: how to apply torque striping on the accumulator.

- Issue : After reviewing all connections and the Hoerbiger safety related document, below actions are taken to reduce the risk of a loosening accumulator.
- Action Supplier : Checking the accumulator connection was included in the assembly process.
- VRP&S' advice : Add torque striping between the connection of the accumulator and the manifold block (see figure 4) and perform a weekly check on this section.
