404.

GERSTLAUER EUROFIGHTER

Train chassis cracking and seat post cracking

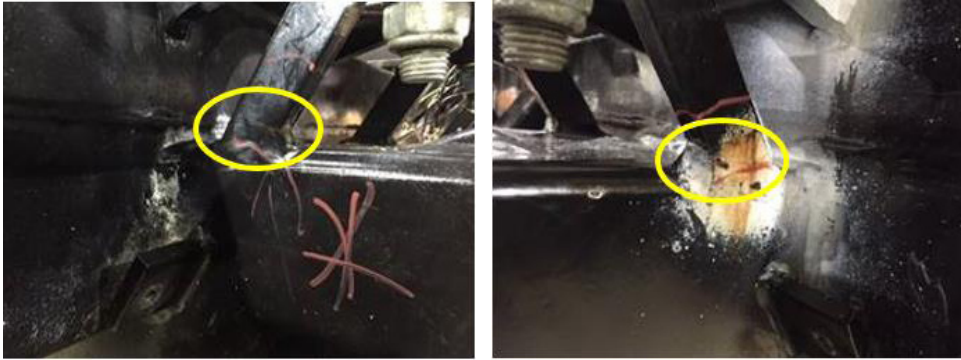
▲ The strengthening arms between the seat frame and chassis

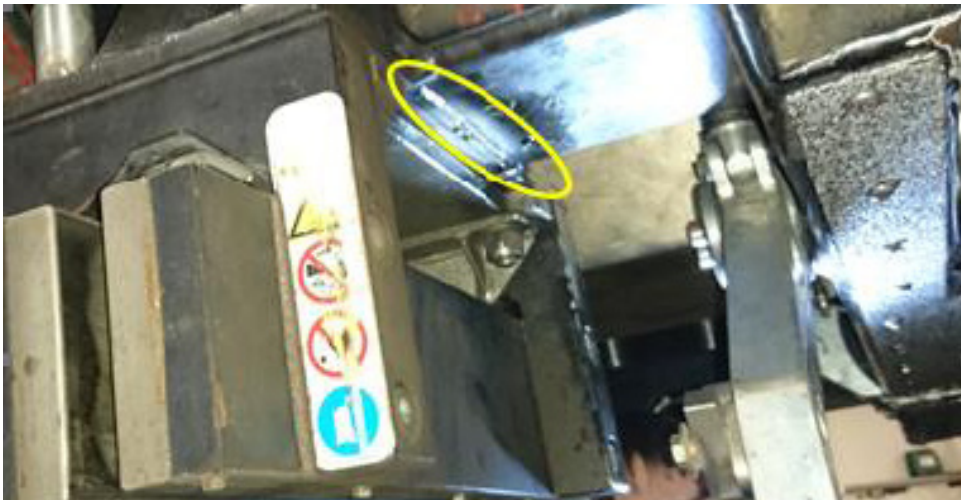
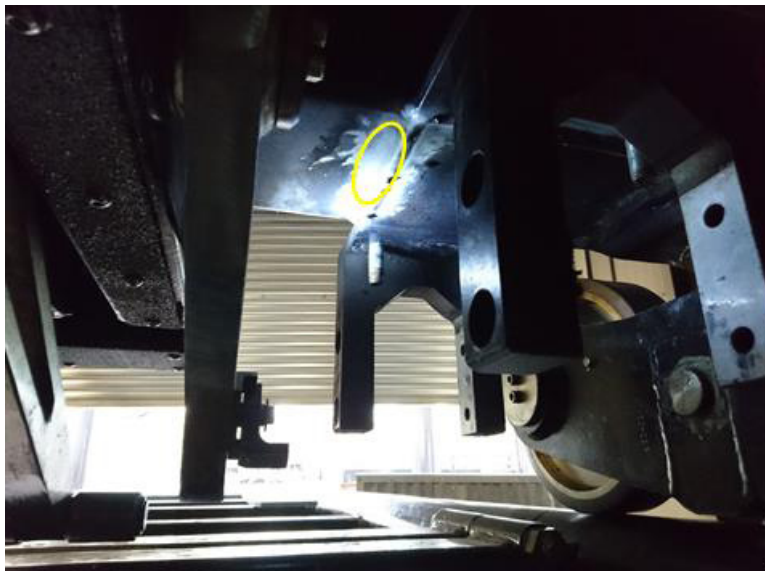
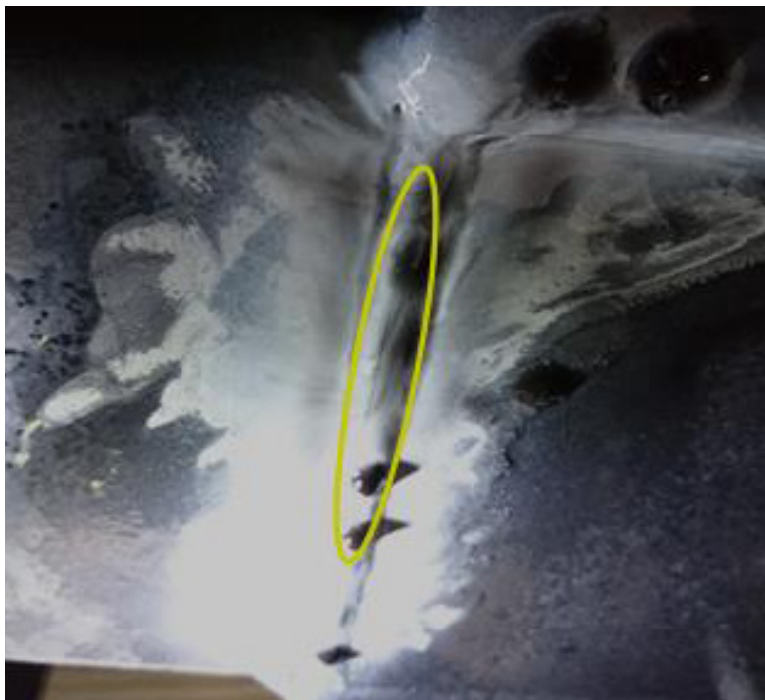
Additionally, again in relation to a Gerstlauer EuroFighter, the same IB has found an area of cracking next to where the magnetic brake is fixed to the chassis (see images). To fully inspect the area by MPI the magnetic brake requires removal.

▼ An area of cracking was found next to where the magnetic brake is fixed to the chassis (see following three images)
