404.

GERSTLAUER EUROFIGHTER

Train chassis cracking and seat post cracking

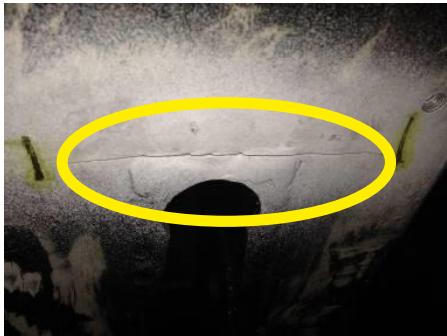
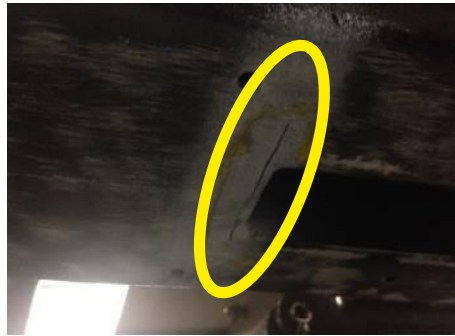
These trains are used on a number of different track configurations. This particular one has a number of indications of cracks but the majority of these are hidden under drive plate materials. The extent of the cracks can therefore only be fully seen when the drive plate is removed. This may not be included in the normal NDT schedule so IBs are recommended to pay attention to all areas relating to this.

▲ Drive plate area

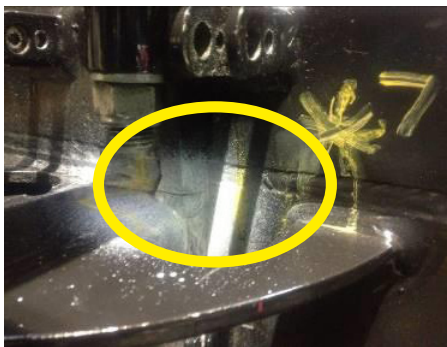
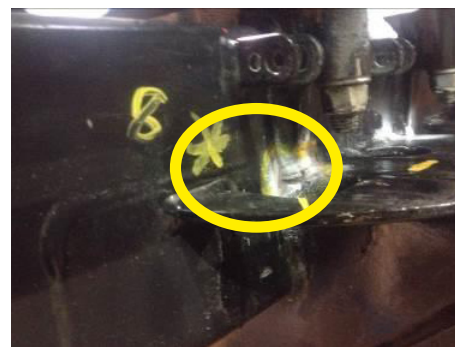
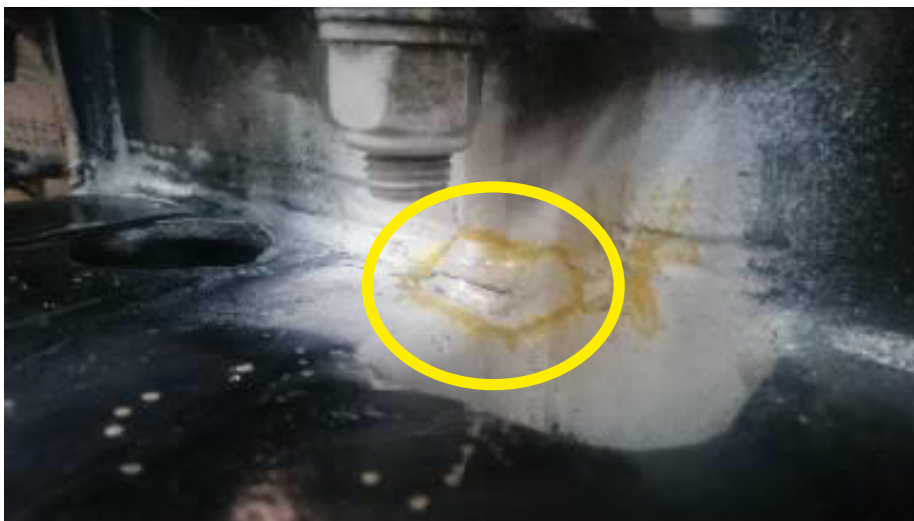
▲ Strengthening gusset cracking below seat

We have received a report from a UK registered inspection body that numerous areas of cracking have been found on the train chassis of a Gerstlauer EuroFighter. The areas of cracking were found by both visual and NDE inspection. The manufacturer has issued a WPS (weld procedure specification).

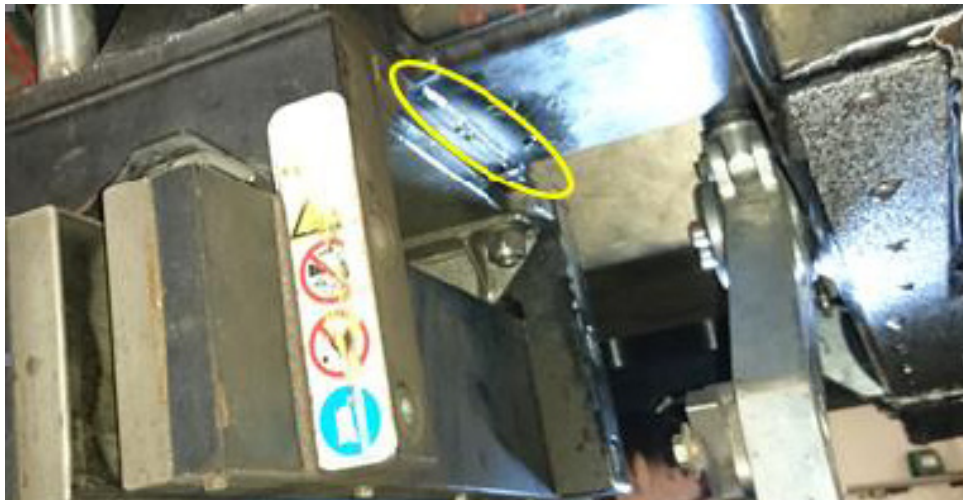
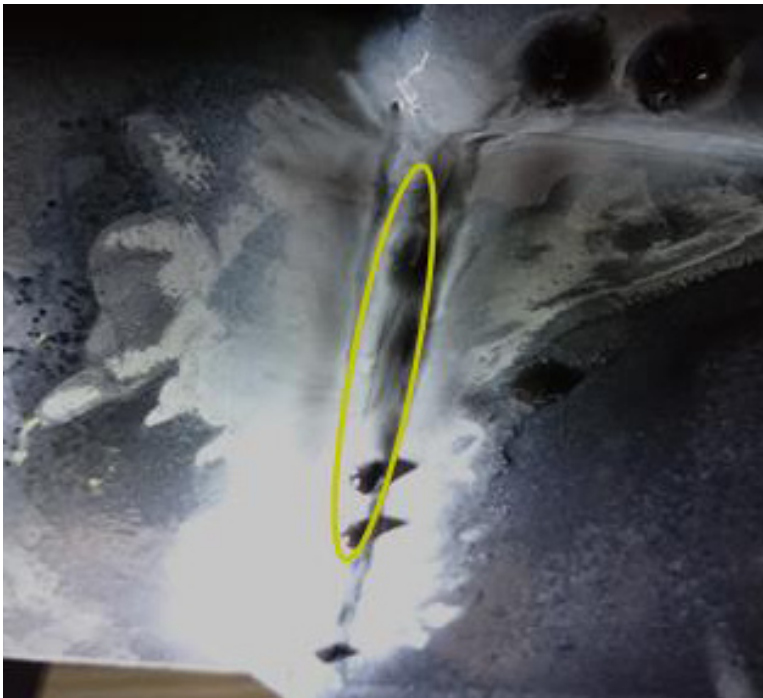
Additionally, again in relation to a Gerstlauer EuroFighter, the same IB has found an area of cracking next to where the magnetic brake is fixed to the chassis (see images). To fully inspect the area by MPI the magnetic brake requires removal.

▼ An area of cracking was found next to where the magnetic brake is fixed to the chassis (see following three images)

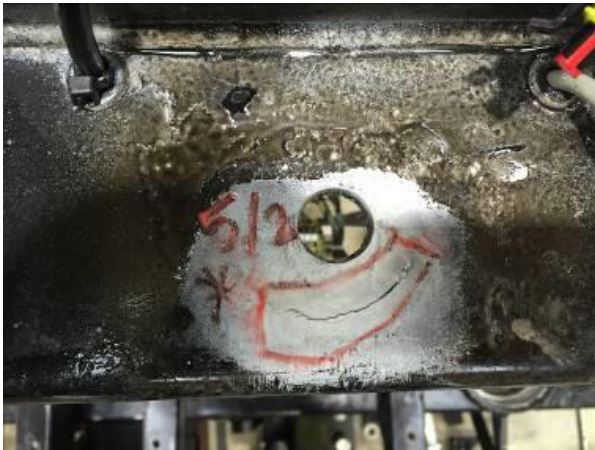
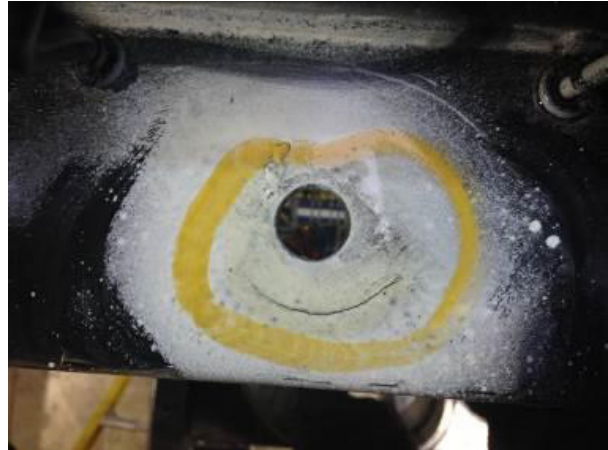
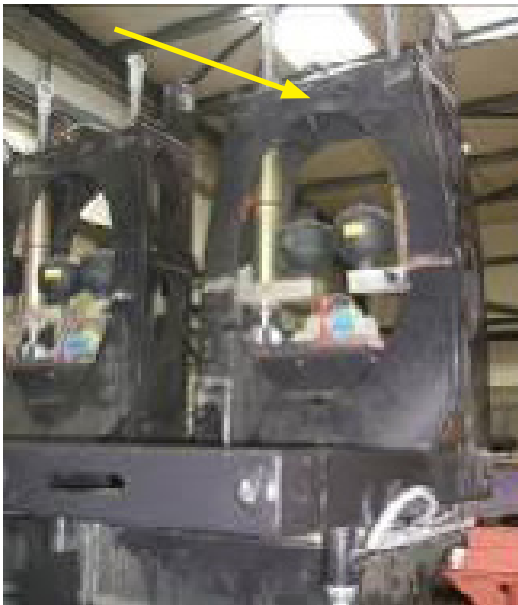
Seat Post Cracking

Also in relation to a Gerstlauer EuroFighter, we have received a report from the same IB that areas of cracking have been found on the top of numerous seat posts. These were found by both visual and NDE inspection. The manufacturer has issued a WPS.
