## 405. Intamin Drop Tower seat bracket cracking

We have received a report from a UK registered inspection body that numerous areas of cracking have been found on the seat brackets on an Intamin Drop Tower ride. These areas of cracking were found by Visual Examination and Dye Penetrant Testing and are in unexpected areas.

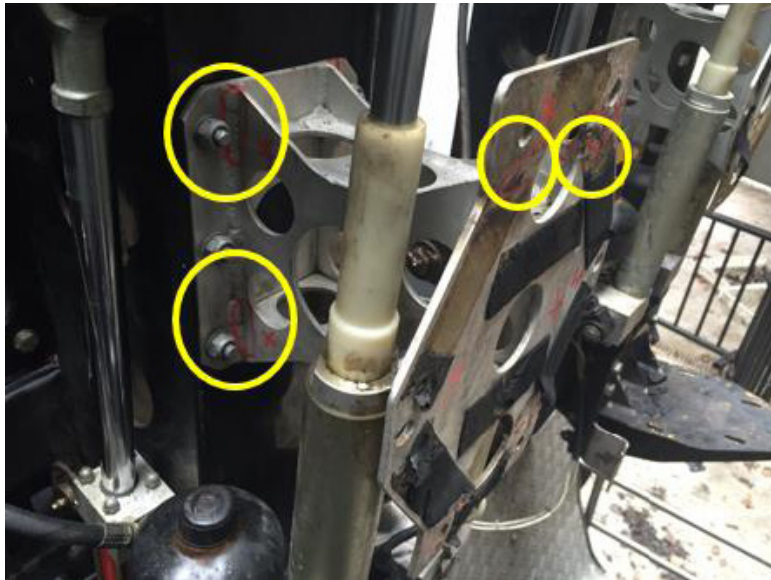
▲ Bracket installed on the Kart

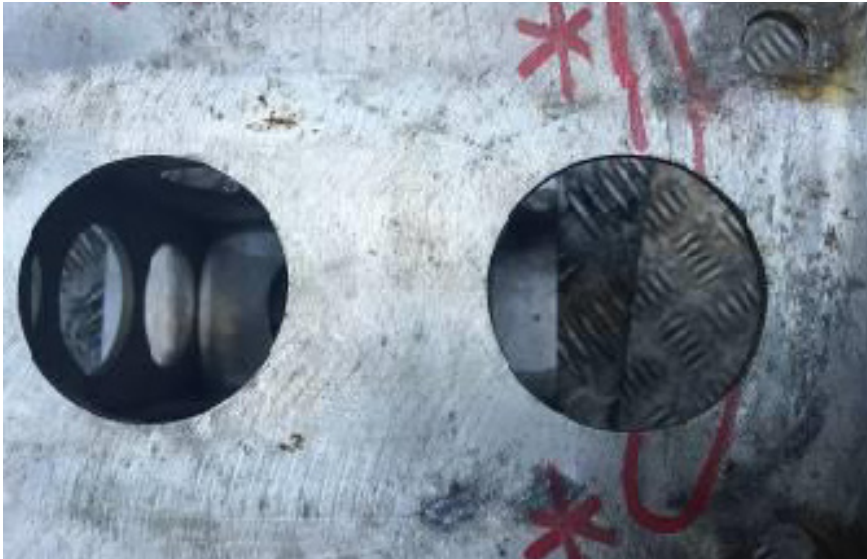
▲ Cracking on the rear of the bracket found visually

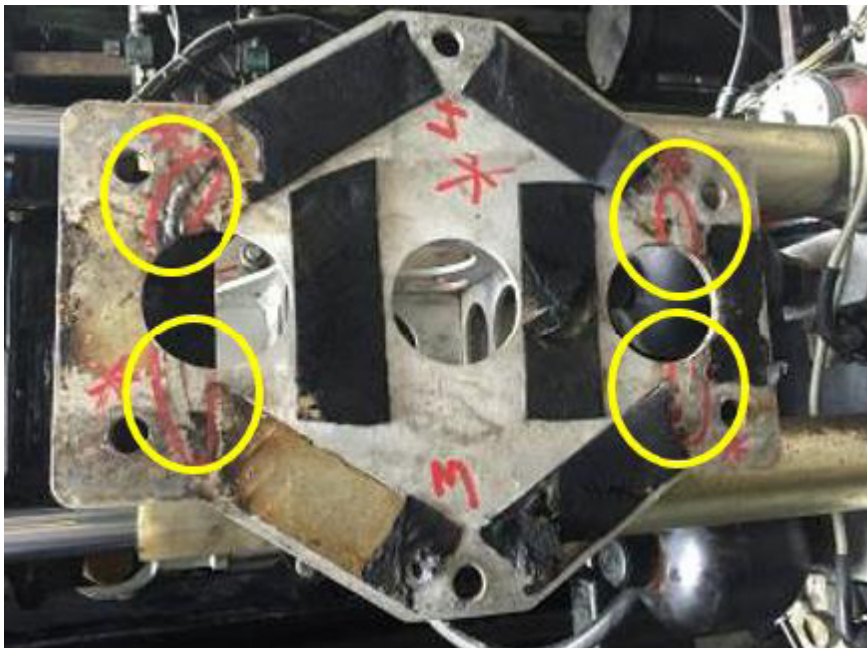
▲ Cracking on the front of the bracket found visually
