## Lifting Paratrooper weld failure

A UK inspection body has recently been informed of a car attachment pin weld failure on a Lifting Paratrooper made by Hrubetz in 1979. Fortunately the failure occurred during the dismantling of the ride. However, the exact events that lead to the component failure are still not known.

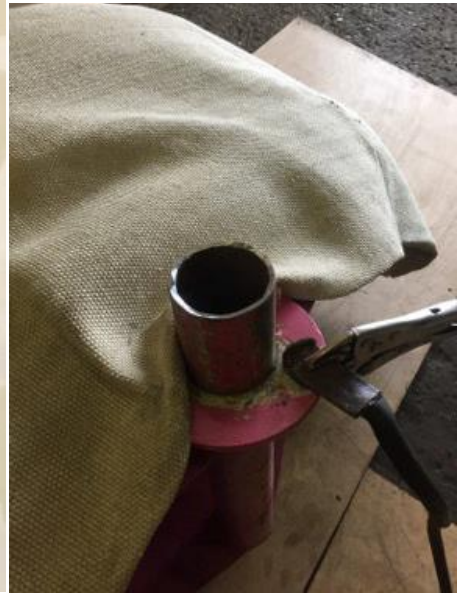
Figure 1

It appears that the weld around the plate that holds the attachment bolt to the car frame failed and allowed the bolt to come away from the car frame. (See figure 1)

The failure could be due to a variety of factors such as:

- Poor manufacturing welds
- Over stressing of the weld due to over tightening of the securing bolt
- Weld fatigue due to age
- Severe impact during take down procedure

The IB involved is recommending its clients take the following action before their ride is next operated:

- Remove all cars and visually check the area for indications
- If operators are unsure they should have this done by an ADIPS registered NDT inspection body
- If it is not already, this weld should be added to the ride NDT schedule and checked annually with MPI. The defect criteria would be no cracks
- Should any defects be found all car attachment bolts should be replaced immediately

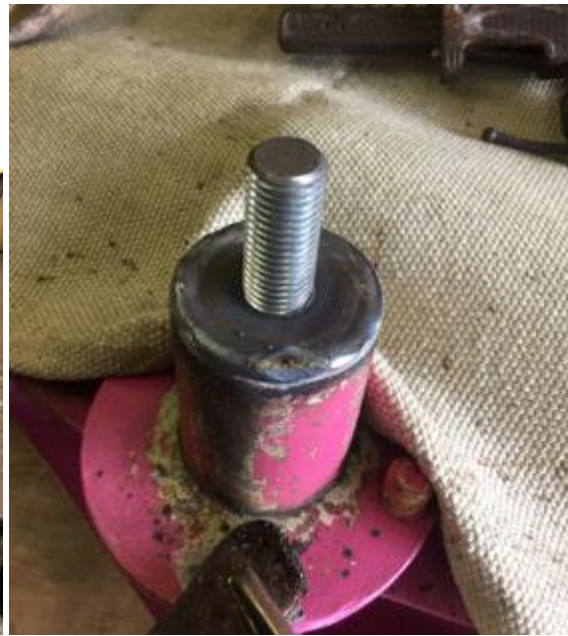
Figure 2

In this case the operator has opted to replace all 10 car attachment bolts. (See figure 2)

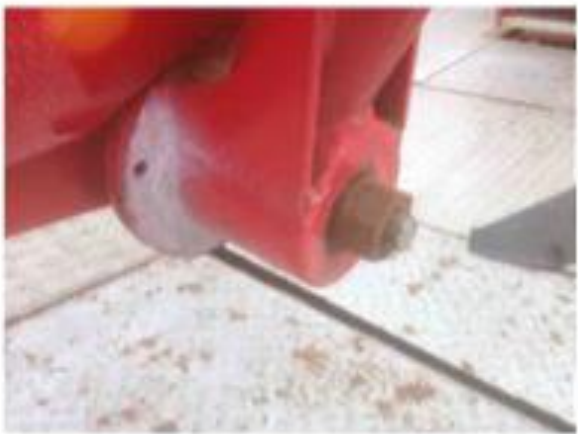
General image of component when assembled

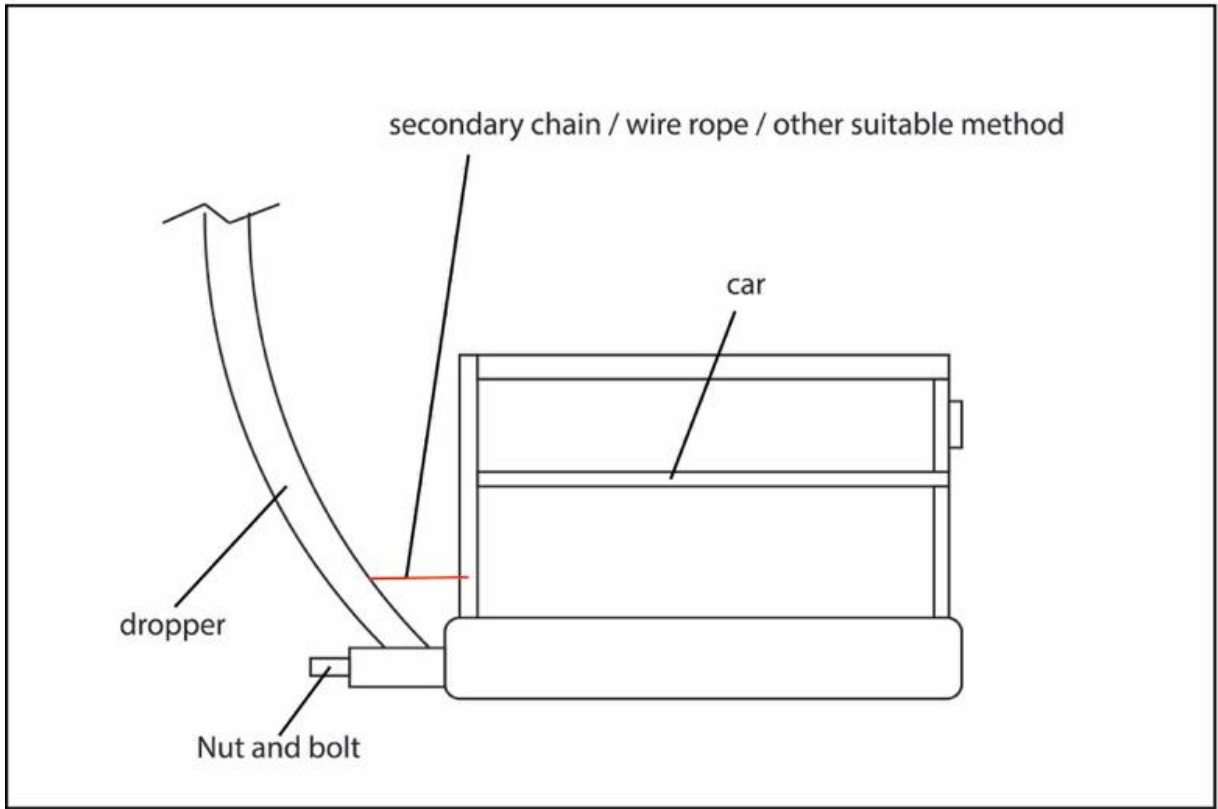
Figure 3

Consideration should be given to the addition of a secondary chain or wire rope between the car and dropper to remove this single point of failure. While this will not be as strong as the bolt, should the bolt fail the secondary only needs to stop the car sliding forward and out of the tube on the bottom of the dropper until the ride stops. (See figure 3)
