443.

Pfleger Sky Flyer

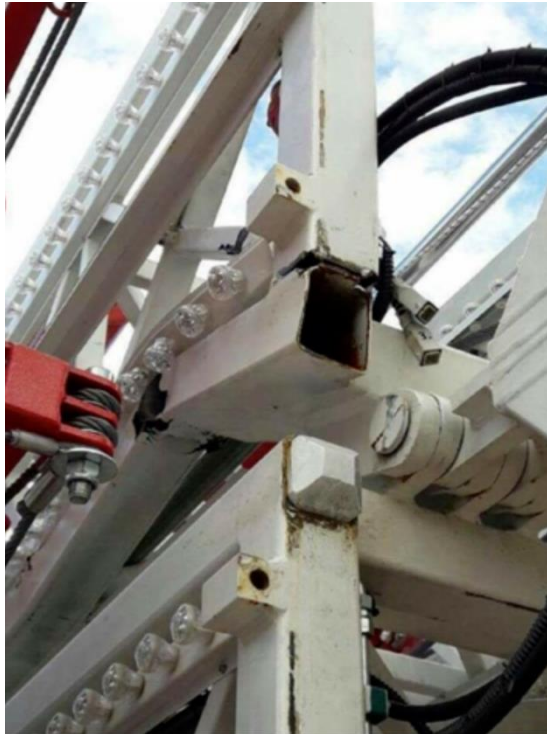
From the information provided to date it is believed this is a self-erecting machine in that it has hydraulic rams to help assembly and dismantling. The failure occurred on the mid pivot on the main tower leg. There is considerable force around this area during build-up and pull down due to the position of the hydraulic folding rams and bell crank arrangement and it would appear that some form of local buckling failure occurred near to the attachment of the lifting cylinders. This happened during the build-up or pull down process and not while in operation. Members of the general public would not, therefore, be affected but it is clear the operational staff would be at risk. It is worth noting that the box section looks very thin (see image).

With only the above information currently available, it is difficult to provide any detailed recommendations but the committee would suggest owners/operators check with their design reviewers that this temporary case has been covered in the design and maybe confirm the correct thickness of SHS has been used.
