PRODUCT IMPROVEMENT BULLETIN

Ride Manufacture	r: Dartron Industries, Inc.	Affected Production D	Dates:
Ride Name:	StarTrooper	Affected Serial #'s	111141-5S
Model #

Abstract of Issue: StarTrooper bushing change

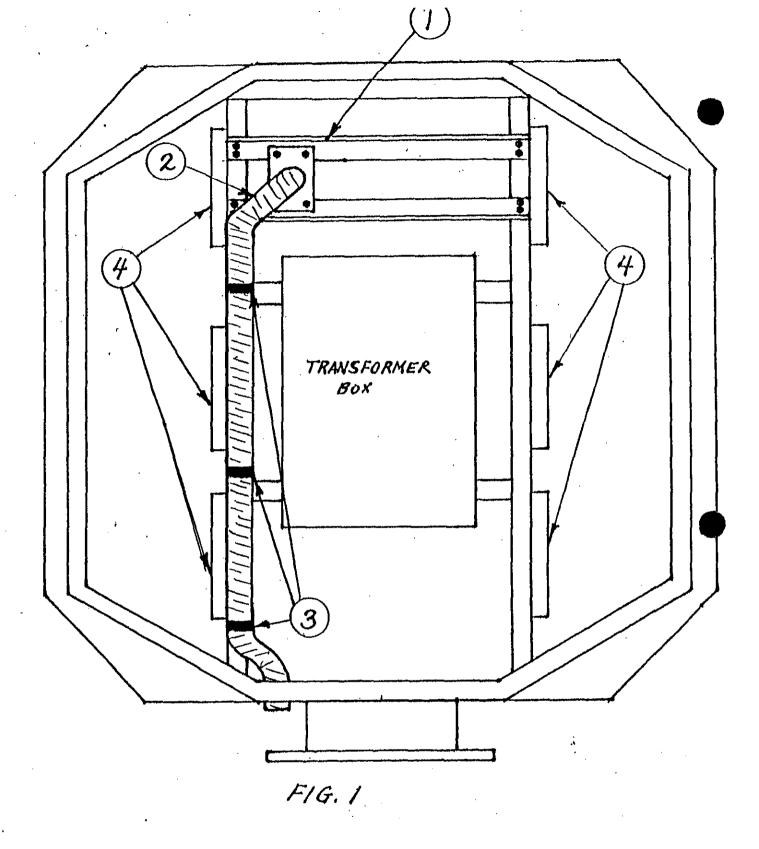
- I. FAN MOTOR ASSEMBLY
- 2. DUCTING
 - 3. CLAMPS
 - 4. BALLASTS

- 11. Replace upper ballasts.
- 12. Restore power to center ornament.
- 13. Check fan operation.
- 14. Replace ornament panels.
