TECHNICAL BULLETIN — July 2013

370. Electrical Safety of Inflatable Blower Fans

Electrical safety - inflatable blower fans

Health and Safety Executive - Safety alert	
Department Name:	Field Operations Directorate - Southern Division
Bulletin No:	FOD 3-2013
Issue Date:	9 July 2013
Target Audience:	Entertainment and Leisure industries ^[1] , Inflatable equipment industries and service Inspectors/personnel, Education ^[2] , Catering and Hospitality ^[3]
Key Issues:	Measures to help maintain the electrical safety and integrity of mains voltage powered fan blowers (imported from China) which could be use in wet conditions for inflating play equipment or advertising inflatables.

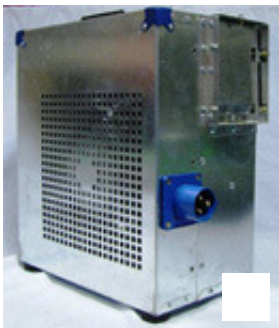
The Health and Safety Executive (HSE) have become aware of an electrical safety issue with a particular design of fan blower that has been imported into the UK by a number of suppliers. This type of fan blower is typically used to inflate play equipment (small bouncy castles) and advertising inflatables. The type of fan design affected is one where the electrical socket is fitted to the front of the casing, below the blower outlet (i.e. not on a cable lead) and you can see the rear of the electrical socket & conductors (as below).

[4]
Inflatable blower
fan

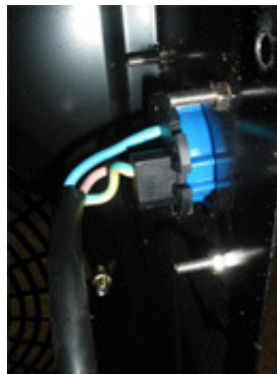
[5]
Affected fan - rear
of electrical
socket &
conductors

[6]
Affected fan - rear
of electrical
socket &

conductors
