TECHNICAL BULLETIN — July 2014

379. Zamperla Jump Around Radial Arm Cracking

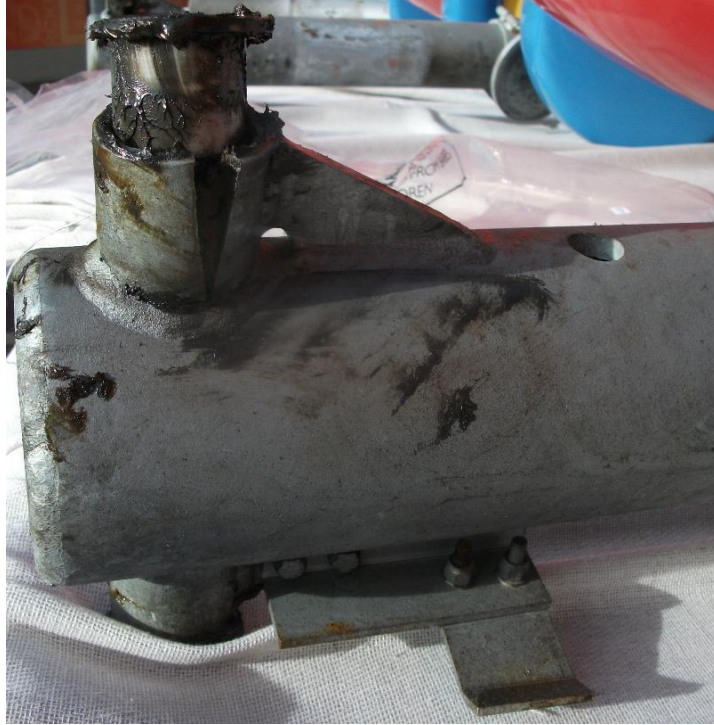
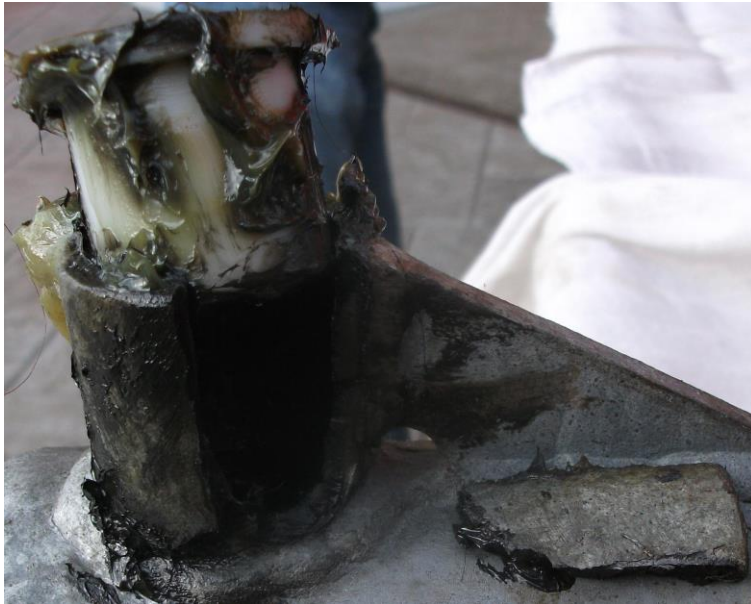
Cracking has been detected on the radial arms of a Jump Around device. The device was manufactured by Zamperla in 2011. The cracking is on the housing for the pivot pin connection to the main rotating centre structure, as shown in the photographs below. Inspection Bodies should pay particular attention to these areas when carrying out Annual Inspections.

According to the ride manufacturer similar problems have been reported on four Jump Around rides, out of a total of approximately 150 that have been manufactured to date. The cause of the problem is still to be confirmed.
